Copper Applications

A Case Study

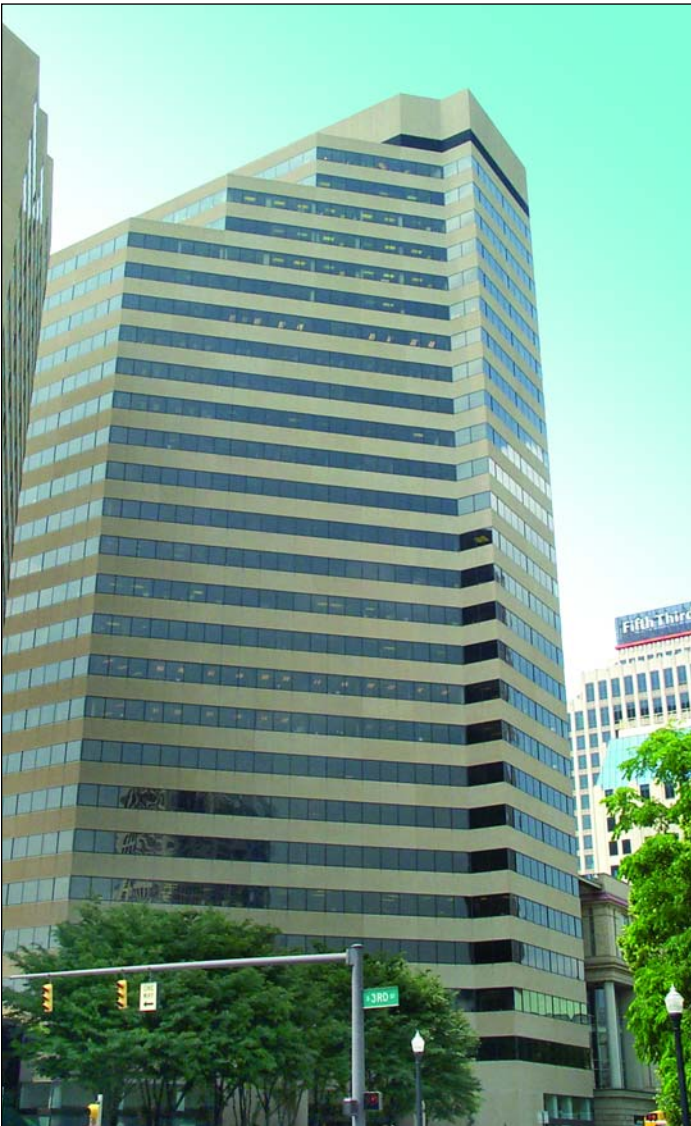
Caveat emptor — Let the buyer beware! Good advice, whether you're buying a used car or dealing with high-end commercial property. Case in point: Capitol Square, an attractive 27-story, 400,000-sq ft office tower located in downtown Columbus, Ohio (cover photo). Built in 1982, Capitol Square and its electrical system served its early occupants well. Until, that is, growing loads and some false economizing taken at the time of construction caught up with the original system.

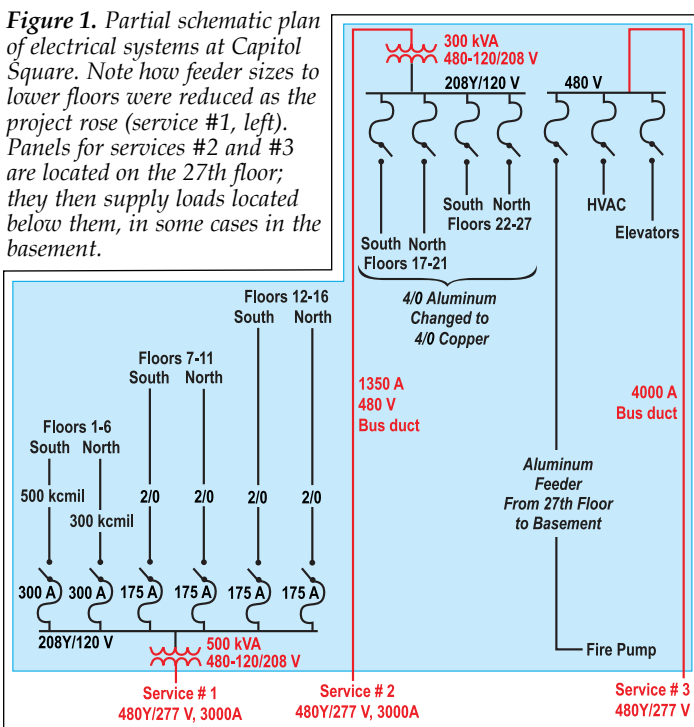
Ohio-based consulting and engineering firm with a reputation for solving power quality issues. PowerEdge sent Tim Cookson, an electrical engineer and a certified power quality specialist. Cookson went over Capitol Square's electrical system from top to bottom. The discrepancies he discovered can be found in many older buildings — maybe yours.

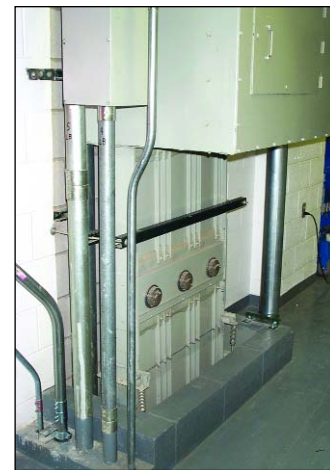
Figure 2. A 1,350-A/480-V copper bus duct leading from the Capitol Square basement to the building's utility loft on the 27th floor, from where it feeds the 300-kVA transformer that supplies 208Y/120-V service to the 17th through 27th floors. Aluminum feeder cables had loose connections, which contributed to the voltage drop experienced on the upper floors.

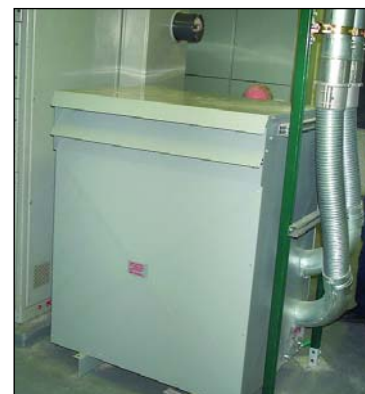
"Feeders from the transformer to the floors below were wired with 4/0 aluminum. The aluminum conductor wasn't supported with wedges, as required, but that was just one of several problems. The 208Y/120-V service is three-phase, to which someone had apparently added an AWG #6 copper equipment grounding conductor as an afterthought because the green wire was run outside the conduit (Figure 4). Equipment grounding conductors are required to be installed in the same conduit as circuit conductors.

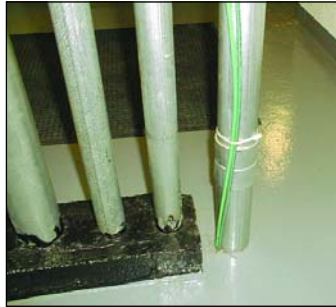
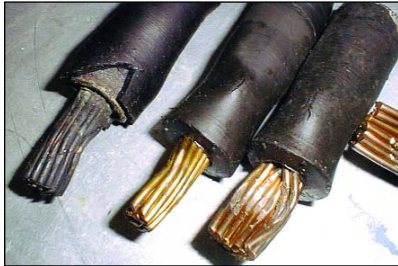
Figure 5. Many instances of improper connections between 4/0 aluminum feeder cables and copper breaker terminations on floors 17–27 caused the aluminum to overheat, damaging the insulation. High resistance contributed to large voltage drops on these floors.

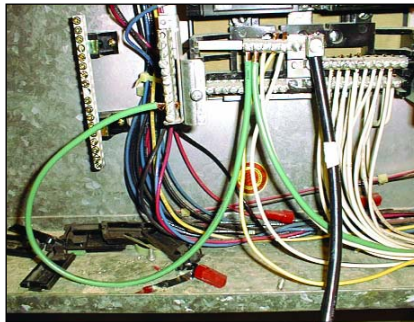
“As you’d expect, we found high currents on the grounding system in several locations: 17.8 A on service #1, 8.6 A on #2 and 23 A on #3. The 500-kVA transformer in the basement had 33 A of current on the grounding electrode conductor, and the 300-kVA transformer on the 27th floor registered 95 A (at 120 V) on the improper neutral-to-ground bond.

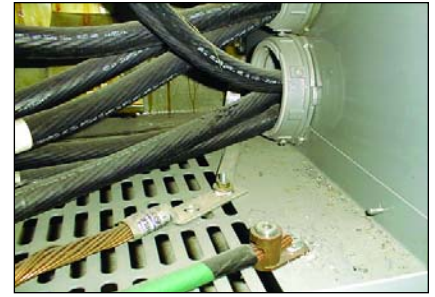
copper. But we discovered that the original contractor had cut some corners, even on the service to the lower floors. The #1 low-voltage service was brought up in six risers. On the south wing side, 500-kcmil copper fused at 300 A had been run up to the sixth floor. But then, the feeder size was reduced to 300-kcmil for supplying the same floors on the north wing. The feeder size was reduced yet again for floors 7 through 11 and 12 through 16, where 2/0 (175-A fuse) risers were installed. When I see a situation like that, I suspect the builder was trying to reduce costs as the project went along. It’s really false economy, because cutting corners doesn’t leave any margin for error, and that was exactly what happened at Capitol Square.”

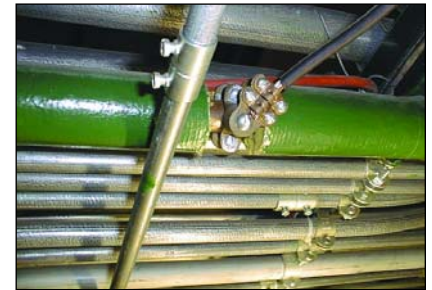
Safety and grounding fixed first

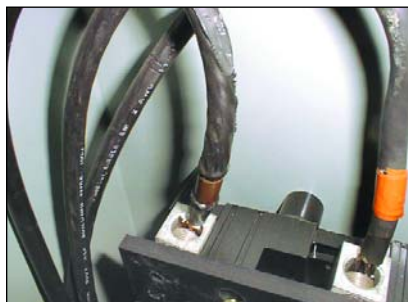
Figure 10. Evidence of overheating is seen in the damaged insulation on this aluminum conductor leading to the chiller disconnect switch on the building's 27th floor. The aluminum has been replaced with copper of the same wire gage.
