# Copper Applications

## Copper Corrects Power Quality Problems in Columbus, Ohio, High-Rise Office Tower

Recurring Problems Vanish when Copper Replaces Aluminum Feeders

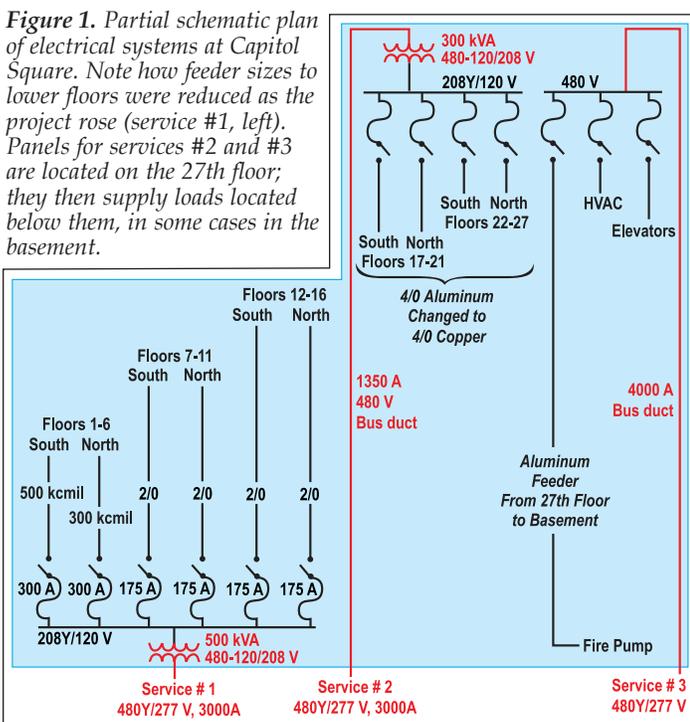
**Figure 1.** Partial schematic plan of electrical systems at Capitol Square. Note how feeder sizes to lower floors were reduced as the project rose (service #1, left). Panels for services #2 and #3 are located on the 27th floor; they then supply loads located below them, in some cases in the basement.

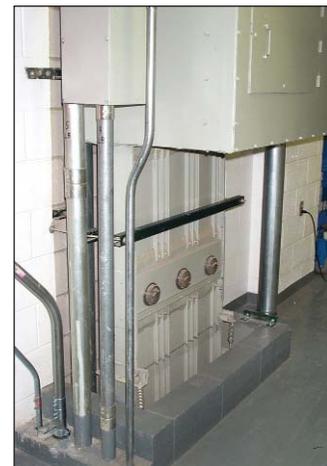
"Low-voltage service to the upper floors, designated as service #2, is supplied by a 1,350 A/480-V copper bus duct from the basement to the 27th floor (Figures 1 and 2). There, it feeds a 300-kVA step-down transformer that supplies 208Y/120-V service back down to floors 17 through 27 (Figure 3). The transformer was overheating so badly that building maintenance had to set up a large fan to cool it.

**Figure 2.** A 1,350-A/480-V copper bus duct leading from the Capitol Square basement to the building's utility loft on the 27th floor, from where it feeds the 300-kVA transformer that supplies 208Y/120-V service to the 17th through 27th floors. Aluminum feeder cables had loose connections, which contributed to the voltage drop experienced on the upper floors.

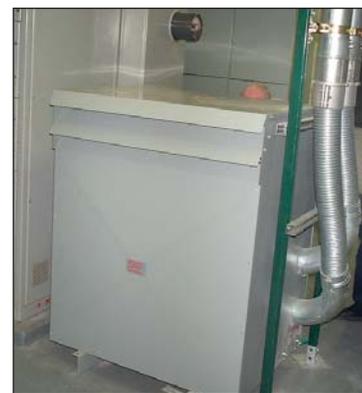
**Figure 3.** A 300-kVA transformer located on the building's 27th floor supplies 3-phase 208Y/120-V low-voltage service to floors 17 through 27. Poorly made high-resistance connections to the transformer caused large current differences on parallel conductors leading from the transformer. Loose connections on aluminum feeder cable throughout the system caused the transformer to overheat.

“We also measured unusually high differences in current draw on parallel aluminum conductors leading from the 27th-floor 300-kVA transformer; as high as 62 A on phase A, 108 A on phase B and 29 A on phase C. That was clear evidence of poor (high resistance) aluminum connections at the transformer and/or switchboard. We also found that improper grounding and bonding methods had been used in the transformer. Both the grounding electrode conductor and the neutral-ground connection had been made to a painted surface inside the transformer case (**Figure 7**). Painted surfaces offer questionable resistance and reliability, the last things you'd want at a grounding connection. And, neutral-ground bonds belong at the service entrance or at a separately derived source (transformer), nowhere else.

tors, reliable bonds could be made inside the cabinets (**Figure 9**). We corrected the poor connections at the transformer and eliminated the imbalanced parallel-phase currents. Improper neutral-ground bonds were removed. The 300-kVA transformer now runs at an acceptable temperature.

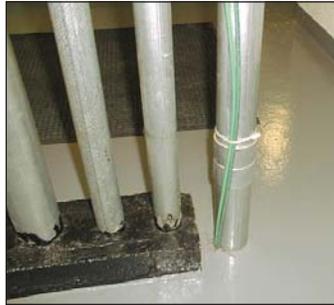
"Feeders from the transformer to the floors below were wired with 4/0 aluminum. The aluminum conductor wasn't supported with wedges, as required, but that was just one of several problems. The 208Y/120-V service is three-phase, to which someone had apparently added an AWG #6 copper equipment grounding conductor as an afterthought because the green wire was run outside the conduit (Figure 4). Equipment grounding conductors are required to be installed in the same conduit as circuit conductors.

**Figure 4.** During an earlier undocumented fix, a green wire had been run outside conduit carrying 208Y/120-V, 3-phase power from the 27th floor to floors 17–27. Replacement of aluminum feeder cables in the conduit with copper of the same gage left sufficient room to pull the green wire and an IG conductor inside the conduit. This avoided replacing the conduit, an expensive job.

“JLL told us that safety and grounding issues would be our top priority,” said Cookson. “So the first thing we did was have JLL's new electrical contractor remove that 4/0 aluminum and replace it with copper. Making that change increased feeder capacity to 200 A. Using 4/0 copper also meant he didn't have to go to larger conduit, which would have made this a much more expensive retrofit. The new copper even left us enough room in the existing conduit to pull a full-sized 4/0 green wire for the 3-phase service and, while we were at it, install a true isolated ground (IG) conductor leading directly back to the neutral-ground bond point at the source, as it should.

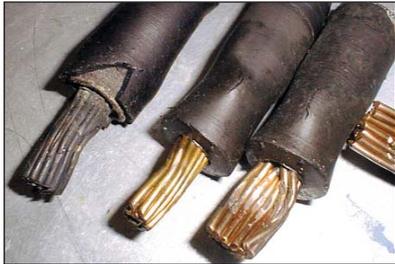
"Transitions from aluminum to copper on floors 17 through 26 were made improperly (Figure 5), and many of the connections were loose. We picked up a lot of hot spots when we checked the panels with our infrared (IR) scanner. The loose connections caused voltage to drop to as low as 102 V on the upper floors during peak loading. The upper floor feeders were fused at 140 A, which is consistent with

the aluminum wire originally installed, but when fuses kept opening, someone simply increased the fuse size to 200 A!

**Figure 5.** Many instances of improper connections between 4/0 aluminum feeder cables and copper breaker terminations on floors 17–27 caused the aluminum to overheat, damaging the insulation. High resistance contributed to large voltage drops on these floors.

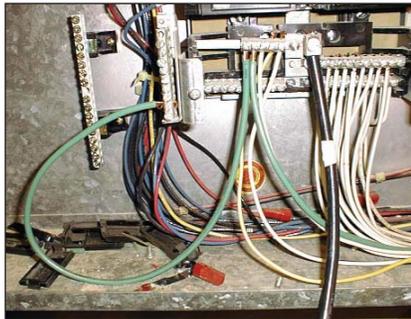
“Breaker cabinets on floors 17 through 26 also contained improper neutral-ground connections (**Figure 6**). Compounding this Code violation, someone had added a connection from all the N-G busses to building steel.

**Figure 6.** Inspection revealed that neutral-ground bonds had been made in all low-voltage breaker cabinets on floors 17–26. Such bonds belong only in the service entrance panel. In addition, grounding conductors had been run from the panels to building steel, compounding the error.

“As you'd expect, we found high currents on the grounding system in several locations: 17.8 A on service #1, 8.6 A on #2 and 23 A on #3. The 500-kVA transformer in the basement had 33 A of current on the grounding electrode conductor, and the 300-kVA transformer on the 27th floor registered 95 A (at 120 V) on the improper neutral-to-ground bond.

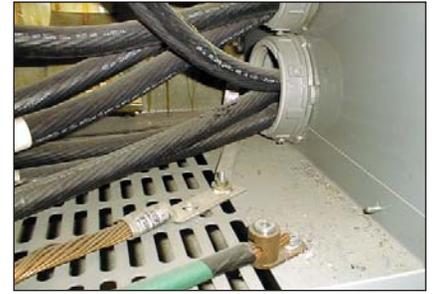
**Figure 7.** Improper grounding and bonding methods had been used inside the 300-kVA transformer. Both the grounding electrode conductor and the neutral-ground bond were connected to painted surfaces, and no equipment grounding conductor was present.

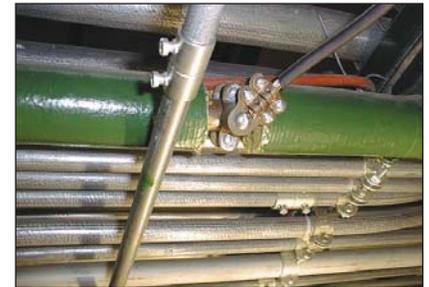
Cookson found that the building's grounding system consisted of a connection to the utility ground and another one to an interior water pipe (**Figure 8**). No connection had been made to the main water service. The interior water pipe connection was questionable, because the meter hadn't been jumpered as required by Code. The building also had a so-called isolated ground (IG); “so-called” in that it was connected directly to building steel on all floors, so it wasn't isolated at all. Like any modern office tower, Capitol Square contains a lot of computers and other sensitive equipment that need good grounding. It didn't have it.

**Figure 8.** Improper grounding connection made to an interior facility water pipe located on the 27th floor. Such connections must be made to the main water service, and a jumper must be installed across the water meter. Neither of those connections had been made.

“We had the contractor drive a low-resistance ground rod at the service entrance, bonding it to the new neutral-ground bus connections. We also bonded the grounding system to the main water service and jumpered the meter and main valve assemblies. Lastly, we bonded the grounding system to building steel. When the contractor finished work, Capitol Square had a low-resistance, better-than-Code-minimum grounding system.

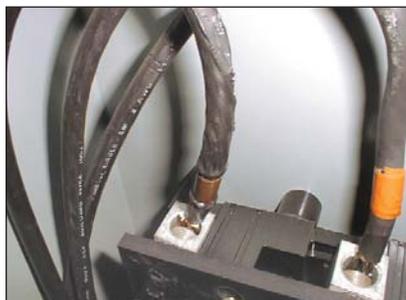
“Finally, we turned our attention to the 4,000-A service, which runs directly to the 27th floor via a 4,000-A/480-V copper bus. It powers the chillers, HVAC system and motor control center. There is a transfer switch to the emergency bus since this service also powers safety equipment, like emergency lighting, fire alarms and fire pump, along with the low-rise and high-rise elevators. The 480-V service running back down the building had also been wired with AWG 4/0 aluminum. The aluminum was obviously overloaded because we found evidence of damaged insulation at the chiller disconnect switch (**Figure 10**). The aluminum is being replaced with 4/0 copper.”

**Figure 10.** Evidence of overheating is seen in the damaged insulation on this aluminum conductor leading to the chiller disconnect switch on the building's 27th floor. The aluminum has been replaced with copper of the same wire gage.
