The *Asperida*, a Copper-Nickel Sailboat after More than Thirty Years in Seawater

**Harold T. Michels and Kenneth P. Geremia
Copper Development Association Inc.
260 Madison Avenue
New York, NY 10016
hmichels@cda.copper.org
Phone 212-251-7224**

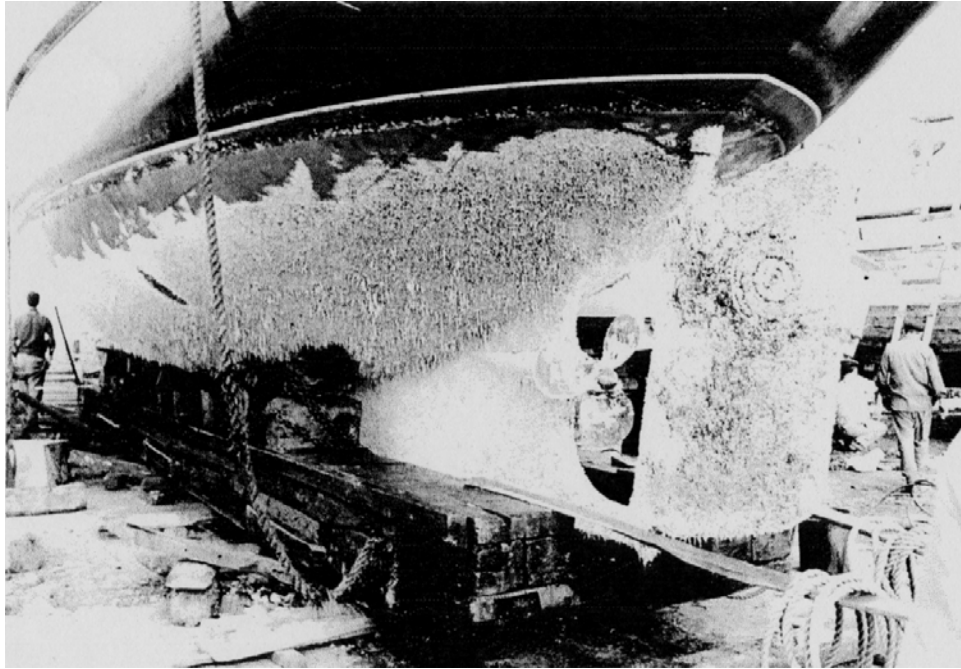
Delivery of the *Asperida* was taken in March 1967.³ In the subsequent months, the vessel suffered from several hard hits in the canals in France. This caused 20% to 30% elongation in small areas of the plates and welds. However, no weakness or failure was observed in the hull. The first growth of grass was observed on the boottop antifouling paint. After about four months in seawater, thin calcareous shell freckling appeared on the hull, but this was easily brushed off by hand, leaving a smooth, clean surface.³ In December of 1967, late in the launch year, Dr. Coons⁵ wrote about two issues. The first related to fouling which developed during an extended stay in a harbor in Spain that is notorious for encouraging excessive marine growth on boat hulls. When the boat arrived in the harbor, it had a thin non-complete cover of barnacles. After a few weeks, sea growth established but was easily removed with a plastic pot scrubber to about 30 cm below the waterline. After several more weeks, the boat was hauled. It was found to be covered with 2.5 cm or more of marine growth, as shown in Figure 3. The marine growth

FIGURE 3: Marine growth after several weeks in a harbor in Spain, which is well-known for high levels of biofouling.

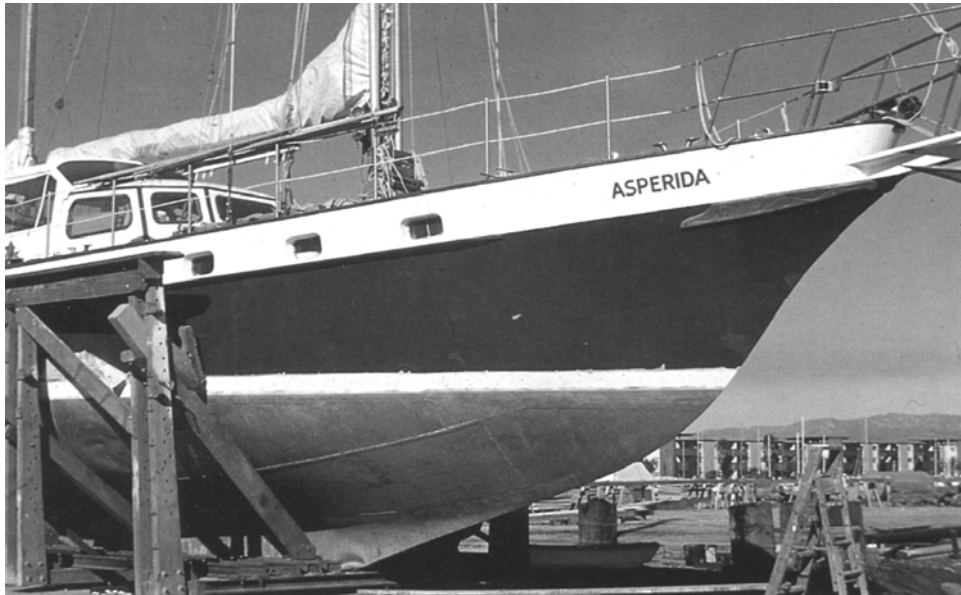
An article on the *Asperida* appeared in *Nickel Topics* magazine eight years after the launch date.⁷ The hull was found to be barnacle-free, after being hauled and hosed down to remove harbor slime, as shown in Figure 4. A few barnacles managed to cling to the hull, aft, near the keel, as can be seen in Figure 5.⁷ These were popped loose with finger pressure. The hull was also reported to discourage algae growth. The *Nickel Topics* article⁷ stated that the hull had a lightly etched appearance, indicative of normal, barely perceptible general corrosion. Several areas aft, near the keel, showed a few shallow pits, which ranged from 0.025 mm to 0.127 mm in depth.^{2,7} Brass screws holding down the teak deck were failing by dezincification. They were probably made of C26000, which composition is shown in Table 2, and were replaced with unidentified nickel-aluminum-bronze alloy fasteners.^{2,7} The original manganese-bronze propeller displayed significant dezincification, as can be seen at the bottom of Figure 6, and was replaced with one made of nickel-aluminum-bronze.^{2,7} Neither the original nor replacement propeller alloy was identified.

FIGURE 4: The barnacle-free hull of the Aperida after being hosed down to remove harbor slime, showing a crumpled forward end of the keel as a result of collision with a submerged rock

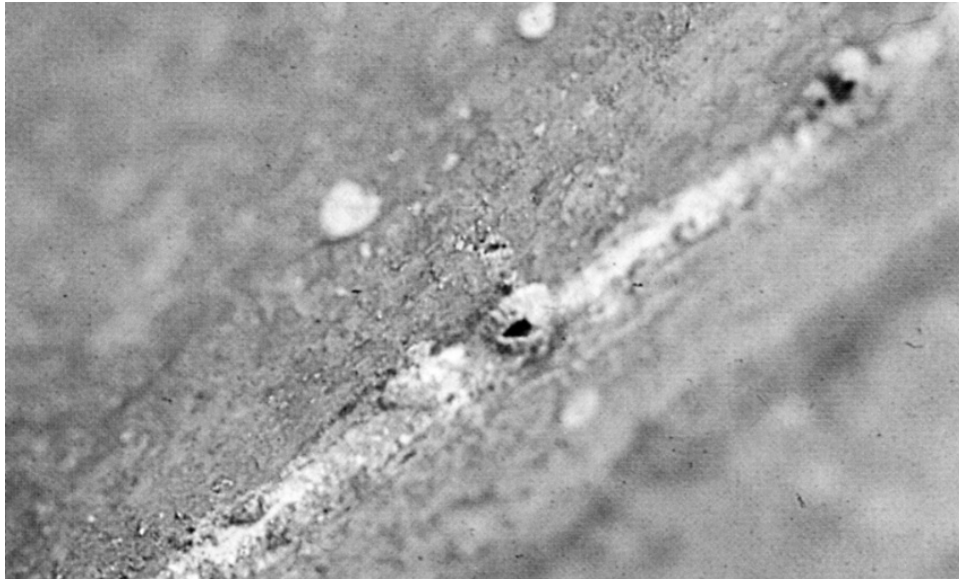
FIGURE 5: Close-up of weld, aft, near keel showing several barnacles, which managed to cling until popped off with finger pressure

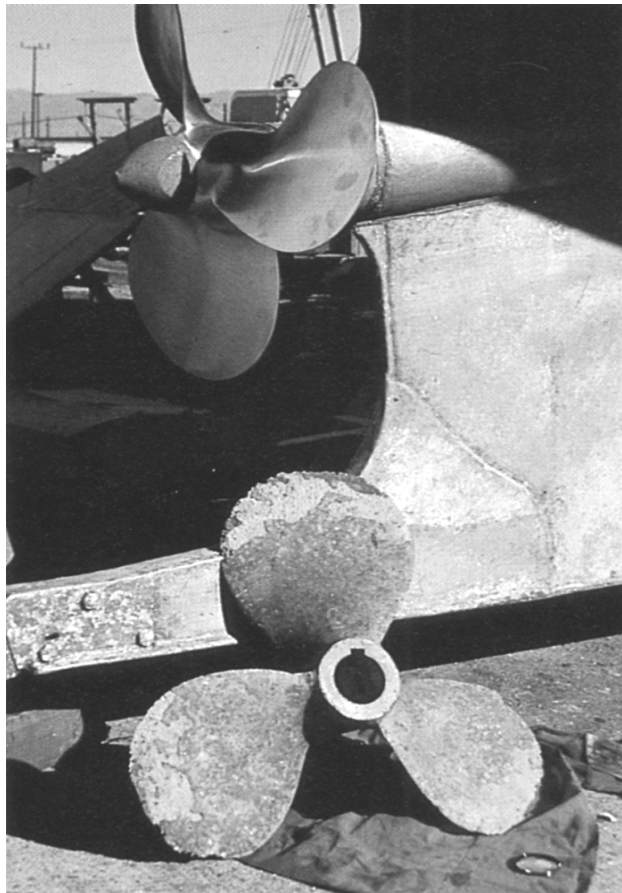
FIGURE 6: Manganese-bronze propeller, which failed by dezincification

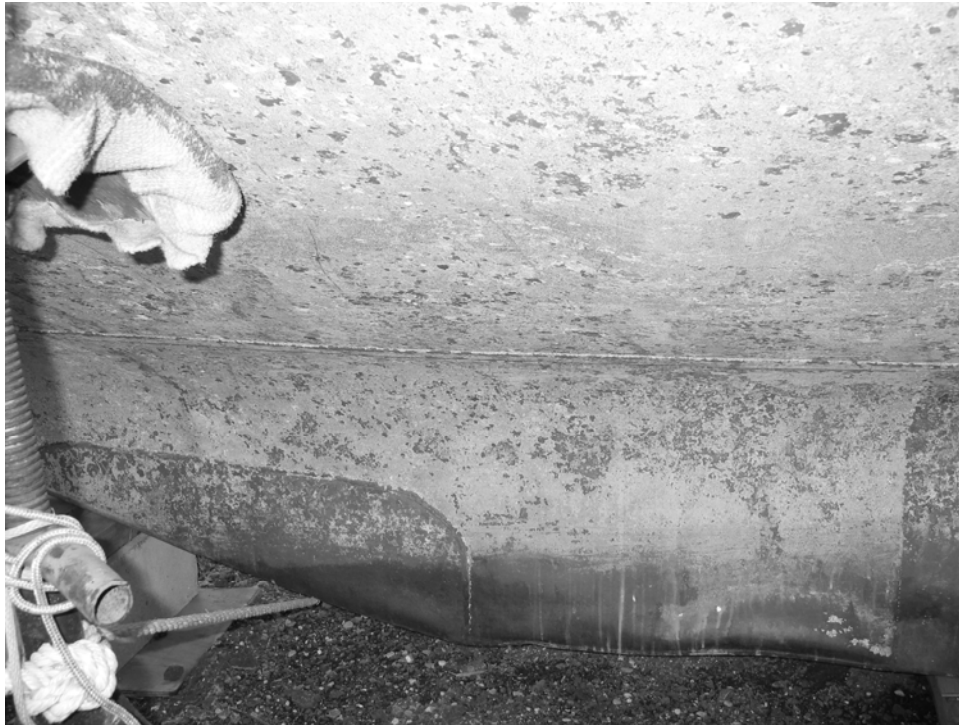
The hull of the *Asperida* was inspected in May, 2004 while it was undergoing a complete refurbishment and refitting in New Jersey. The most obviously damaged area of the hull was the forward end of the keel, which was crumpled and dented, as shown in Figure 7. The plate had not ruptured and the welds had not cracked, which is a testimonial to the ductility of C71500. Also note the horizontal lap weld and the mottled corrosion film, which was a green patina, on the hull. See Figure 4 for an earlier photograph of the crumpled keel, taken in 1975 from the port side. The stern, as well as the web connecting the hull to the trailing edge of the keel, can be seen in Figure 8. Note that the boottop paint at the waterline has been mostly worn away, probably by wave action and weather over time. The paint on the hull, above the waterline, is almost completely gone. The inside of the hull including the hull plates, ribs and deck beams can be seen in Figure 9. Note that these areas have never been painted, and the corrosion is not extensive. The black spots are newly formed high-temperature oxides related to recent welding. Also note that the bottom of the new marine grade plywood deck can be seen in the top of Figure 9. The forward bilge areas were generally quite clean, although a moderate and visible amount of a brown corrosion film has occurred, as shown in Figure 10. However, in one area of the bilge, where the head waste holding tank fitting failed, more corrosion is apparent, as shown in Figure 11. Waste had sat in the bilge for a prolonged period. The corrosion films in this area are mostly brown but are green at the corners and edges of the bilge. Nonetheless, extensive corrosion is not apparent and no failure has occurred. It should be noted that the bilge has never been painted and has required no maintenance.

FIGURE 7: Portion of hull, portside, showing patina, horizontal lap weld and forward end of dented keel

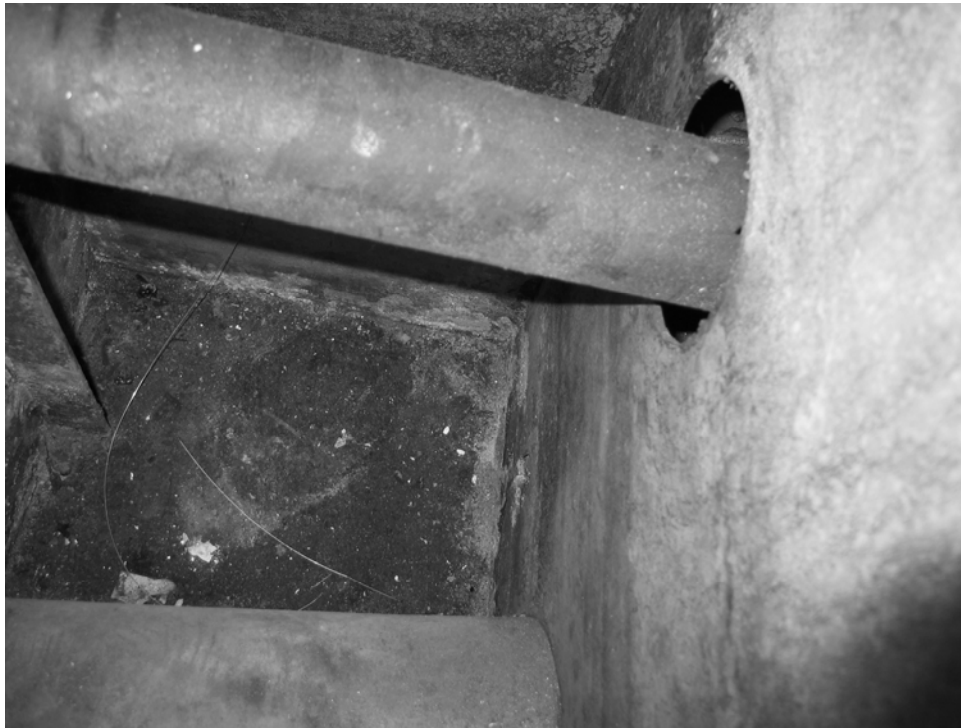
FIGURE 11: Unpainted aft bilge, with shaft passing through, where waste holding tank ruptured

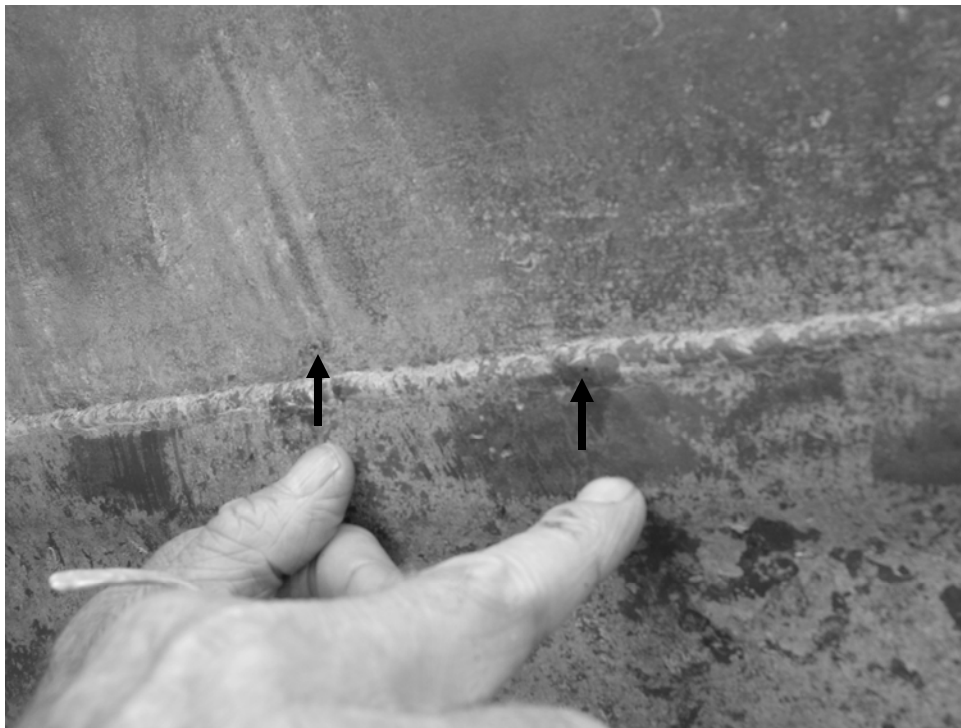
The welds were in generally good condition and were not corroding preferentially. However, an occasional weld defect was observed. An example can be seen in the butt weld above the right digit in Figure 12. A possible pit can be seen on the hull plate above the weld near the left digit. Some gouges can also be found below the weld. These types of defects were very far apart and few in number. The exception was in the bow, where a large number of weld defects are apparent, as can be seen in Figure 13. These weld defects were introduced when the hull was constructed in 1967. They were subsequently exposed as a result of erosion over the past thirty-plus years. However, they have not resulted in leaks, and thus they do not appear to warrant repair.

FIGURE 12: Butt weld with a single defect seen above right digit, and pit in plate above left digit, on port side, amidships, above the waterline

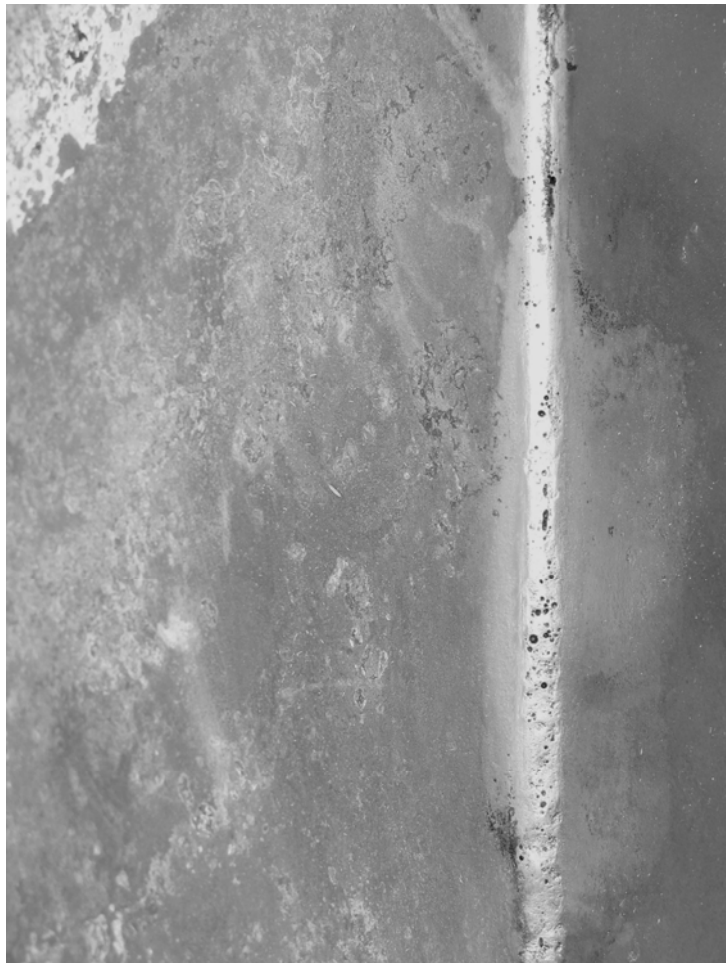
- The weld defects in the bow are attributed to gas that was trapped during initial construction, but they have not leaked and do not require repair.
- Both the C71500 hull plates and W60715 welds have exhibited excellent ductility and mechanical strength, which was apparent when the deformed regions of the hull were examined.

FIGURE 13: Numerous defects in bow weld below the waterline
