A Case Study

POWER QUALITY

A Tale of Two Churches

Lightning protection and robust
grounding essential for steeples, roof structures

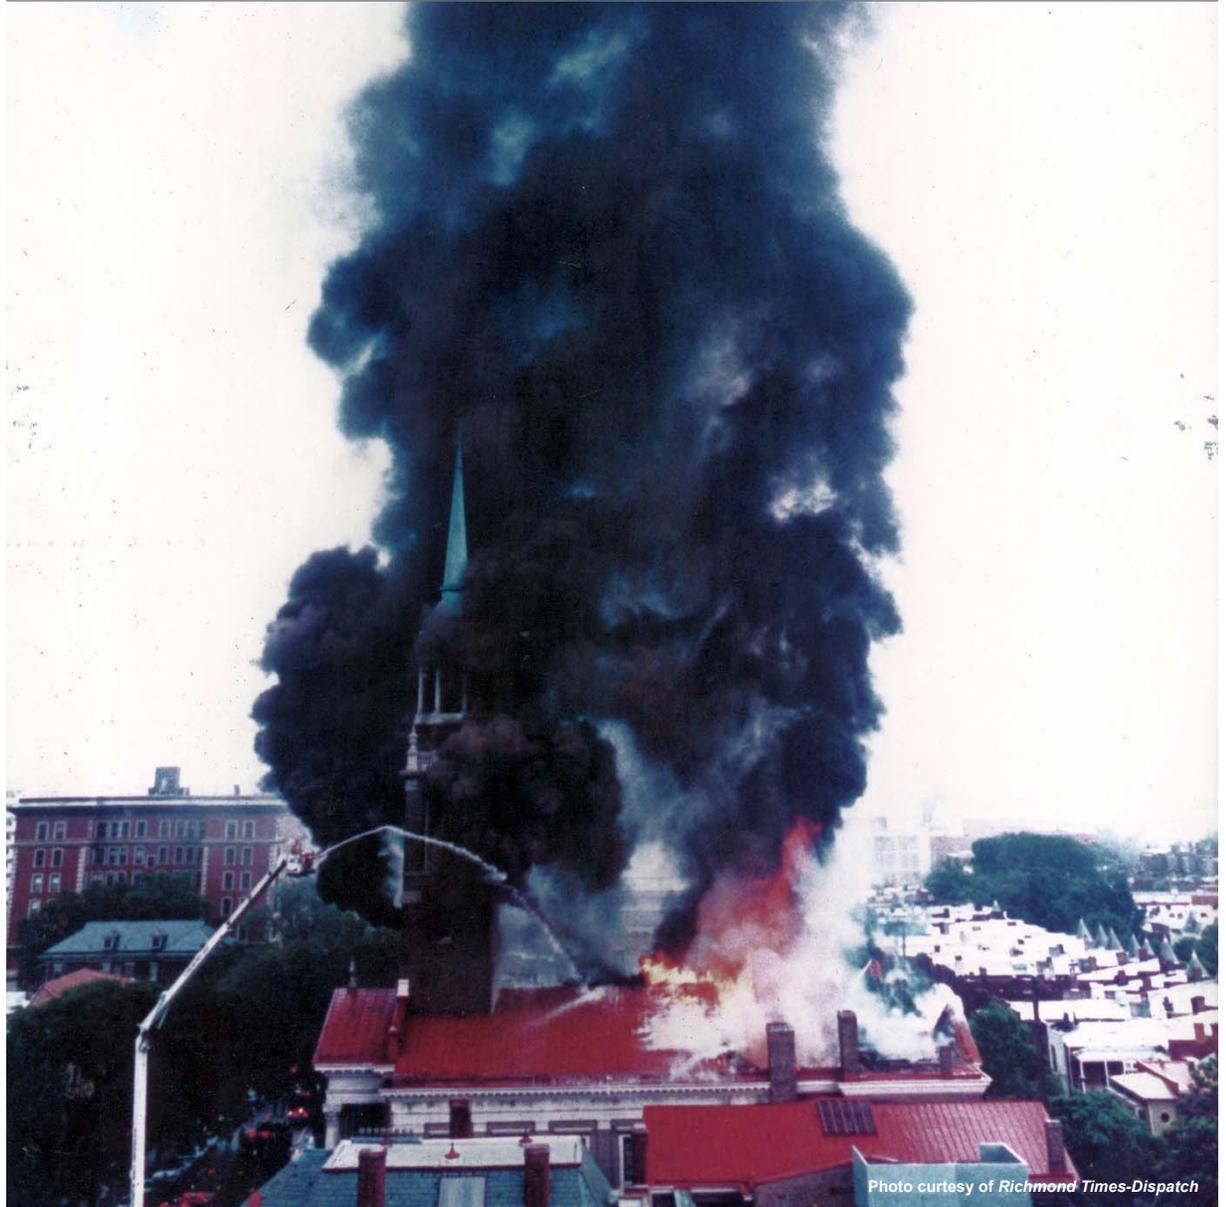
The near-total destruction of Richmond, Virginia's historic St. James Episcopal Church by a 1994 lightning strike is believed to have resulted when the strike hit the ungrounded, copper-clad steeple, from which energy traversed the wooden roof structure, setting it ablaze, rather than being directed safely to earth. An alternative explanation sees the strike initially contacting a distribution transformer behind the structure.

In July, 1994, a thunderstorm that spawned more than 1,000 cloud-to-ground lightning strikes throughout the city sent a massive bolt into the church, leading to its near-total destruction (cover photo). Two scenarios have been posited: the first proposes that lightning initially struck a pole-top distribution

transformer located in the alley behind the church, and that the explosion of that transformer engulfed the rear of the church, destroying it and setting the roof afire. An alternative scenario offered by J. J. Loehr is based on his analysis of the damage some days later. Mr. Loehr suggests that lightning first struck the steeple and that, running out of vertical grounding conductor at or near the base of the steeple, it turned horizontally to run along the gable of the roof, igniting its wooden rafters. According to Mr. Loehr's analysis, the strike then blasted through the rear wall of the church, finally finding earth via the alleyway transformer's ground connection.

For Mr. Loehr, the rebuilt church presented an opportunity to install a robust, standards-based lightning protection system that would shield the structure well into the future. "The church had no lightning protection beforehand," said Mr. Loehr, "So we installed an all-copper, Class II lightning protection system, beginning with a Franklin electrode at the top of the cross atop the steeple. We used 28-strand, 0.066-in copper lightning cable as down-conductors, connecting them to 3/4-in X 10-ft driven electrodes wherever we were able. The cables are practically invisible from street-level. We installed additional air terminals along the periphery of the new roof and on all exposed conduits and structures on the roof itself. Everything, including the building's electrical and water systems was interconnected, and everything is also now at the same ground potential."

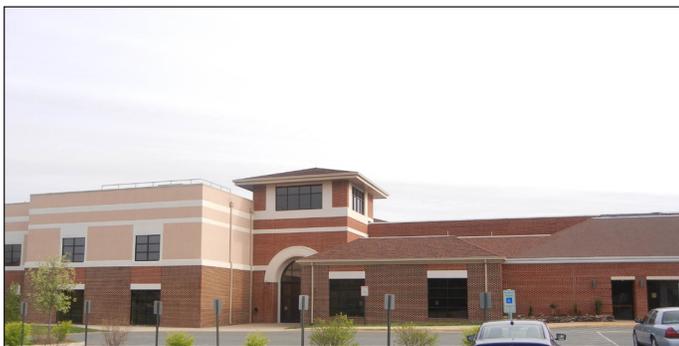
Figure 1. The "new" structure at the Mount Ararat Baptist Church complex stands out prominently among parking lots and roads on the church's large lot, making it especially vulnerable to lightning strikes. Two towers on the structure, one shown at center, were found to be inadequately grounded.

There are two low architectural towers on Mount Ararat's newer building, (Figure 4). The architect had specified an air terminal atop each of the two towers, and that down-conductors should connect the terminals with building steel. That's just what was done. *But there was no mention in the construction spec about grounding the building steel.* As a result, the towers and their inviting air terminals weren't really grounded at all.

Mr. Loehr's fix was to bond the two tower-mounted air terminals to the rooftop lightning protection system and, by way of a heavy-gage, buried copper conductor, connect the grounding systems of the old and new structures. Doing that ensured that the facility's entire grounding and electrical systems were finally at one common potential.

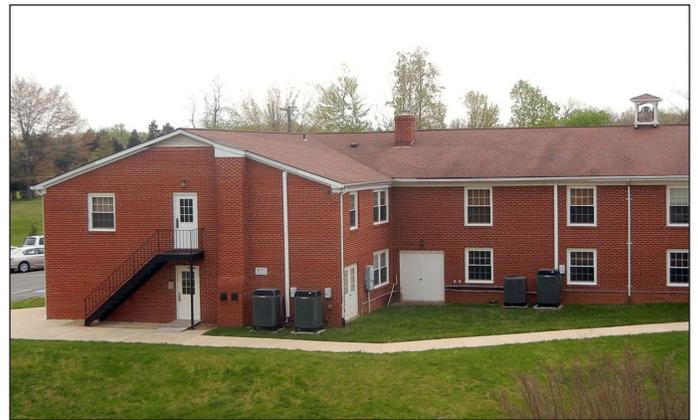
Figure 2. The 2013 lightning strike destroyed a chimney on the "old" structure that stood to the left of the short belfry. From there, it entered the complex via telephone lines, severely damaging or destroying \$100,000 worth of HVAC equipment, an elevator, computers, telephone equipment and important safety devices. Several of the new lightning protection system's rooftop air terminals and their ground conductor connection can be seen in the foreground on the "new" structure's parapet.

"We lost about \$100,000 worth of equipment in that single strike, including the chimney — there were bricks blown everywhere! — and all kinds of HVAC equipment and controls, one of our passenger elevators, all of our computers and telephones, and a lot of life-safety stuff. We just recently found out that a fire light pull-down station was damaged. It's not a device that ordinarily goes bad. We also lost the mini-annunciators that we have all throughout the building. That was rather costly.

The first thing that struck Mr. Loehr was that although *portions* of both structures were grounded to earth, the buildings' electrical and grounding systems weren't connected to each other. Mr. Loehr concluded that this situation stemmed from the church's incremental growth history.

In fact, the churches grounding systems were a hodge-podge waiting for trouble. "For example" Mr. Loehr recalled, "the older portion of the church, which has a gable roof, had steeple protection only, and even that was questionable. The new building and its flat roof had some lightning protection but only in scattered locations. There was some grounding to earth here and there, but none of those systems were interconnected, so a lot of the surge and stray-current problems the church had been experiencing over the years were likely due to differences in potential between the various grounding systems and between the two buildings themselves.

"What we did to correct this situation was to install a new rooftop lightning protection system on the new building and use that system as a facility-encompassing bus to tie all of the various grounding and electrical systems together, exactly like one would do with a conventional buried ring-ground except that it was at roof level. That made sense in any event, first, because we had to connect all the air terminals on the roof anyway, and, second, because placing the ring on the roof avoided having to install a buried ring-ground through parking lots, roads and sidewalks, not to mention the cemetery, (Figure 3). We installed additional driven electrodes per UL Standard 96A, then bonded them and all existing ground electrodes to the roof-top ring.

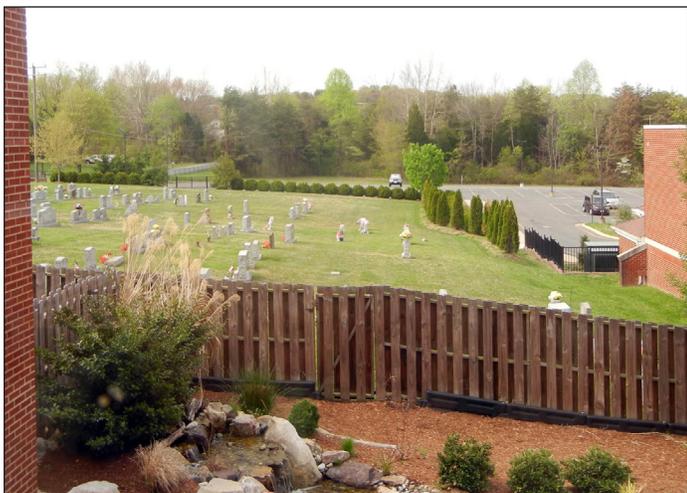
Figure 3. A small cemetery remains adjacent to the Mount Ararat Baptist Church. Along with roadways and paved parking lots, the cemetery made the installation of a conventional buried ground ring impractical.

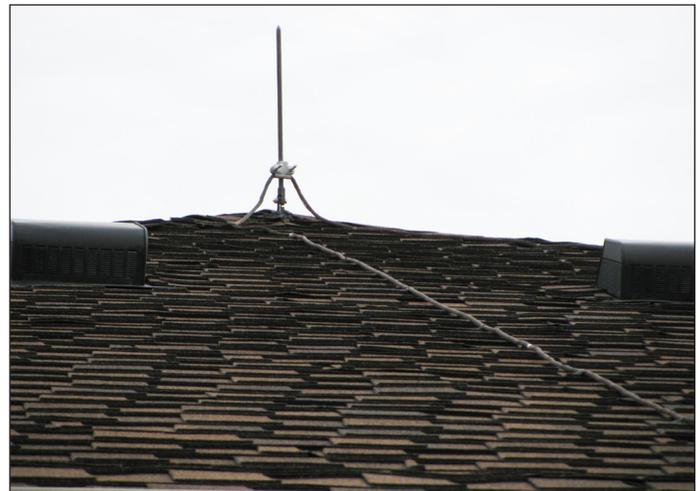
Figure 4. The weathered copper down-conductor leading from the Franklin terminal on one of the church's two towers blends well against the roof's reddish shingles. Attention to aesthetic details such as this helps make externally mounted lightning protection system components unobtrusive elements of the building's appearance.

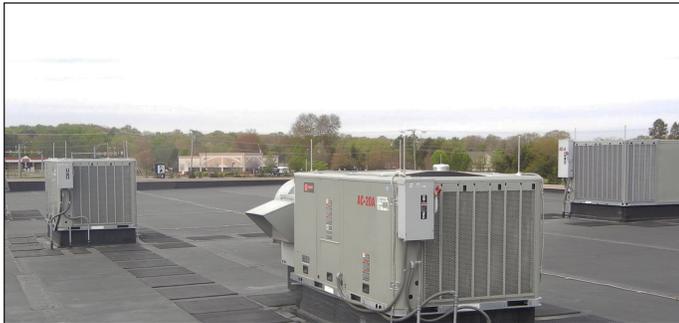
Figure 5. Rooftop lightning protection system on Mount Ararat's "new" building. Note Franklin rods mounted on all metal bodies on the roof, whether grounded or not. All equipment is bonded to a network of grounding conductors that, in turn, are bonded to a conductor ring encircling the structure at the roof's parapets. The ring serves the same purpose as a conventional buried ring-ground on properties where excavation is practical. From the rooftop ring, copper down-conductors lead to driven 10-ft grounding electrodes.

"Technically, we installed a perimeter Class I system on the new structure — that's for installations less than 75 feet above ground. A perimeter ring runs along the parapets. The ring is bonded to the air terminals, the HVAC system equipment and all other metallic bodies on the roof. What is important

in a lightning protection system is the interconnection of all metal bodies to the system. You don't want a side flash from a grounded metal body to an ungrounded body. Consequently, metal bodies like air conditioning systems, exhaust fans, vent pipes, railings, are bonded to the equipment and other metal objects that are on the roof.

"With all the roof-top elements now connected and bonded, we then ran copper down-conductors to grounding electrodes placed at the required average 100-ft spacing around the building. We also interconnected selected down-conductors to the building's phone, water, communications and electric systems by way of wall penetrations. Now everything that involves electricity or grounding is at the same ground potential" (Figure 5).

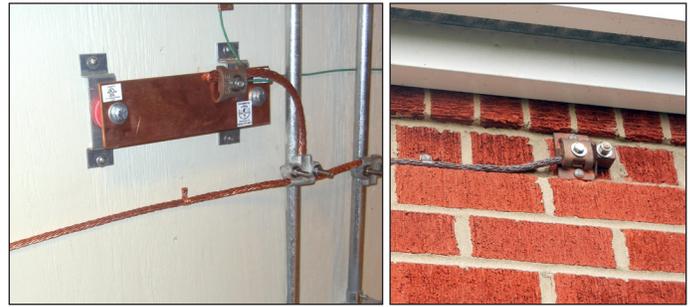
Figure 6. Indoor grounding bus with wall penetration (left); the right-hand photo shows one of several outdoor wall penetrations, from which the heavy-gauge copper conductor to the left of the penetration lug leads downward to a driven earthing electrode.

The ground conductors of interior electrical, communications and safety systems, as well as water lines, were connected to common grounds that terminate at copper grounding buses located at convenient spots throughout the structures. The buses were located near to down-conductors at the outside of the building so that through-wall connections could be made between the down-conductors and the grounding buses. (Figure 6). In this manner, all interior and systems were now common to the rooftop ring and the driven earthing electrodes, placing the entire complex at the same ground potential. It was this feature of the lightning protection and grounding system that ended the surges and electrical damage the complex had experienced for years.

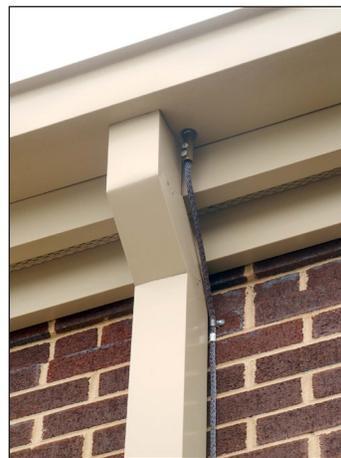
Figure 7. Rather than looping down-conductors over gutters, Loehr Lightning Protection Company routes them through the overhang when necessary, sealing the penetration with a solid copper rod enclosed in a water-tight fitting. The result is a cleaner, less conspicuous installation.

"When it comes to gutters and downspouts, we could have just run the down-conductor over the gutter and down the downspout or leader. That meets the standard, but it really doesn't look that great. What we do is run the cable *through* the overhang or the gutter with a solid rod enclosed in a water-tight fitting. It eliminates the awkward looping and it's a lot less conspicuous, (Figure 7).

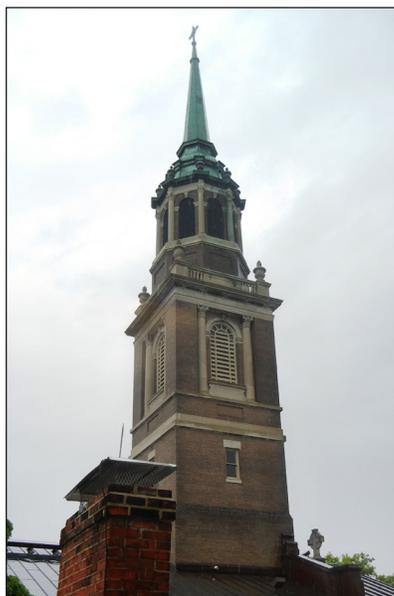
Figure 8. St. James's 160-ft, copper-clad steeple stands at the front of the church. Although a 1994 lightning strike probably hit the steeple, destroying the church, the steeple itself remained relatively unharmed. The steeple was not grounded before the lightning strike. Now, the steeple, the periphery of the church's roof and all rooftop equipment are protected by strike termination devices (Franklin terminals), all bonded to a securely grounded, 100% copper lightning protection system.

The church had never been struck by lightning, giving rise to a belief that the steeple was adequately grounded. A metal staircase was known to run up to the chimes inside the steeple, but no knowledge of its connection with any grounding system exists.

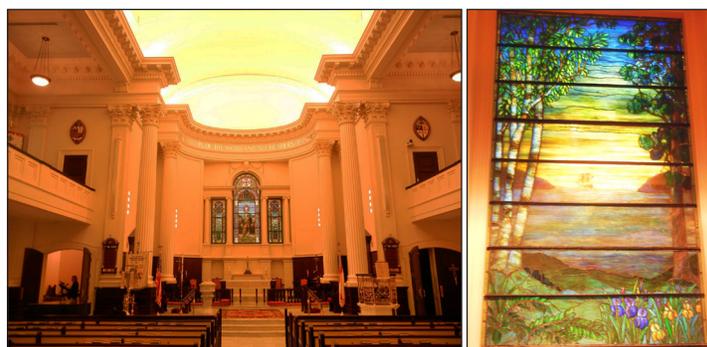
Inside the church, the balconies at the sides of the apse had fallen but, fortunately, not all the way to the ground. They were all left tilting inward, in which position they protected the stained-glass windows, including several designed by William Comfort Tiffany (Figure 9).

Figure 9. (Left) Restored interior of St. James Episcopal Church, Richmond, Virginia. Almost everything visible in the figure was destroyed by the 1994 fire save the baptismal font and the brass lectern and pulpit. The balconies, left and right, fortunately sagged rather than collapsing completely, thereby shielding priceless Tiffany stained-glass windows from damage, (Right).
