## Upgraded Grounding and Bonding Systems Prevent Costly Disasters for Florida Radio Group

MARC Radio Gainesville is an example. It recently acquired three new FM stations that share a transmission facility in Trenton, Florida: WDVH, WPLL and WHHZ. Frank Garcia, the group's former chief information officer, recognized lightning-related problems at all three of the stations.

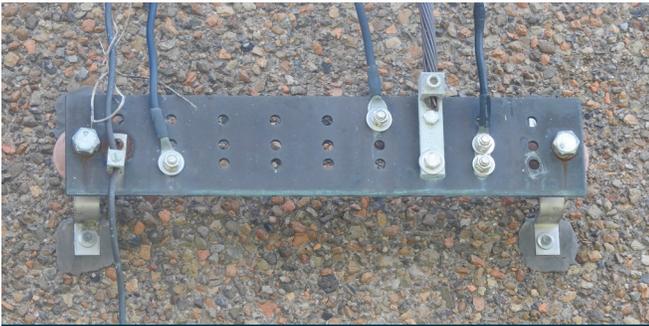
FIGURE 1.

Upon initial inspection, the improper grounding and bonding at the transmission site were found to be the major cause of the problems (**Figures 1 and 2**).

*This old ground bonding bar will be replaced, wiring errors corrected and conductors here and internally (Figure 2) upsized to 4/0 stranded copper conductors to ensure adequate current carrying capacity to the ground field.*

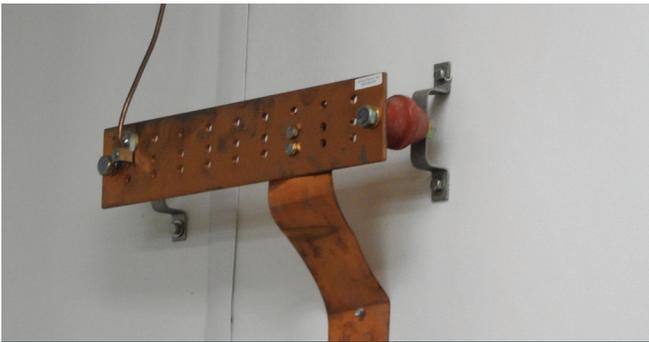
FIGURE 2.

*This interior ground bar now has a 4/0 from it to the ground bar in Figure 6. All lugs are now double-holed copper, removed, treated and re-bonded.*

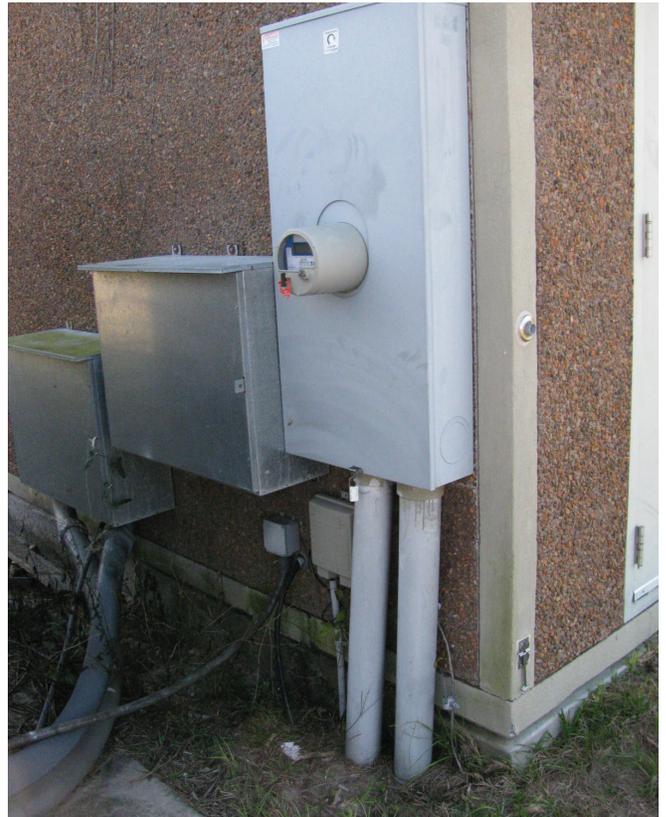
FIGURE 3.

In Trenton, the transmitter facilities are located on what is basically a sand hill. Therefore, ground rods needed to be quite deep. At the service entrance, West drilled an 80-foot-deep ground rod that is tied to two other 80-foot rods, starting 80 feet away and 80 feet apart (Figure 3). Together, they provide less than a 5-ohm ground.

*At the service entrance West drilled an 80-foot-deep ground rod that is tied to two other 80-foot rods, starting 80 feet away and 80 feet apart. Together, they provide less than a 5-ohm ground.*

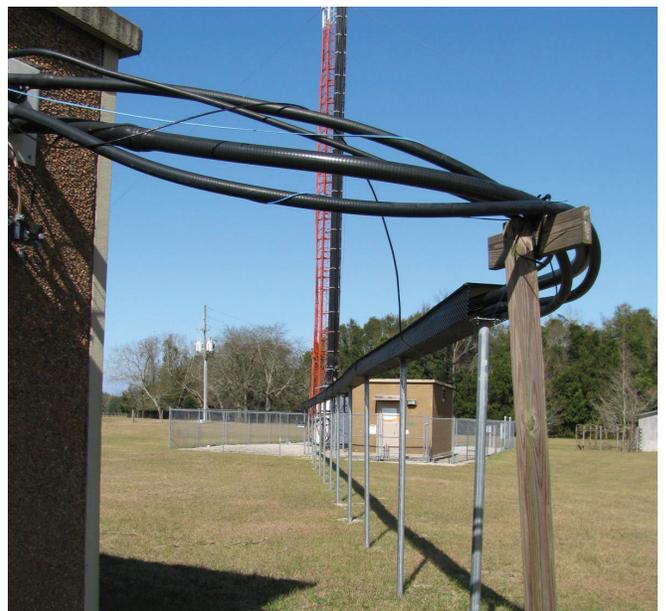
FIGURE 4.

*The ground system is tied to the waveguide bridge and to the facility's bulkhead grounding bar, as well as a halo ground with 4/0 stranded copper. The waveguides and bridge are not grounded to the tower; they are properly grounded to the facility.*

Next to the transmission facility is a bridge that takes the waveguides to the antenna tower (Figure 4). They are not grounded to the tower; they are properly grounded to the facility. Because the waveguides strictly service the antennas, it does not present a difference-in-ground-potential situation.

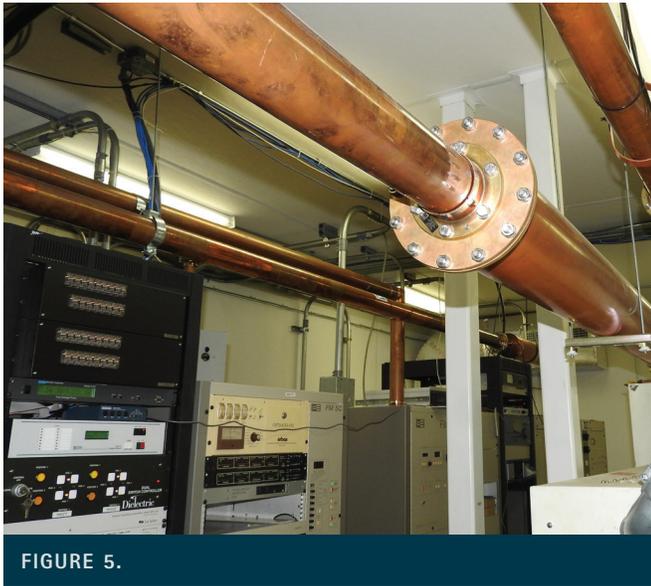
FIGURE 5.

*Waveguide pipes are used in the building because it is transmitting FM signals. The first thing West is doing is completing the existing bonding connections to all the proper points for the waveguides and the bank of electronics.*

Waveguide pipes are used in the building because it is transmitting FM signals (**Figure 5**). The first thing West did was complete the existing bonding connections to all the proper points for the waveguides and the bank of electronics.

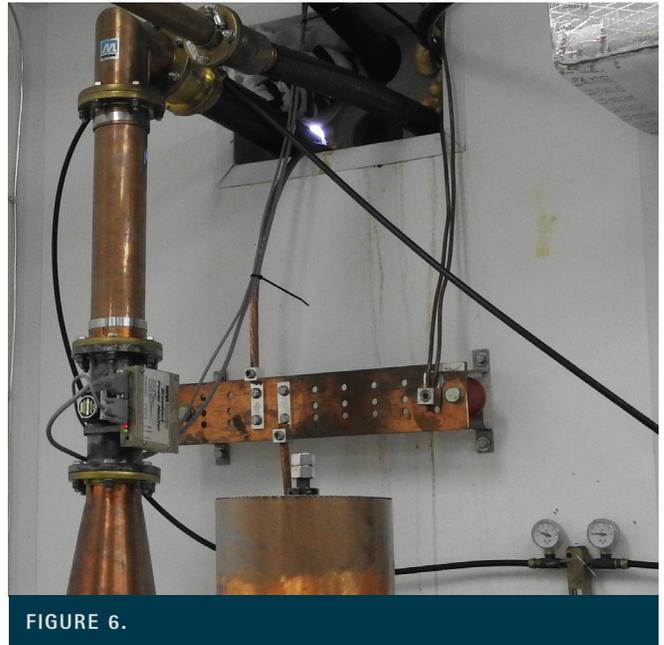
FIGURE 6.

Previously, the interior had two independent ground bars, one on each side of the building. West replaced one of the original ground bars with a new larger busbar that connects to the main ground system. He also replaced an old, inadequate ground bar (**Figure 6**), corrected wiring errors and replaced all the undersized solid conductors with 4/0 stranded copper.

*Connections to the copper bulkhead ground bar use conductive grease and stainless steel hardware, including flat and lock washers and nylon locking nuts. Note the 2 wires under one lug (right), later corrected.*

"We updated the ground bond of the transmitter building and corrected errors (**two wires on one lug in Figure 6**)," West said. "The conductors are now AWG 4/0 going to the bonding bar (**Figure 2**) as well as the halo, two-hole lugs in all cases, and conductive grease with stainless hardware, flat and lock washers along with lock nuts. That can eliminate the need for more frequent maintenance checking the torque tightness of the bolts and nuts."

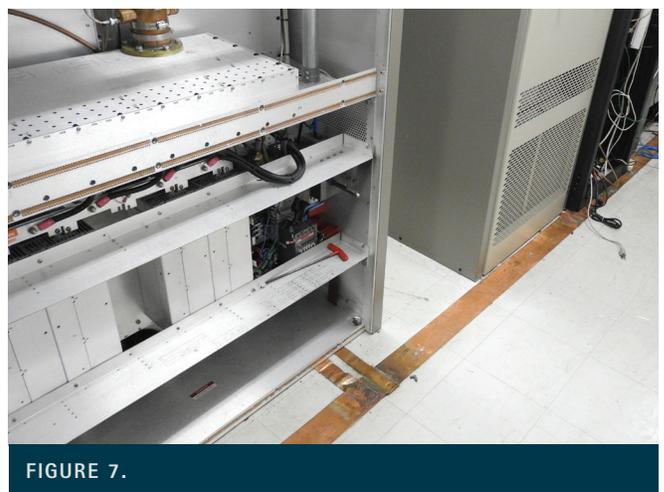
FIGURE 7.

Since it is critical that everything be bonded together, 4/0 copper runs around the baseboard of the facility to a second busbar that bonds the flat copper strap connecting to the racks of signal-processing equipment (**Figure 7**). All components now have a common ground with properly sized conductors.

*Because it is critical that everything be bonded together, 4/0 copper will run around the baseboard of the facility to another busbar, which bonds the flat copper strap connecting to the racks of signal-processing equipment. All components will now have a common ground with properly sized conductors.*

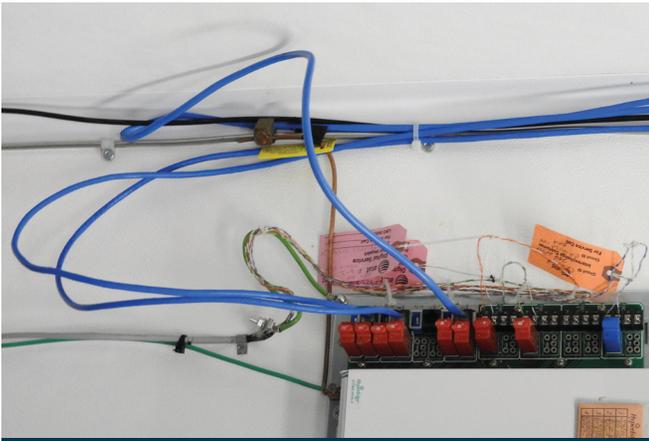
FIGURE 8.

When West came to the facility, he found the communication lines tie-wrapped together and running around the building attached to a lightning halo (**Figure 8**). If the facility were to be hit really hard, lightning energy would have been induced into those low-voltage cables and equipment would have blown up, or vice-versa. The station's RF engineers were tasked with mounting hangers below and a distance from the halo conductor.

When West came to the facility, he found the communication lines tie-wrapped together with the halo ground and running around the building. This is a poor practice because an event on the halo ground can be coupled onto the telecom equipment, and other network and low-voltage lines tie-wrapped to the halo due to inductive coupling. To remedy this, the station's engineers are going to mount hangers below and a distance from the halo conductor.

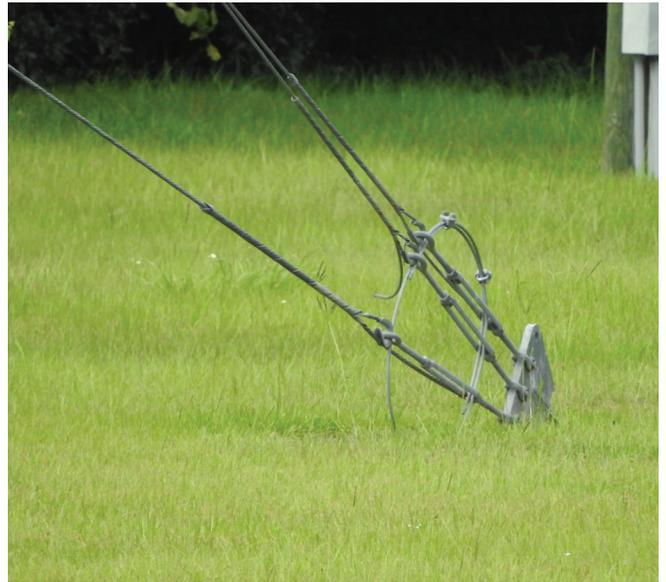
FIGURE 9.

West found that the tower was already grounded properly. It has multiple metallic supports that go very deep into the concrete (Figure 9). Each support has a conductor that bonds the guy wires to a ground rod.

West found that the tower was already grounded properly. It has multiple guy wires connected to a metallic supports that go very deep into the concrete footings.

"If lightning energy hits the tower, the grounded supports strip it off much like a voltage divider," West said. "Very little reaches the base of the tower; it's dissipated sideways."
