Copper-Tube Corrosion

in Domestic-Water Systems

Identifying and mitigating the seven forms of corrosion

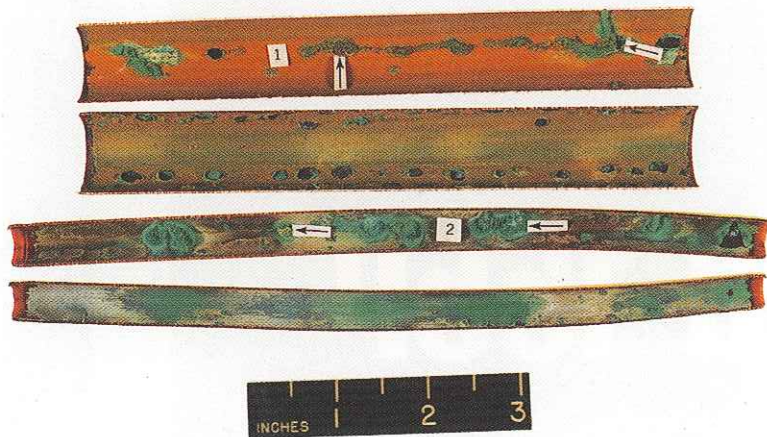
PHOTO A. Soldering-flux-induced pits covered with friable green tubercles of copper-corrosion products. The tube-wall perforations (see arrows) and most of the pits exist along relatively narrow bands, which are nearly parallel to the longitudinal axes of the tubes (i.e., along the “ghosts” of flux runs).

Containing porous, reddish-brown cuprous oxide (Cu_2O), flux-induced pits are covered with relatively voluminous, friable tubercles of green-colored copper-corrosion products (Photo A). Typically, the tubercles consist of basic copper carbonate (i.e., malachite) and/or copper chloride(s).

Flux-induced pits tend to occur preferentially along relatively narrow bands that are nearly parallel to the longitudinal axes of tubes and fittings (i.e., along the “ghosts” of flux runs). Often, these bands are covered with tubercle ridges (see the top tube half-section in Photo A), rather than distinct hemispherically shaped tubercles. Flux-induced pits also often occur preferentially on the periphery of petrolatum-base flux residues/runs, which often exist on water-side surfaces when plumbing technicians apply flux excessively. When flux is applied excessively, globules of solder also can be found on water-side surfaces of tubes and fittings. Although

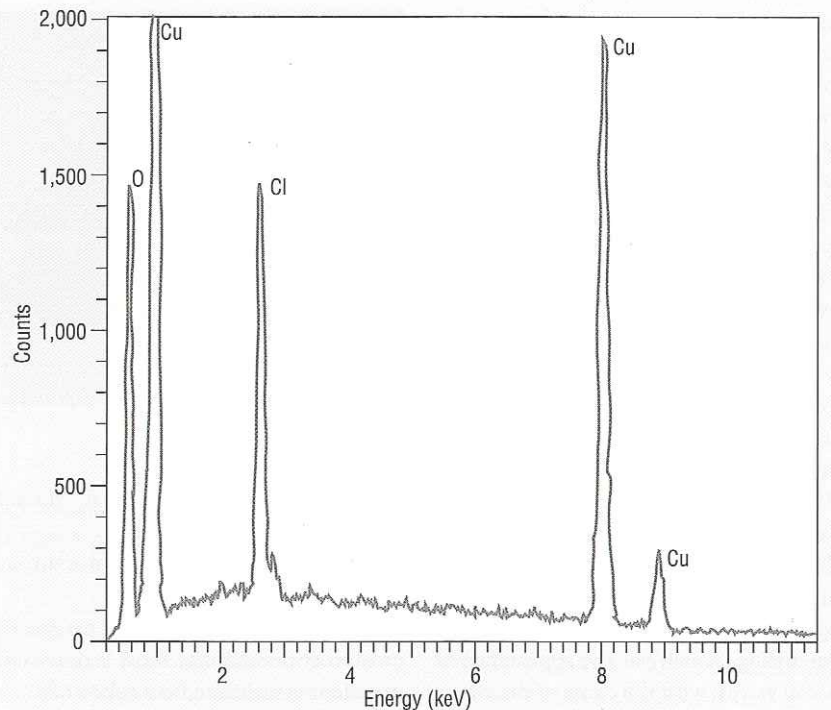
FIGURE 1. Energy dispersive spectroscopy normally reveals large amounts of chloride at soldering-flux-induced pit sites.

Soldering-flux-induced pitting can be confirmed using energy dispersive spectroscopy (EDS). Chlorides in major amounts—and, sometimes, zinc (from the soldering flux)—can be detected in pits or on the edges of pits (Figure 1). Copper chloride exists with Cu_2O at pit sites. This is understandable, as soldering fluxes commonly contain activating chlorides, such as ammonium chloride, zinc chloride, tin chloride, and/or hydrochloric acid.

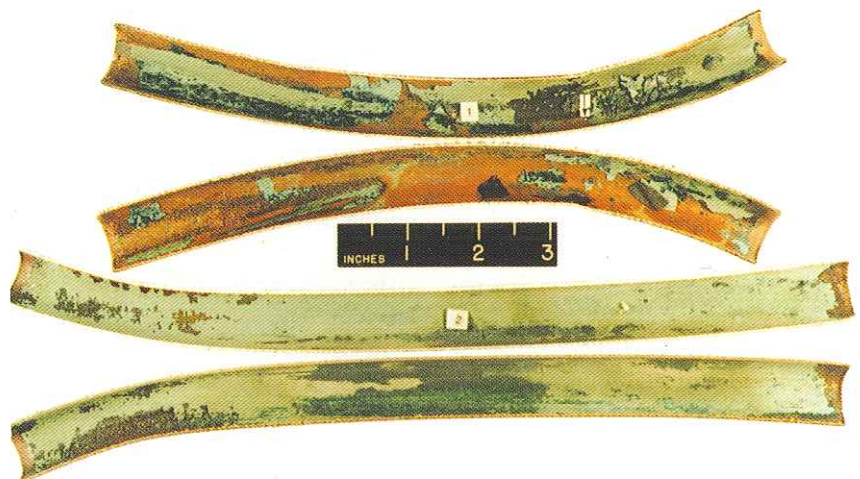
PHOTO B. Hydrogen-sulfide-induced pits overlaid with friable green to black tubercles of copper-corrosion products. Loosely adherent and porous layers of copper sulfide have broken free from the upper two tube half-sections.

H_2S -induced pitting occurs randomly on water-side surfaces of copper tubes and fittings (Photo B). The pits typically contain porous, dark-reddish-brown-to-nearly-black Cu_2O and are overlaid with friable green tubercles of copper-corro-

sion products. Most often, the tubercles consist of copper sulfate, which sometimes is admixed with black copper sulfide(s). Regardless of the composition of the tubercles, black, loosely adherent, porous layers of copper sulfide(s) are associated with pitting attack. The presence of these corrosion products can be verified using EDS and microchemical analysis (MCA).

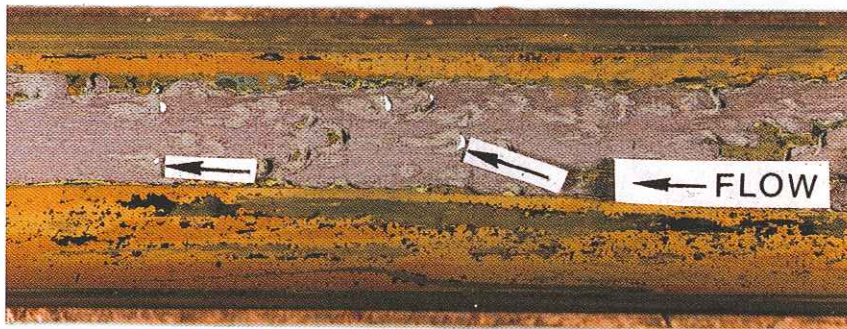
PHOTO C. U-shaped pits and associated tube-wall perforations (see arrows) in a localized product-free area are distinct enough that the direction of hot-water flow can be determined.

Erosion corrosion can be recognized readily (Photo C). Areas of attack typically are grooved and essentially free of residual corrosion products. Affected areas normally are bright and shiny, like a new penny. This is understandable, considering the erosion phase of this rapid, repetitive process removes copper-oxide films from copper surfaces. Often, the U-shaped pits in areas of attack are distinct enough that the direction of water flow can be determined. The orientation of the pits gives the impression of "horses walking upstream." Lengthwise sections of tube normally reveal undercutting, which has the appearance of ocean waves, with the crests of the waves facing the direction of water flow.³

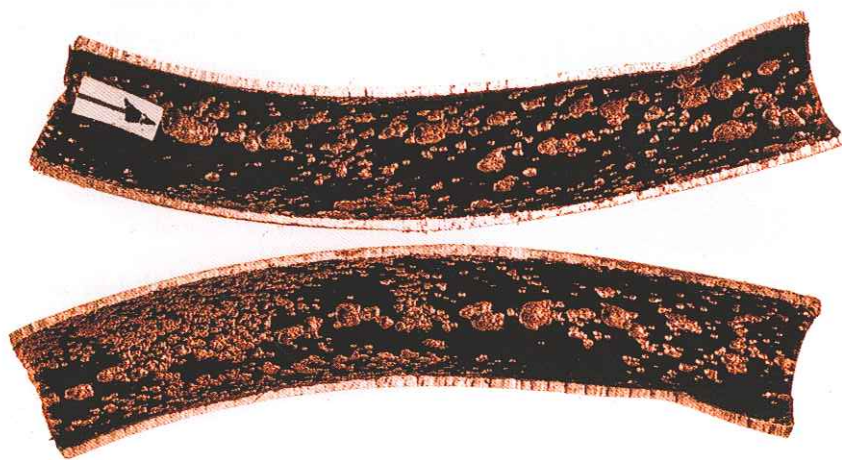
PHOTO D. A tube-wall perforation (see arrow) in a localized area of severe cavitation. Surface heating caused the formation of black cupric oxide where cavitation had not occurred.

Cavitation, a special form of erosion corrosion, occurs when vapor/gaseous bubbles form at low pressure and collapse/implode at high pressure, producing very high localized pressures (shock waves) that destroy copper's protective tarnish film and create boundary-layer water temperatures that are much higher (above 160 F) than those of the water being conveyed. Typically, cavitating copper is distinguished by the absence of residual corrosion products and the presence of bright, sponge-like, rounded pits (Photo D).

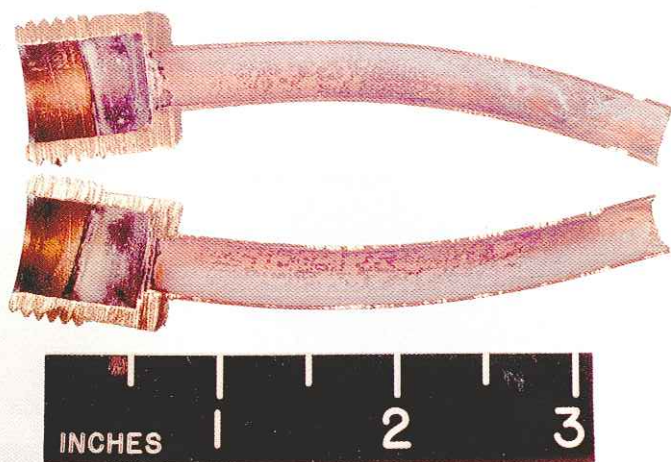
PHOTO E. A loosely adherent flocculent-type layer of blue-tinted copper-corrosion products on the water-side surface of a tube.

side surfaces of copper tubes and fittings do not form or completely form a naturally protective Cu_2O film, developing instead a thin, loosely adherent, flocculent-type layer of blue to blue-green copper-corrosion products⁷ (Photo E). Typically including copper hydroxide, these products are formed during periods of water stagnation.

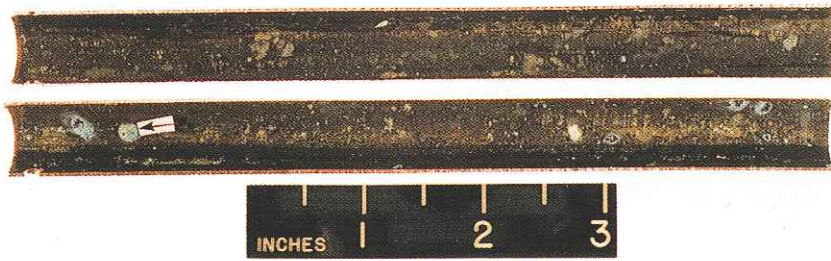
PHOTO F. Concentration-cell corrosion in the form of pitting attack under the thicker layers of hydrated hematite and silica deposits on the water-side surface of a cold-water line. The perforation through the tube wall (see arrow) is covered with a friable tubercle of green copper-corrosion products.

The source of deposits on tubes and fittings almost always is suspended solids in the water conveyed. Often, these deposits consist of iron oxides and/or silica/sand (Photo F). It is not unusual for the source of iron oxides to be the corrosion of cast-iron/ductile-iron mains used to distribute water or galvanized-steel service lines used to connect buildings to water mains. Iron oxides also can result from the oxidation of natural constituents in water (e.g., iron bicarbonate). When deposits consist primarily of silica/sand, the cause normally is the overpumping of a well or a deteriorating concrete or cement-lined water main. In rare cases, the source of deposits is post-precipitation of colloids leaving the water-treatment plant.

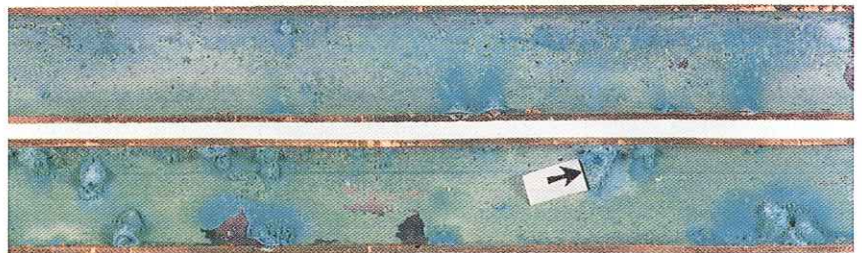
PHOTO G. Tubercle-covered, corrosion-induced pits on the water-side surface of a tube that conveyed a domestic cold water containing appreciable amounts of dissolved carbon dioxide in conjunction with dissolved oxygen.

The randomly occurring pits contain porous, reddish-brown Cu_2O and are overlaid with discrete, friable, relatively voluminous tubercles of green copper-corrosion products (Photo G). Typically, EDS and MCA reveal that the tubercles consist primarily of basic copper carbonate.¹¹ EDS sometimes shows that copper chlorides coexist with the Cu_2O in the pits. Copper in areas where localized pitting has not occurred will be covered with a protective tarnish film of Cu_2O , which, in general, will be overlaid with a thin layer of green deposits (typically, malachite), the source of which is the pitting of copper upstream.

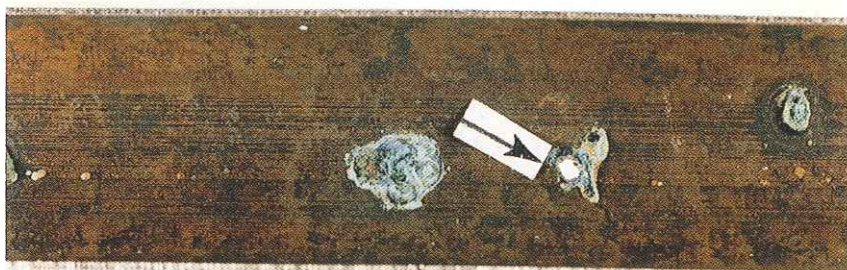
PHOTO H. Chemistry-related-hot-water-induced pits covered with friable tubercles of green copper-corrosion products. Loosely adherent layers of brown hydrated hematite deposits cover black cupric oxide on the water-side surface of a hot-water line.

Typically, hot-water-induced pits contain porous, reddish-brown Cu_2O and are covered with friable, relatively voluminous tubercles of green copper-corrosion products (Photo H). EDS and MCA usually reveal that the tubercles consist primarily of copper sulfate. Often, EDS will detect small amounts of the pit-initiating metal in the tubercles. Rarely will EDS detect chloride-containing products in the pits.

Where pitting has not occurred and copper is covered with a thin layer of CuO , a friable, loosely adherent layer of brown (Photo I) or brown-black (Photo H) deposits is common. The deposits

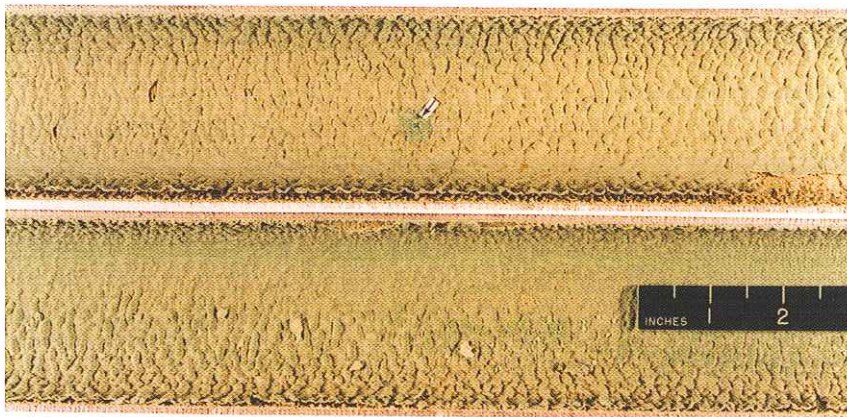
PHOTO I. A tube-wall perforation (see arrow) covered with a friable tubercle of green copper-corrosion products. The cupric oxide on the tube surface is covered with a relatively thick, loosely adherent layer of brown deposits from the hot water conveyed. EDS will reveal that the deposits contain significant amounts of aluminum.
