Reliable Grounding Saves Years of Seed Development Protects Equipment, Stops High-Cost Losses

The world's largest independently owned agricultural seed producer had a serious problem. For lack of a simple thing like adequate grounding, the Harris Moran Seed Company faced the loss of several years of research and development and a threat to its competitive position.

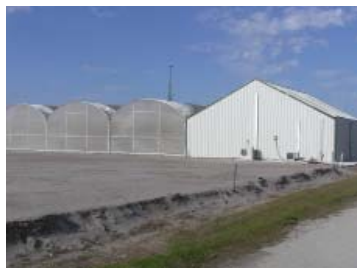
Figure 1. The Harris Moran Seed Company's Research Station comprises a laboratory, offices, 12 greenhouses and several acres of cropland. Years of research & development results were threatened due to a poor electrical grounding system.

To speed up the process, Harris Moran established a research station east of Ft. Meyers, Florida, where the climate allows two to three crops per year. The station consists of a laboratory, offices, a dozen greenhouses and several acres for controlled growing (**Figure 1**). It is surrounded by a 30,000-acre tomato farm belonging to one of the Harris Moran's customers.

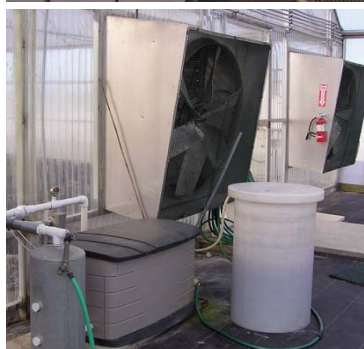
Figure 2. Time-sensitive breeding takes place in greenhouses (top), in which temperatures are controlled by fan-driven evaporative coolers (bottom) to maintain the ideal growing range. In the past, high-voltage surges destroyed the well pump that supplies the coolers, causing greenhouse temperatures to rise to 115° to 125° F and destroying several years' work in a single afternoon.

Most of the station's time-sensitive breeding work takes place in greenhouses, in which thermostatically controlled evaporative coolers maintain the ideal 85° to 90°F growing range (**Figure 2**). A 25-hp pump supplies cooling water from the farm's 60-ft well. The well also provides water to injectors and drip irrigation systems (**Figures 3** and **4**). Those systems simultaneously feed water and nutrients at controlled rates to optimize growth. Sensors located throughout the facility supply data to computers that monitor and control the entire system.

"When the well pump gets knocked out during the summer months and the evaporative coolers lose their water supply, greenhouse temperatures quickly rise to 115° to 120°F. Several years' work can be wiped out in an afternoon. That's the worst case scenario, and it has happened.

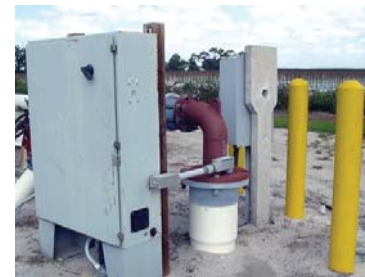
Figure 3. A 25-hp pump draws water from a 60-ft deep well at the Harris Moran Research Station. The well's plastic casing does not provide a natural grounding path. That fact, plus poor grounding elsewhere on the station led to several pump failures.

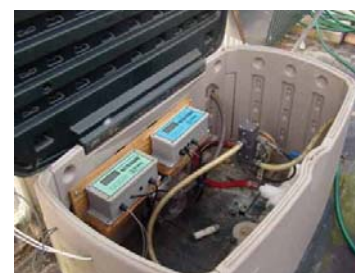
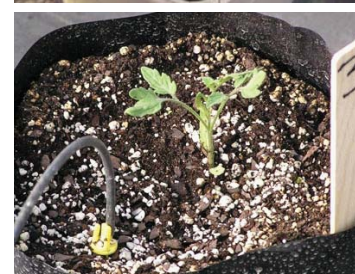
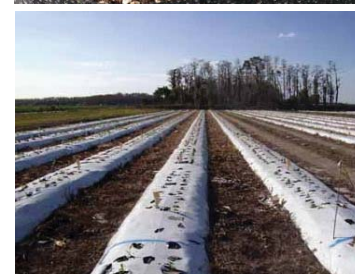
Figure 4. Injectors (top) supply irrigation and nutrients to seedlings (center) and seed crops (bottom). High-voltage surges damaged this electronically controlled system.

"A failure in the data collection and control system is almost as bad, and we had those, too. If the irrigators and nutrient injectors fail, plant growth is affected, but that's nothing compared with loss of a crop cycle."

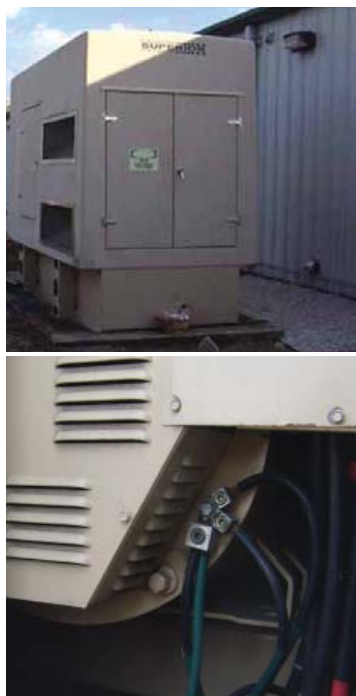
Figure 5. A 200-kVA emergency generator (top) powers the research station during outages. New, 1/0 AWG grounding conductors (green wires, bottom) were installed as part of a system-wide upgrade.

Power *supply* wasn't the problem. When the grid goes off-line, the station's 200-kVA emergency generator (**Figure 5**) takes over through an automatic transfer switch. Much more important is the *quality* of the incoming power, meaning, in Harris Moran's case, the absence of high-voltage surges.

He then bonded the three new electrodes to the system grounding bus in the main service entrance panel, as required by Code, but instead of AWG #4, he used AWG 1/0. For good measure, he also ran and bonded AWG 1/0 to the emergency generator (**Figure 5**) and distribution transformer.

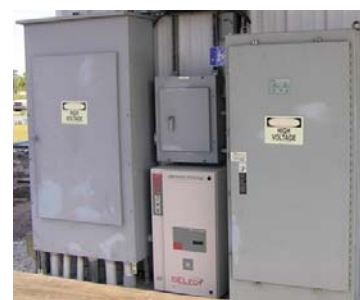
Figure 6. A portion of the service entrance showing a 200-kA-rated SEL 200 SPD mounted on the main panel and a smaller SPD on the panel at right. Other panels, here and throughout the station, were also surge-protected, as well as the well pump.

For added protection, Phillips and West backed up the new grounding electrode with surge protection devices (SPDs) on every critical panel and sub-panel, plus one on the well pump. Lightning can get pretty powerful in Florida, so they selected a Current Technology SEL 200 unit for the main service entrance panel, **Figure 6**. The SEL 200 is rated at 200 kA line-to-neutral, line-to-ground, neutral-to-ground and line-to-line. Protection per phase is rated at 400 kA.
