## Added Copper Improves Grounding, Subdues Thunderstorm Threats

Lightning-plagued 2,000-foot Tower Now On-Air 24/7

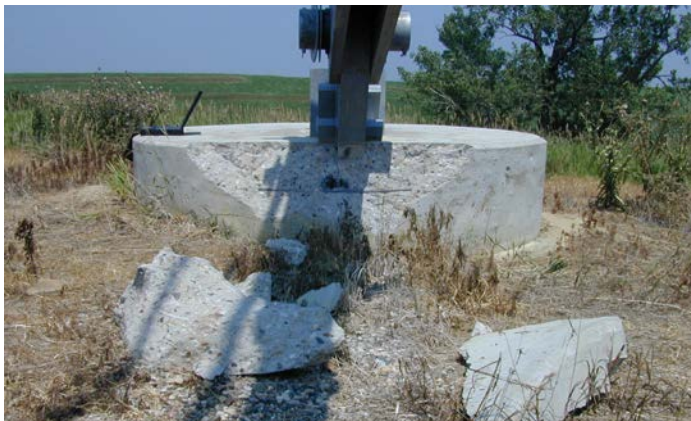
As with most other lightning incidents at the tower, the two strikes in question followed guy cables to earth, but these hits were apparently stronger than usual,<sup>1</sup> packing enough energy to damage two of the massive, reinforced concrete anchors that secure the cables (**Figures 1 and 2**). The anchors extend between 40 and 52 feet underground.

The damage the 2001 strike caused to the outer "B" anchor (see **Figures 1 and 3**) was superficial, and the incident was shrugged off as part of Siouxland's summer weather. It was the more damaging second strike, this one to the outer "A" anchor (**Figures 2 and 3**), that got the station management's undivided attention.

**Figure 1.** Lightning damage to the outer "B" cable anchor from a June 2001 strike. The strike ejected 100-lb blocks of concrete several yards from the anchor after bypassing the existing high-resistance grounding system.

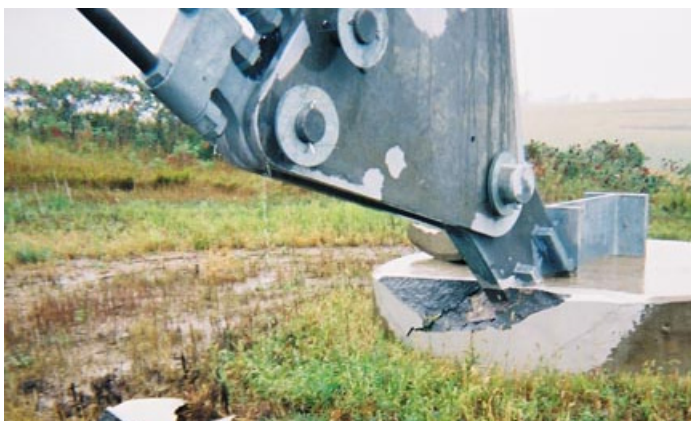
**Figure 2.** Damage to the outer "A" anchor from October 2003 strike. This event led to an upgrade of the entire facility's grounding and lightning protection system.

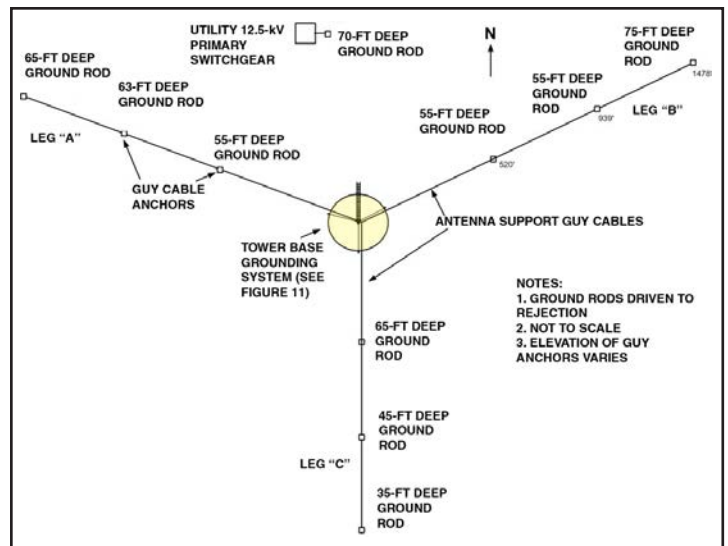
**Figure 3.** Plan view of the KPTH-KMEG tower guys with newly emplaced grounding rods. The improved grounding system installed at the KPTH-KMEG tower includes multiple deep electrodes to achieve very low resistance to earth. The originally installed system utilized 8-ft electrodes, some of which had ground resistances as high as 200 ohms. See detail of shaded area at Figure 11.

In place of the existing 8-foot rods at the guy anchors, Conroy drove 35- to 75-foot-deep stainless steel electrodes (**Figure 3**), again using bentonite as a backfill agent. He measured ground resistance as the rods were being driven, stopping only when an acceptably low level was attained. The new electrodes were left protruding approximately three feet above grade to facilitate testing and inspection and to prevent cable damage from mowing equipment, as well as corrosion from herbicides, (**Figure 15**).

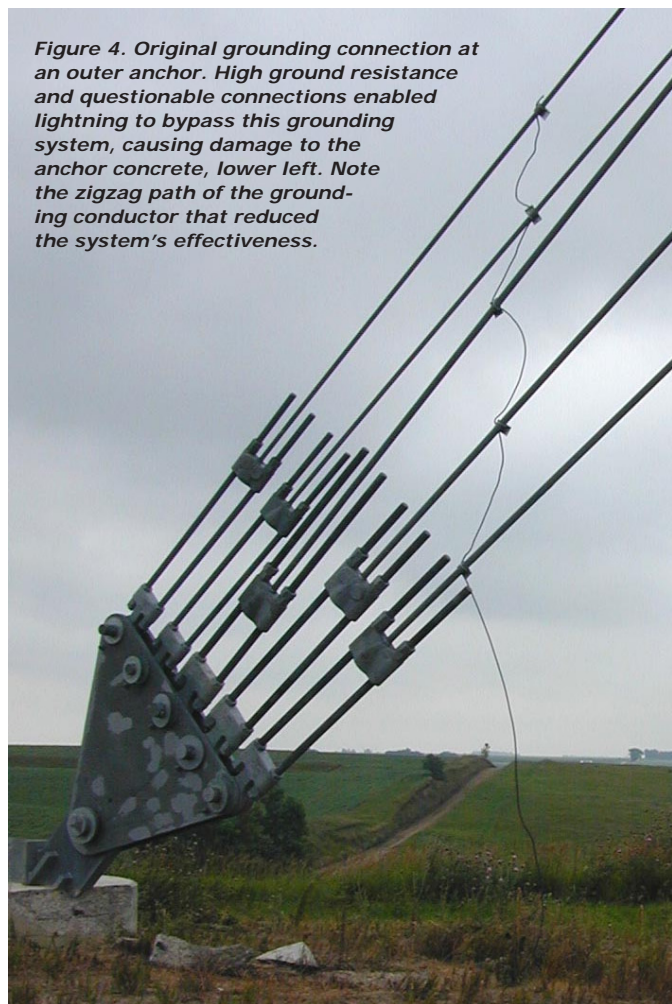
“Next, we looked at how the guy cables were grounded. The grounding connections to the guy cables are upstream of the anchors (**Figure 4**) in order to keep the anchors out of the lightning’s path,” Conroy explains. “There were some other problems with the connections that I’ll get to in a moment, but it’s reasonable to conclude that the lightning bypassed the high-resistance grounding system entirely and, instead, preferred the natural, lower-resistance path to earth offered by the concrete and 40- to 50-foot-deep reinforcing rods in the anchor itself.

*Figure 4. Original grounding connection at an outer anchor. High ground resistance and questionable connections enabled lightning to bypass this grounding system, causing damage to the anchor concrete, lower left. Note the zigzag path of the grounding conductor that reduced the system’s effectiveness.*

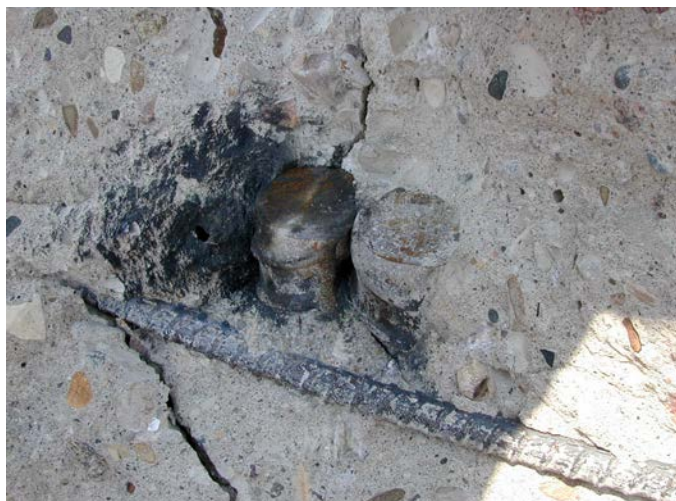
“Remember, reinforcing rods in concrete footings are widely used as Ufer grounds in all sorts of buildings, and they’re usually very effective. However, a direct lightning hit can crack the concrete. In this case, we found clear evidence that lightning followed at least one rebar to earth after it entered the anchor (**Figure 5**).

*Figure 5. Burn scar on shattered concrete is evidence that lightning found a vertical reinforcing rod (center), which likely acted as an efficient Ufer ground, offering lower resistance than that of the installed grounding/lightning protection system.*

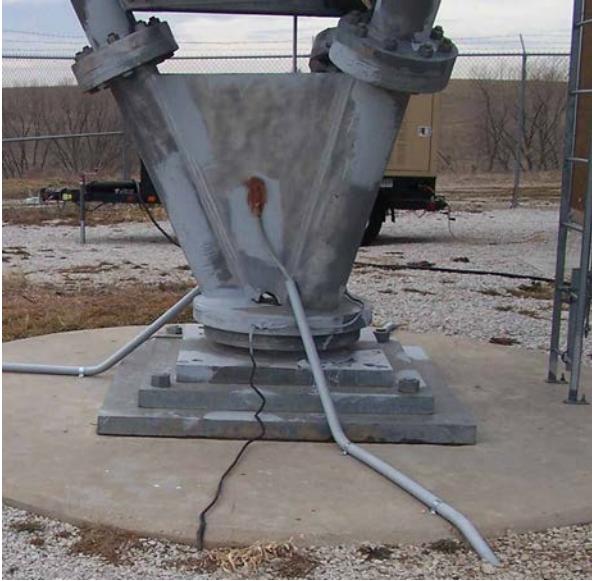
- The mast itself was grounded by two 8-foot copper-clad rods driven near the tower base. The rods had been bonded to the tower with AWG #2 solid bare copper (**Figure 6**). Additional runs of #2 copper, also bonded to the electrodes, connected to a few legs of the 100-foot-long ice bridge that connects the tower with the KPTH transmitter building (**Figure 7**). Still more grounding connections were made to flat-strip copper conductors leading to transformers and nearby equipment (**Figure 8**). Conroy measured a ground resistance of 190 ohms at the tower base.
- Equipment inside the KPTH transmitter building appeared to be properly grounded by way of copper strip conductors and two grounding bus bars from

**Figure 6.** One of two original AWG #2 copper ground leads at the tower base (foreground, bare wire) were augmented by three new 250-kcmil tinned copper conductors (two shown, in protective sleeves).

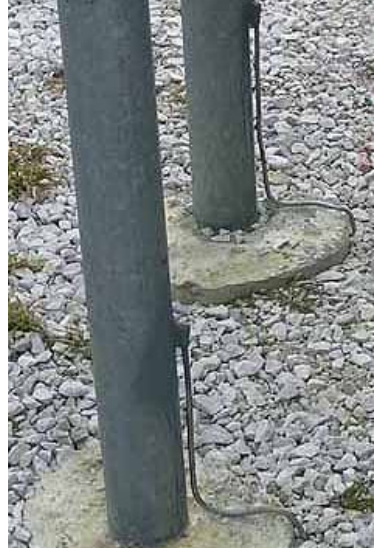
**Figure 7.** Two original AWG #2 copper grounding conductors were bonded to legs of the ice bridge. These and other existing grounds were retained and bonded to the new and more robust grounding system by CPC.

The old system's connections to the tower and ice bridge were retained (**Figure 7**), but two of the new 250-kcmil radials and the ring ground were also bonded to legs of the ice bridge (**Figure 13**) and to existing ground straps at outdoor electrical equipment (**Figure 8**). The old and new systems were then bonded together (**Figure 14**). Conroy reasoned, "With lightning, you can never have too many electrodes, and it's always prudent to spread out incoming surges over as broad an area — and as large a volume of earth — as possible."

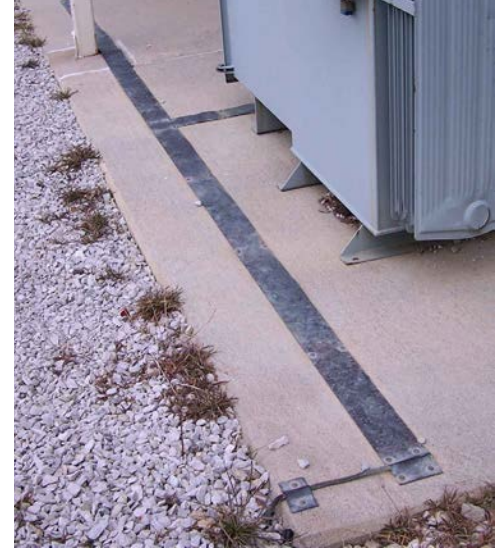
**Figure 8.** Existing flat-strip copper grounding conductors, used with transformers and other outdoor equipment, were retained and bonded to the new system (large conductor in foreground). The existing outdoor grounding system was also tied into these strips (not shown).

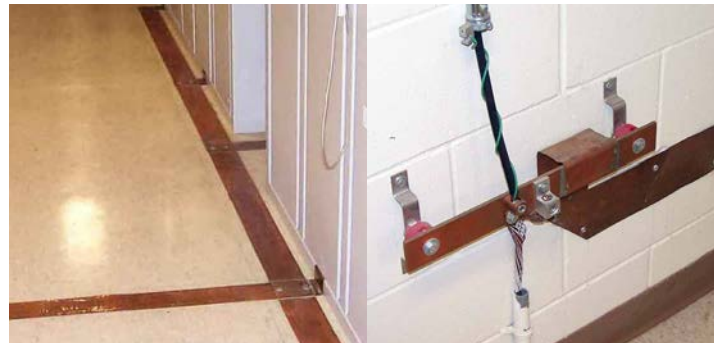
which heavier conductors were fed through walls to the outdoor system (**Figure 9**). These grounding connections were superimposed on the usual equipment grounds. A similar grounding system had been installed at the KMEG transmitter building; however, the ice bridge to that building was not effectively bonded to the grounding system.

**Figure 9.** Grounding connections inside the transmitter building used flat-strip copper (left photo) connected via a ground bus (right photo) to the outdoor electrode field.

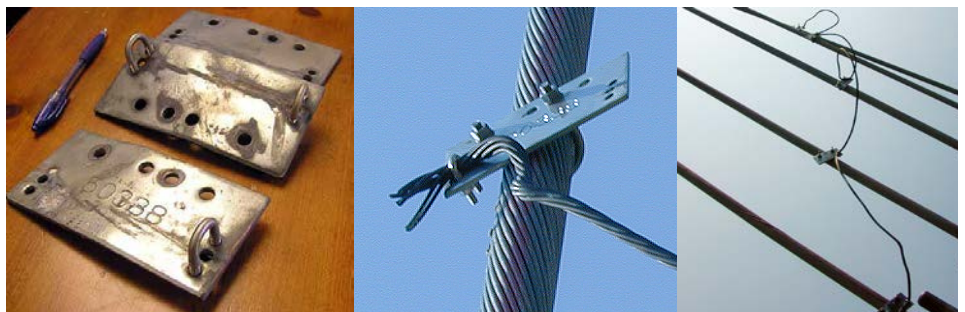
Conroy had misgivings about those connections, since the components were not listed products and the cables were attached at 90° angles to the guy cables. Good practice normally calls for large-radius bends on lightning protection conductors.

**Figure 10.** Connections between grounding conductors and guy cables were originally made with tinned-brass double U-bolts (left) that caused the two cables to cross at right angles (center), creating a zigzag orientation. Wind-driven vibration of the guy cables caused the springy U-bolt connections to loosen, thus increasing electrical resistance.

"Making this situation worse were the U-bolts and tinned-brass plates used to connect the AWG #2 grounding conductors to the guy cables. The plates forced the grounding conductors to cross the cables at right angles at the point of connection, leaving the conductors contorted into a zigzag path from the electrode to the uppermost guy (Figure 10). With lightning conductors, it's better to keep conductors as straight as practical and to use generous radii when turns are unavoidable.

From each electrode, he ran 250-kcmil tinned-copper leads to the guy cables, replacing the original double U-bolts shown in **Figure 10** with listed, tin-plated silicon-bronze connectors that enabled the grounding conductors to run at a shallow angle with the guys (**Figure 16**). He also doubled the bronze connectors on the uppermost guy — the one most likely to see a lightning surge.

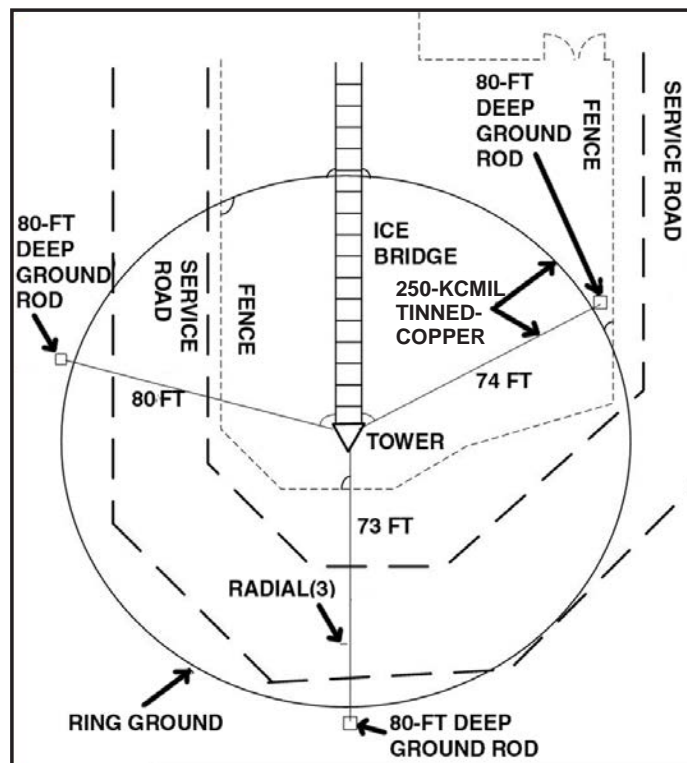
Figure 11. The new grounding system at the tower base includes three deep-driven stainless steel electrodes linked by a 250-kcmil tinned copper ring ground. The ring connects to the tower base via three 250-kcmil radials.

Conroy retained some elements of the existing grounding system but augmented it with a new, more robust system. At the tower base, he kept the two original electrodes but added three 80-foot-deep stainless steel electrodes at 120° intervals around the base and between 73 and 80 feet from it (Figure 11). The electrodes were surrounded along their full length by granular bentonite, a clay mineral that absorbs and retains ground moisture readily and, in so doing, swells to make good contact between the electrode and the surrounding earth. Bentonite also maintains good electrical conductivity under those conditions. Stainless steel electrodes and couplers were used here, because of the depth needed to achieve sufficiently low electrical resistance. However, bentonite is especially beneficial with copper-clad steel electrodes, because it buffers pH and creates an electrochemical environment that protects against corrosion in otherwise aggressive groundwater. Grounding Perfection, Inc., of Fremont, Nebraska, installed the deep ground rods using a ground rod driving machine invented by the company's founder.<sup>2</sup>

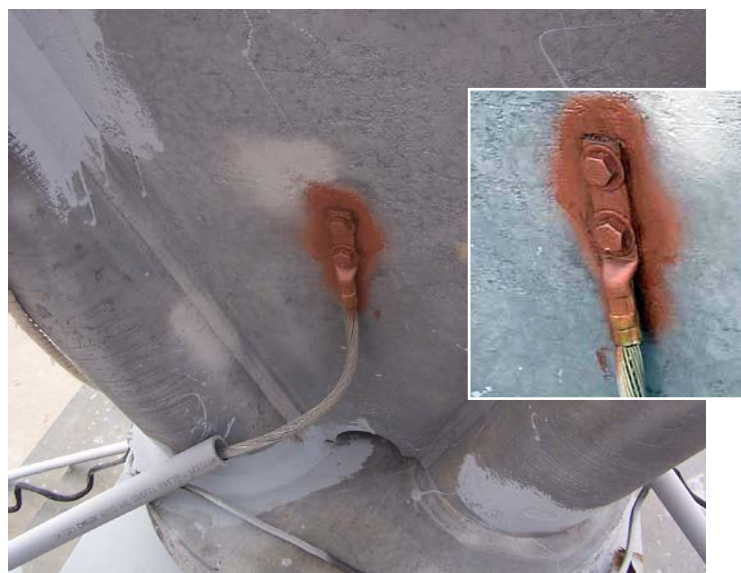
Figure 12. One of three new 250-kcmil tinned-copper grounding electrode conductors installed in 2005. The inset shows the mechanical-type connector bolted to the tower base. Rust-resistant paint coats the connection.

radials from the ring to the tower base. All cable connections were made with tinned, solid-copper mechanical Burndy connectors (Figure 12). Conroy chose tinned-copper for its good corrosion resistance in soils and because it has little tendency to induce dissimilar-metal

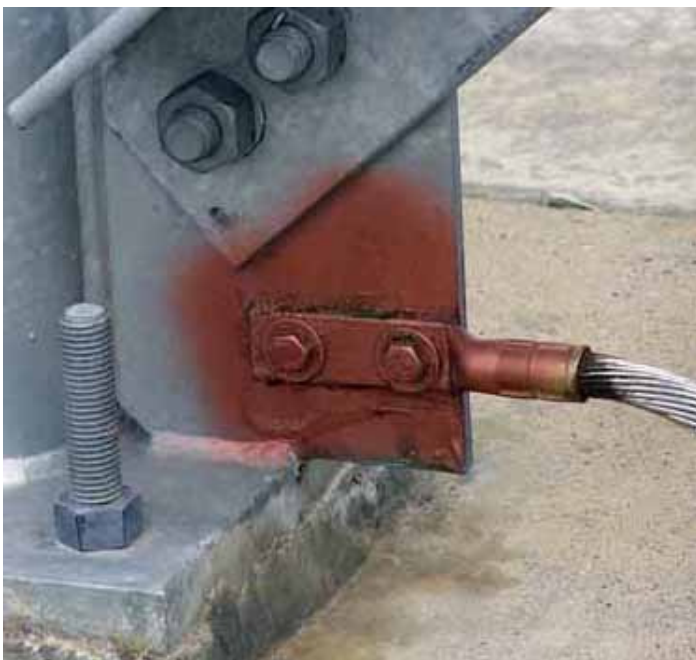
**Figure 13.** A 250-kcmil tinned-copper grounding conductor connected to an ice bridge leg. The ice bridge connects the tower and the KPTH transmitter building.

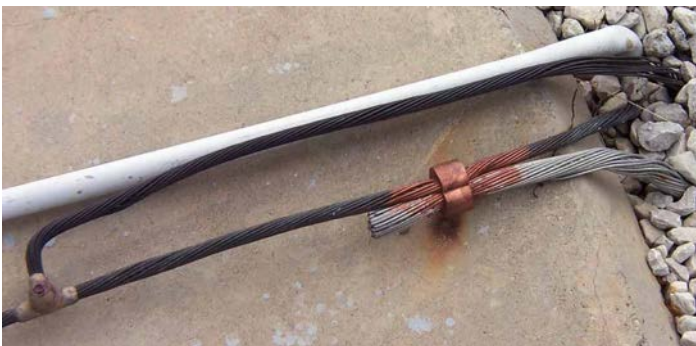
**Figure 14.** Existing and new grounding conductors at the tower were connected to create as large a system as possible. Here, new 250-kcmil tinned-copper grounding electrode conductors are crimp-bonded to old but still functional AWG #2 bare copper.

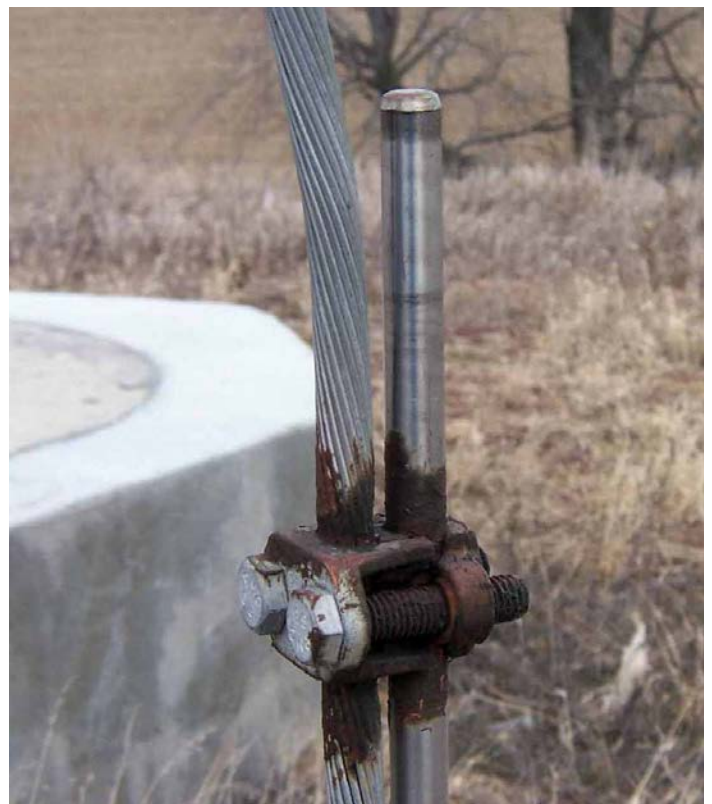
**Figure 15.** One of nine deep (up to 75 feet) grounding electrodes installed at the tower's guy cable anchors. The stainless steel electrodes were mechanically bonded to 250-kcmil tinned-copper conductors using approved, silicon-bronze mechanical connectors. The brown coating is a corrosion-resistant paint.

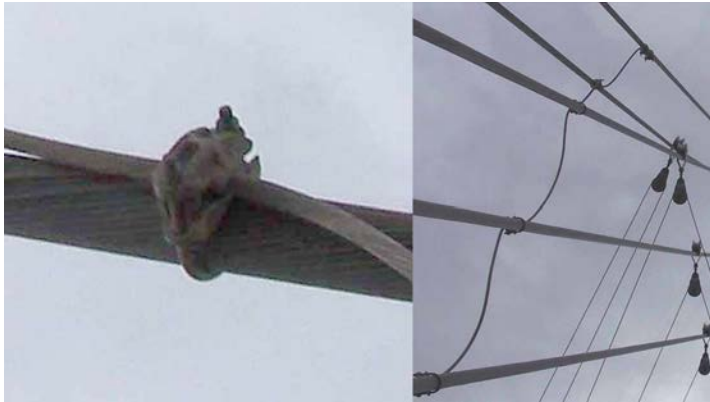
**Figure 16.** *Approved, silicon-bronze connectors enable cables to run parallel at the point of contact, with orientation of the grounding conductors between guys at a narrow angle with the cables. (The pulleys seen at right are part of the cables' sway-damping system.)*

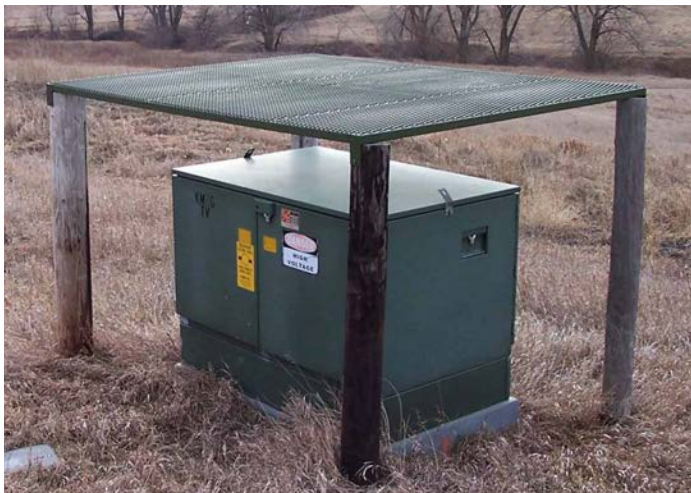
**Figure 17.** *The site's 13-kV utility switch was protected with its own deep grounding electrode, marked by the orange conduit at lower left in the photo. This electrode interrupts and shunts to ground any surges resulting from lightning strikes on the nearby power grid.*

Finally, Conroy installed another deep electrode at the utility switch and bonded it to the ground conductor in the 13-kV feeder (**Figure 17**). This electrode, he reasoned, would provide a low-resistance path for the primary lightning protectors located in the primary switch and would better shunt to ground any high-voltage surges caused by lightning strikes to overhead lines on the nearby grid.
