APPLICATION OF COPPER-NICKEL ALLOY UNS C70600 FOR SEAWATER SERVICE

Wilhelm Schleich
KM Europa Metal AG
Klosterstr. 29
49074 Osnabrück
Germany

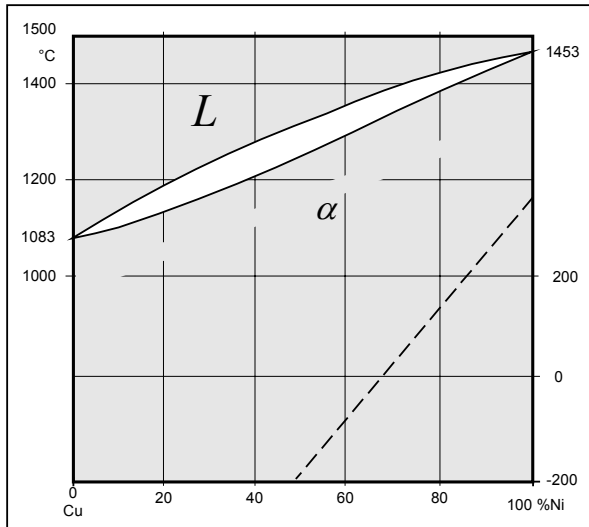
Figure 1: Phase diagram for Cu-Ni alloys.

Copper and nickel have similar atomic radii and lattice parameters and so the phase diagram is relatively simple (Figure 1)¹. At all temperatures, Cu-Ni alloys are represented by a single phase face centered cubic structure. The absence of phase transformation during thermal cycles reduces the effect of welding on mechanical characteristics and the corrosion resistance of the material. This crystallographic structure reveals very good ductility and impact strength even at temperatures well below freezing point. The slow diffusion rate for nickel in copper leads to concentration gradients in the melt and consequently increases a segregation tendency in the cast structure at normal cooling rates (Figure 2). Thus, to provide a uniform establishment of protective oxide layers, the homogenization of the segregated structure is required by hot forging or cold working with a subsequent recrystallisation anneal.²

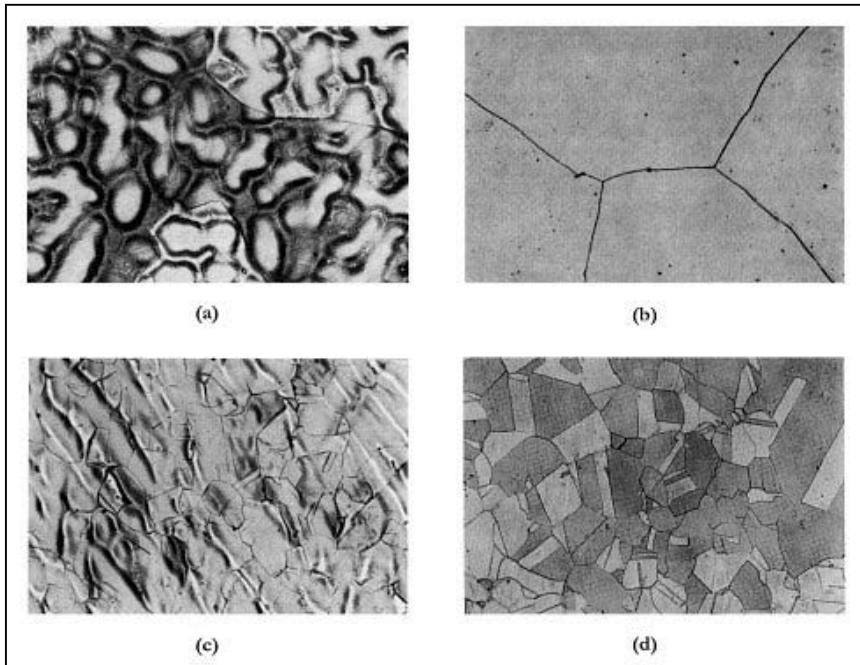
Figure 2: The matrix of UNS C71500 etched with FeCl_3 , (a) cast, (b) cast and annealed at 1100°C/ 30 min, (c) cast, 50% cold worked, and annealed at 850°C/ 4 h, (d) cast, 50% cold worked, and annealed at 850°C/25 h.

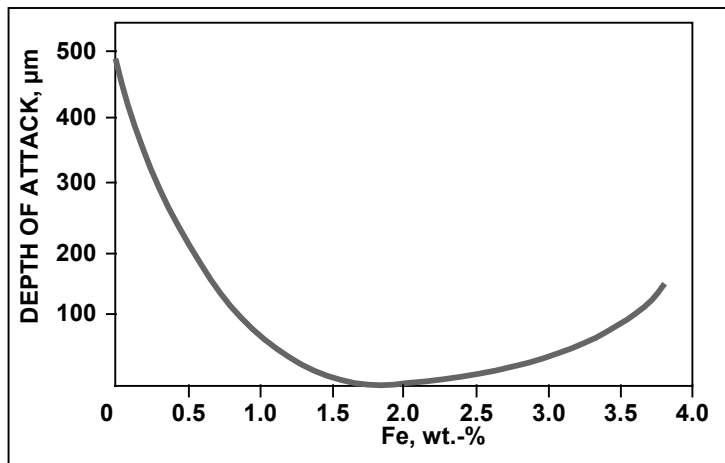
Figure 3: Influence of iron content on depth of impingement attack on UNS C70600 in seawater after 30 days duration test at 3 m/s.³

Table 1 compares the common international compositional standards for cupronickel. Some specifications monitor more strictly the iron content which is an essential alloying element and responsible for the improvement in corrosion resistance of the alloy. The alloying range between 1,5 and 2,0 wt.% Fe provides optimum resistance in flowing seawater (Figure 3)³. To provide the appropriate quality of cupronickel products, the cooling rate from the solution annealing temperature must keep the precipitation of iron containing particles to a minimum. The quality of the piping can be easily assessed by measurement of the relative magnetic permeability, which should be lower than 1.5.⁴ As for all metallic materials, if the CuNi 90/10 has to be welded, the maximum limits for some impurities such as lead, sulfur, carbon, and phosphorus should be carefully controlled.

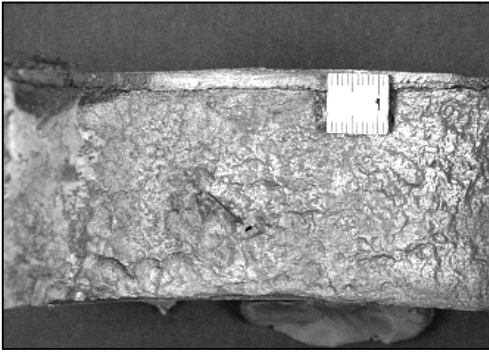
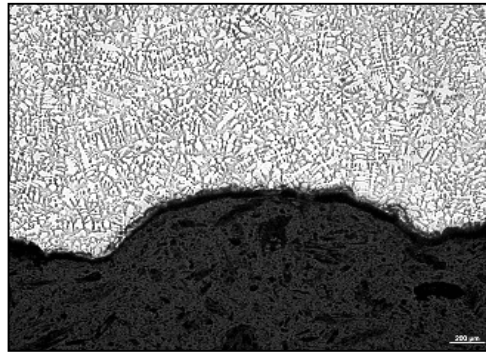
Figure 4: Erosion-corrosion damage of the inner surface of the weld neck (left), cross-section of the weld neck demonstrates a cast structure of the compound (right).

As a confirmation of above considerations, Figure 4 illustrates one of many weld necks installed on an offshore unit operating off the coast of South America. A great number of weld necks downstream valves and pumps suffered corrosion attack. The system was operated at ambient temperature and at a flow rate below 3,5 m/s. The cross-section of the weld neck shows a cast structure. The chemical analysis of the weld neck revealed the presence of 0.952 % Fe, 0.012 % Mn, and 0.087 % S.

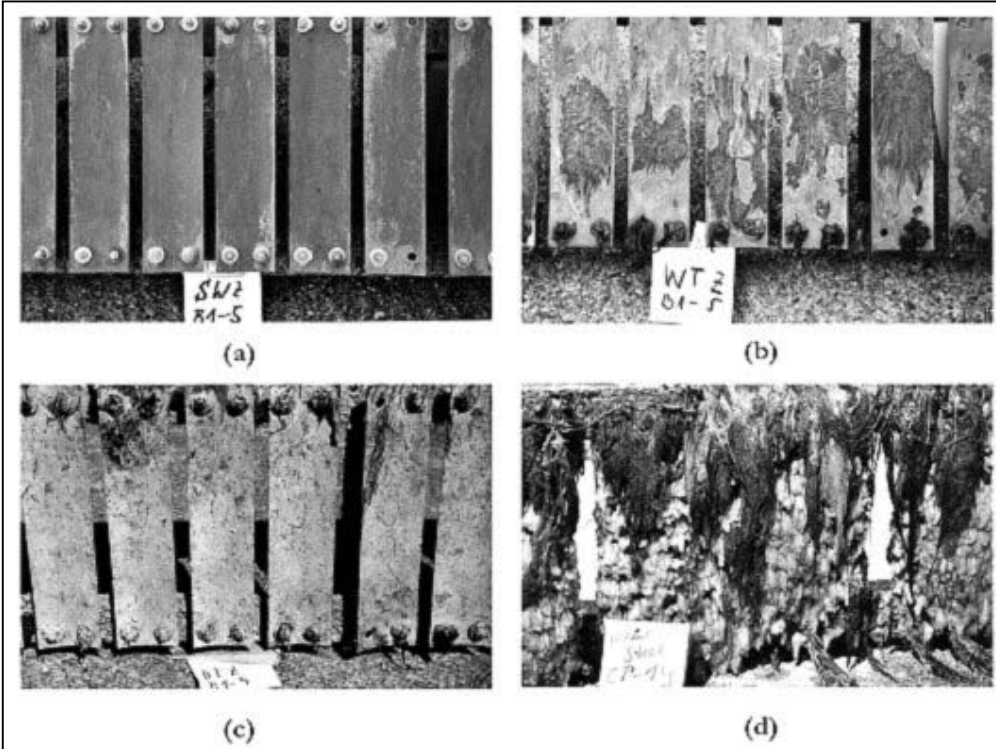
Figure 5: (a-c) UNS C70600 samples after 2 years exposure to different environmental zones at Helgoland, North Sea: (a) Splash, (b) Tide, (c) Submersed, (d) structural steel after 1 year of exposure at the same location under fully immersed conditions.

Figure 5 compares the appearance of cupronickel and steel plates exposed under similar conditions.¹² The significant difference in the accumulation of biological mass on steel samples is evident. Costly cleaning procedures and chlorine treatment of seawater become unnecessary. However, it has been widely recognized that, if cathodically protected, the biofouling resistance of cupronickel is decreased.

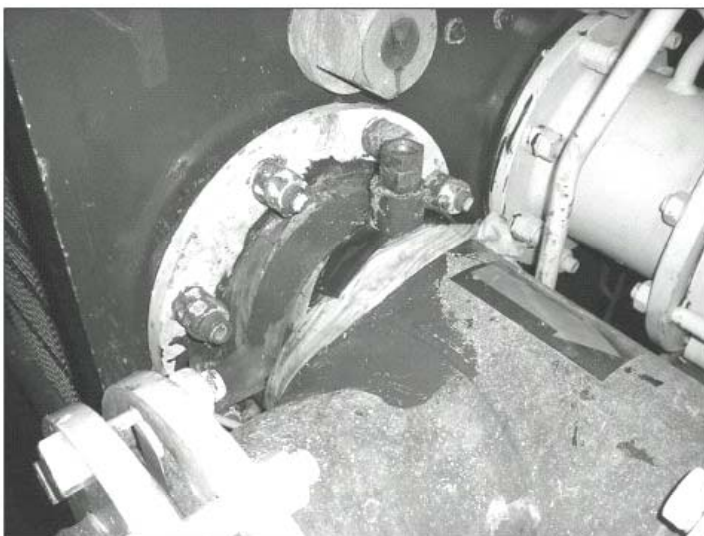
Figure 6: Erosion and galvanic damage behind the welding end at the UNS C70600 outlet pipe of a titanium heat exchanger operated at 4.2 m/s. The pipe and the heat exchanger were not electrically insulated.

Erosion-corrosion is a combined process, which is partly the mechanical impact of a moving medium over a metal surface, and partly electrochemical processes. In the case of copper alloys, it has been generally recognised that increasing flow velocities have no significant effect on the corrosion rate until a critical velocity – the so called breakaway velocity – is reached. Depending of the inner pipe diameter, the maximum flow rates in CuNi 90/10 systems should to be conservatively limited to 3.5 m/s.²² It has to be emphasized, that no erosion failures are known in clean seawater within the above velocity range. Moreover, the reported erosion failures are usually associated with the basic design mistakes of the piping systems (see Figure 6 and the text below).

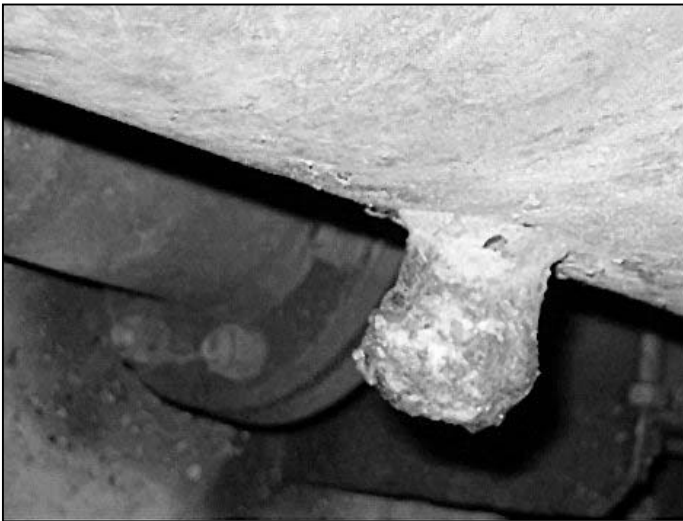
Figure 7: Galvanic corrosion damage of a carbon steel welding end welded directly to UNS C70600-pipe work.

The avoidance of galvanic corrosion is a principal design consideration (Figure 7). Stainless steels undergo significant potential variations depending of chlorine and oxygen content, temperature, as well as presence of a biofilm, e.g. up to +800 mV SCE in seawater containing 0.5-1.0 ppm free chlorine to less than -400 mV SCE in deaerated seawater. In contrast, UNS C70600 reveals only small changes (Figure 8). It has been reported that the corrosion potential of this alloy remains in the range between 0 and -300 mV SCE in natural aerated seawater at 10 and 40°C, in seawater flowing at 3 to 15 m/s at same temperatures, and in seawater containing 0.5 ppm free chlorine at 15 °C. Figure 9³⁴ demonstrates the galvanic series of different commercial alloys in flowing seawater. UNS C70600 has a central position in the series. It is nobler than aluminum alloys, carbon and galvanized steel and less noble than stainless steels and titanium alloys. It can be coupled to tin and aluminum bronze.²²

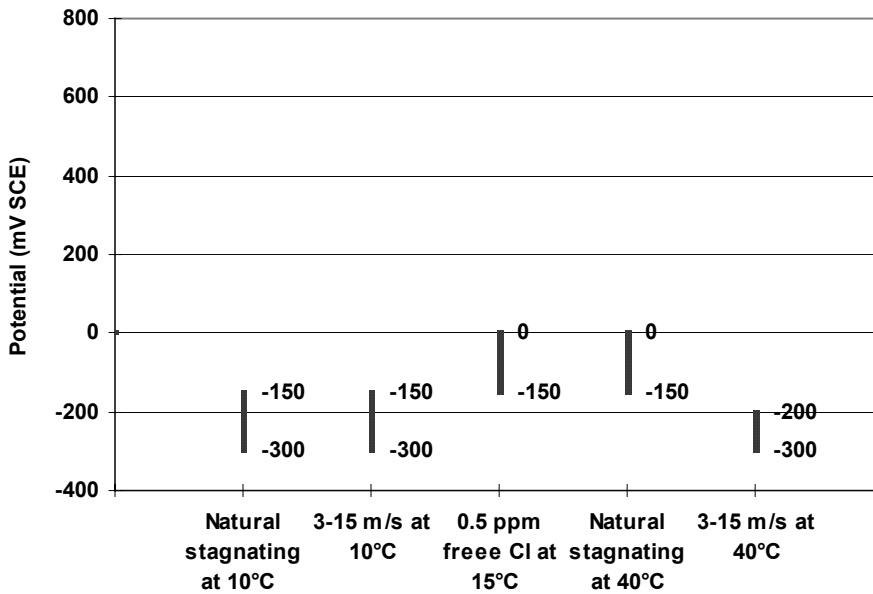
Figure 8: Typical values of corrosion potential for UNS C70600 under different seawater conditions. The potential axis represents the potential range of a super stainless steel.

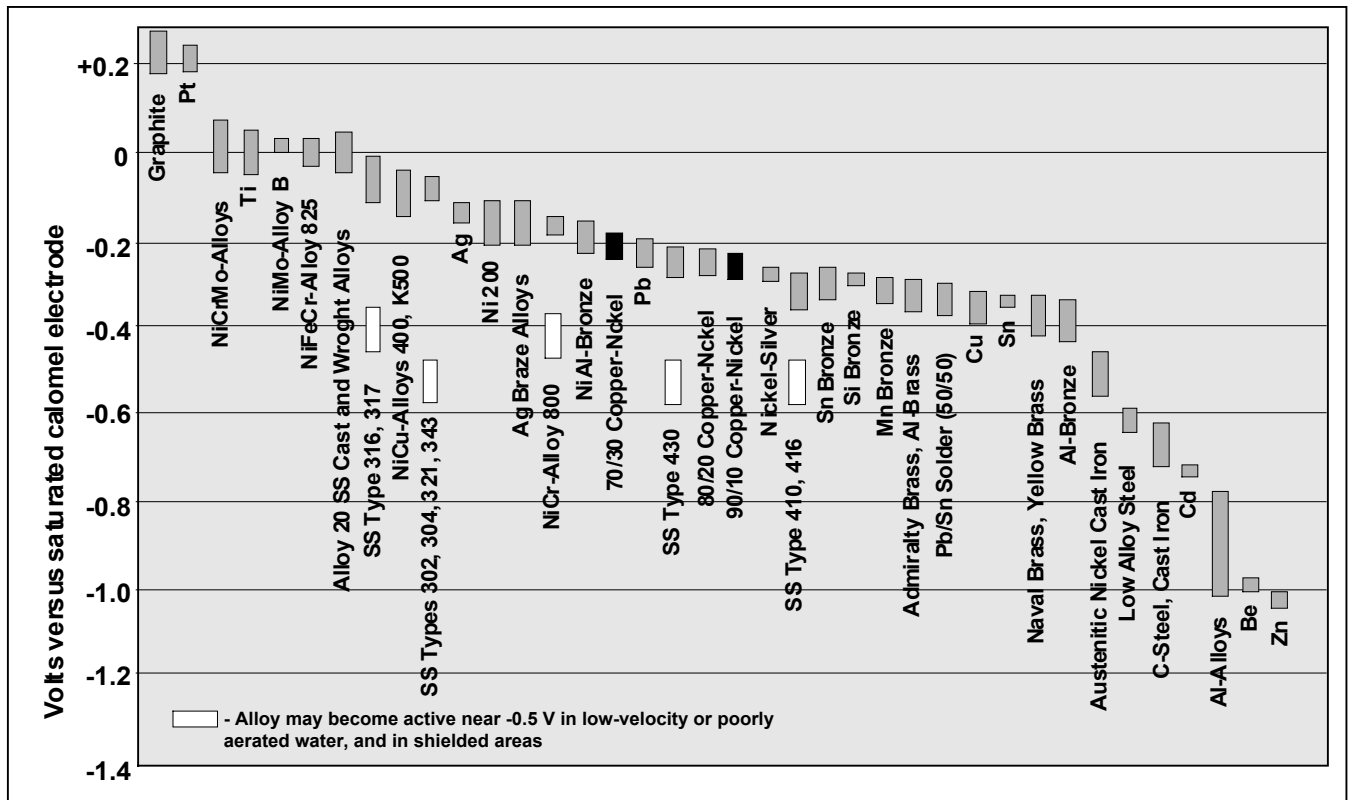
Figure 9: Galvanic series in flowing seawater at 2.5-4.0 m/s, 10-27°C.³⁴
