Evaluation of Copper-Nickel as a Sheathing Material for Hot Riser Protection on Offshore Platforms

Summary

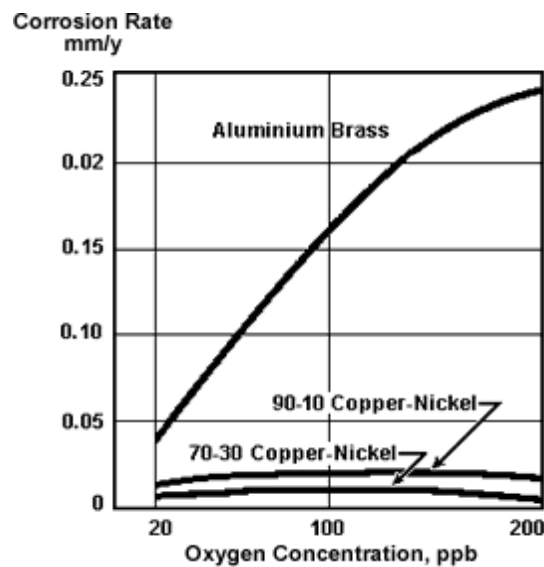
Figure 4. Effects of oxygen concentration on the corrosion of three copper alloys in deaerated seawater (90 days at 104°C T.D.S. = 35,000 ppm)[13]

A review of the effect of temperature and heat transfer for 90-10 copper-nickel was made in reference [12] and looked at ambient to 150°C. In general, temperature had only a moderate effect on the corrosion rate in sea water but the relationship was irregular, assumed to be due to variable factors including pre-existing surface films, flow velocity and pollutants. Much data has been obtained with MSF desalination practices in mind. The corrosion rates are low but the data is of limited value for the splash zone application as the hotter processes in MSF desalination involve de-aerated brines. However, some data [13] looked at the effect of oxygen pick up to 200ppb at 104°C, Figure 4. The corrosion rate of aluminium brass (C68700) was found to be more sensitive to changes in low concentrations of oxygen than 90-10 and 70-30 copper-nickels.

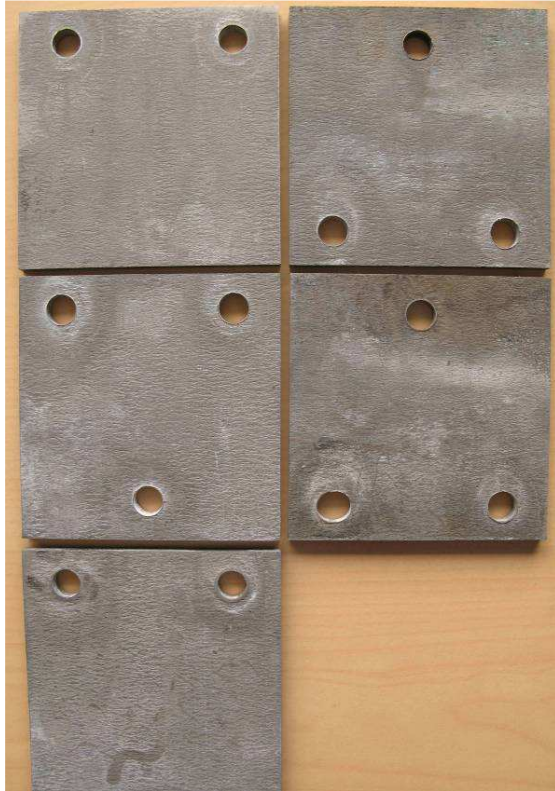
Figure 8 and 9. 70-30 copper-nickel samples after 6 weeks exposure; before and after ultrasonic cleaning.

The 70-30 copper-nickel had a grey appearance after exposure on both submerged and partially submerged specimens. There was a tinge of a brown colouration on the upper sections of the partially submerged samples which were removed by cleaning. No coppery deposits were visible after cleaning. Again, on close inspection no pitting or crevice corrosion could be found.

Figures 6 and 7, 8, 9 and 10 and 11 show the condition of 90-10 copper-nickel, 70-30 copper-nickel and 65% nickel-copper alloy 400 respectively after 6 weeks exposure, before and after ultrasonic cleaning. Samples 1, 3 and 5 show the immersed samples and 2 and 4 show the half submerged samples for each alloy.

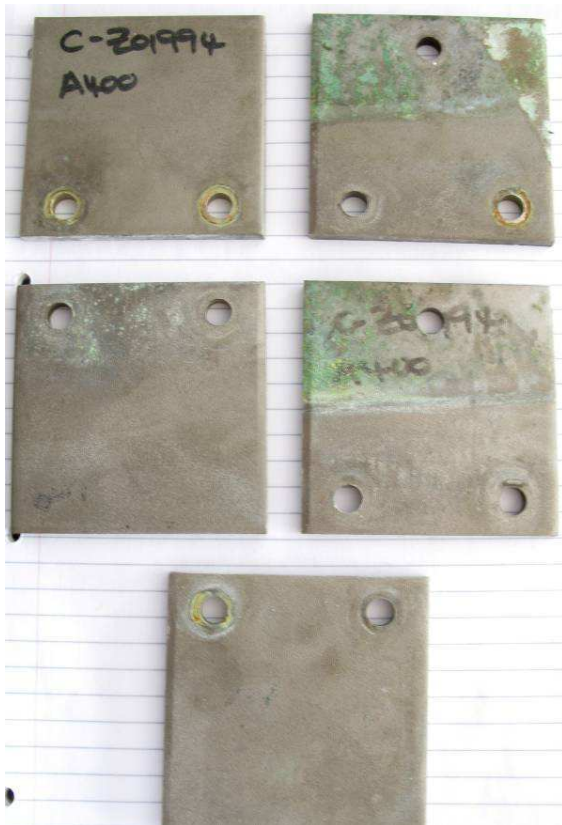
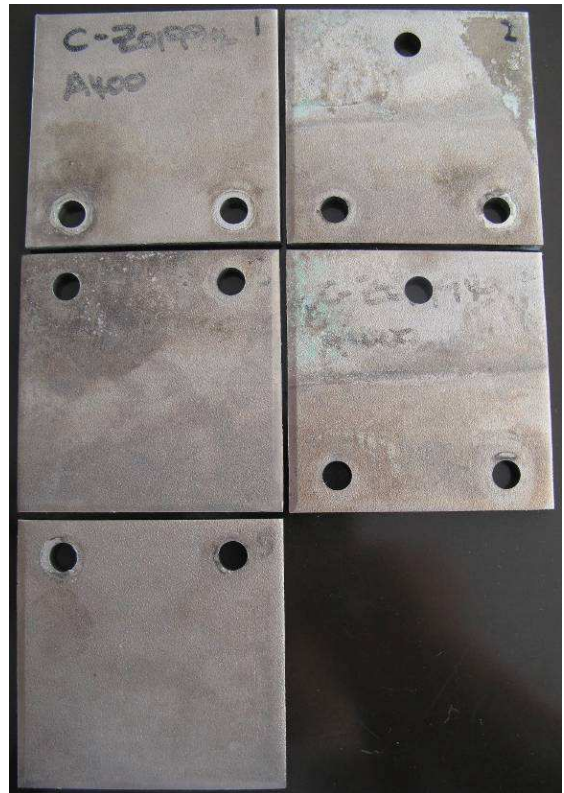
Figure 10 and 11. Nickel-copper alloy 400 samples after 6 weeks exposure; before and after cleaning

The as-exposed, submerged samples in alloy 400 were fairly uniform in surface appearance after the 6 weeks exposure but the partially submerged samples showed a green surface film in the areas above the submerged zones. After cleaning the green film disappeared. Some areas when examined in close up appeared pitted especially on the splash zone surfaces of metals which were partially submerged, see figure 12, and there were signs of crevice corrosion on the submerged samples under the fastener washers, Figures 10,11,13.
