# Corrosion and Biofouling Resistance Evaluation of 90-10 Copper-Nickel

Carol Powell

## Abstract

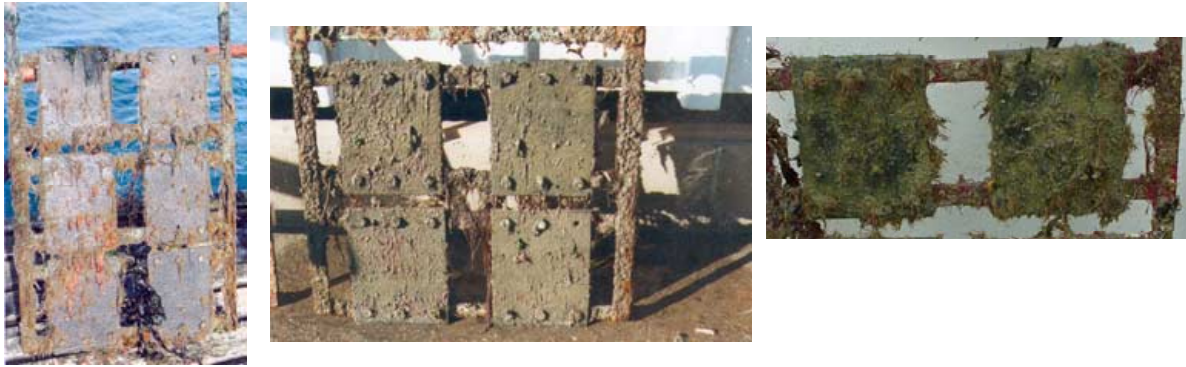
After an 8 year exposure trial period, the embedded granule product panels appeared to have successfully withstood the aggressive exposure conditions. A limited amount of macrofouling was present on the alloyed surface of the panel predominantly located on the polychloroprene, the GRP backing and at the edges with very little above the alloy itself. When wet, fouling deposits could be manually removed to expose the alloy surface.

Figures 2, 3, 4. *Embedded granule panels after 1, 5 and 8 years exposure*

A certain amount of corrosion and roughening of the copper-nickel rods exposed to the sea had occurred; some pits were seen at the ends directly exposed to the sea. However, little reduction in the measured rod diameters was observed; values of *ca.* 1.1 mm were found, similar to the specifications for new material. After 8 years, the rods were still embedded in the rubber matrix, although they could be removed by flexing the supporting matrix.

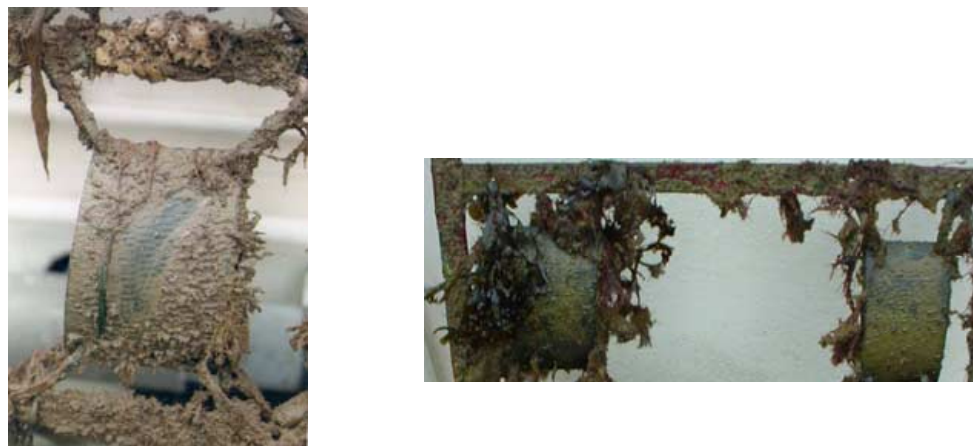
After a 7 year exposure trial period, the panels were largely undamaged by the exposure conditions. A very small amount of macrofouling was present on the alloyed surface of the panel. The fouling, where present, was predominantly located on the EPDM rubber, at the interfaces between the alloy and the rubber, and at the edges of the panels. Very little macrofouling was found on the alloy mesh. When wet, any fouling deposits could be manually removed from the alloy containing side of the panel to expose the alloy surface, Figure 5.

The rear surfaces of the panels were heavily fouled and the detritus could not be removed. Some corrosion and roughening of the surfaces of the copper-nickel exposed to the sea was observed.

Figures 5 and 6. *Expanded mesh panels after 2.5 and 7 year exposures*

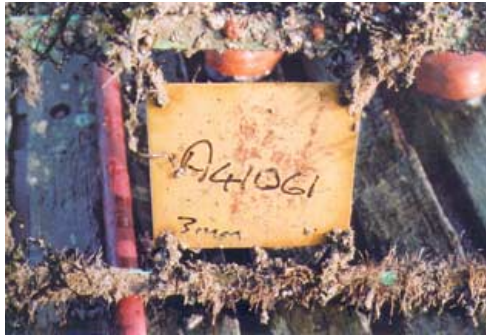
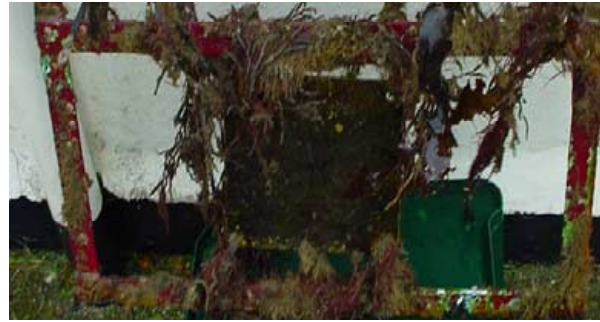
After a 7 year exposure trial period, the hot-rolled copper-nickel panel showed the best overall fouling resistance. It was only in the latter years that any deterioration in the condition of the surface was observed.

Figures 7 and 8. *Hot rolled sheet after 13 month and 7 year exposures*

A limited amount of macrofouling was present on the alloyed surface of the panel. Even after drying, macrofouling organisms and films could be easily removed from the surface. When wet, any fouling deposits could be manually removed to expose the alloy surface. Light generalised corrosion of the copper-nickel surface had occurred.

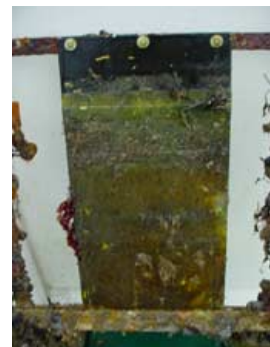
After extended exposure periods, the GRP and steel based-panels had performed extremely well and remained largely free of macrofouling. After approximately 3.5 years exposure, the aluminium samples had corroded with concomitant detachment of the copper-nickel and were removed. In the case of the steel and GRP based samples, the alloy surfaces did not show any signs of detachment from the underlying substrates.

Considerable thinning and removal of the copper-nickel on the knife-edge of the panels was observed. This was attributed in part to erosion-corrosion of the alloy. Fouling plants and organisms were predominantly found at these edges and in overlap regions of the panels. Barnacles and fibrous material were also present after extended exposure times. Where present, macrofouling and detritus were loosely attached and could be wiped away with varying amounts of force. The copper-nickel on the flat surfaces of foil had thinned by a decreasing rate which is consistent with Figure 1 and was measured as averaging 5.5 mm per annum over a 7 year exposure period.

Figures 9,10 and 11. *Adhesive Backed Foil panels as immersed and after 18 month and 7 year exposure*
