# Living with the threat of microbiologically influenced corrosion in submarine seawater systems: The Royal Navy's perspective

**G J E Nicklin, MSc, CEng, MIMechE**  
*UK Ministry of Defence*

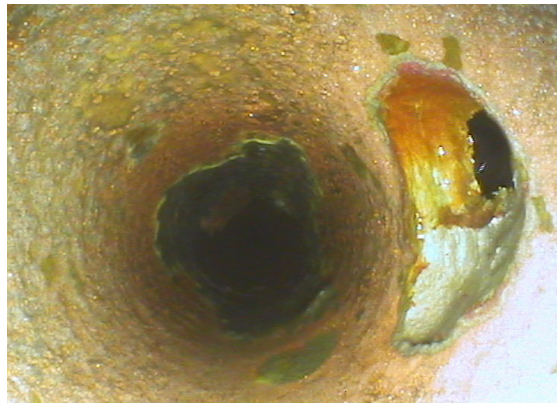
maintenance of UK submarines have, in the past, been successful in ensuring that heat exchangers meet their design life intent. In the current decade, however, a move to reduce the length of maintenance periods, together with pressures on resource and finance have slowly lead to the demise of the care and attention that was once afforded to these components. Whilst it is apparent that no formal conditioning procedure was ever strictly adhered to, it is clear from the literature that coolers were afforded some protection, largely on an ad-hoc basis. In some cases this was achieved by circulating clean seawater imported by barge through the new cooler, in other cases mains fresh water has been used. Regardless of how it was achieved, the conditioning process took time. For those looking to shorten the programme it was an inevitable target, and for submarines entering upkeep periods in 2005 and 2006, it was seen as a luxury which could easily be removed from the package. Such a decision meant submarine coolers would now experience their first seawater exposure with water from a non-tidal basin and as such become vulnerable to MIC attack. In the space of a year, the submarine flotilla lost a total of 8-months operational availability across 2 platforms as a result of rampant pitting corrosion<sup>3</sup>. The first pit to breach through a tube wall occurred after just 6-months of service, an overall corrosion rate of 2 mm/year (Fig 1).

**Fig 1** View along bore of failed cooler tube (7/16 inch OD) showing through wall pit

This paper reviews the actions taken by the UK MOD in light of the lessons learnt from these MIC events, from the immediate response to exclude all suspect basin waters from vulnerable coolers and to re-educate the community on the importance of conditioning, through to the formulation of longer term solutions, including studies with chemical corrosion inhibitors and water treatment technologies.

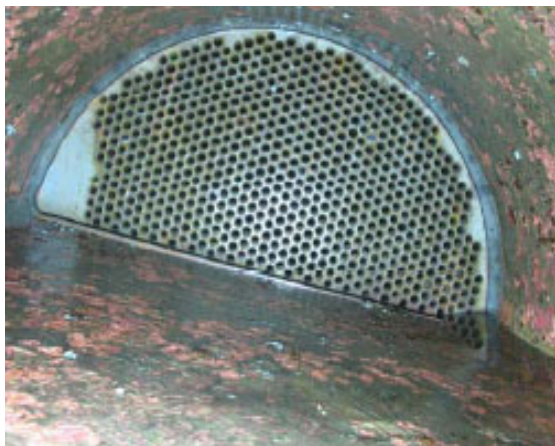
The process of dismantling a submarine cooler to facilitate mechanical cleaning is lengthy, expensive and extremely disruptive to adjacent equipment. Extensive system pressure testing is furthermore required following re-build. In 2004 therefore, the UK MOD conducted trials on a number of chemical descalers that would allow the non-intrusive clean of a cooler's internals by circulating a 'treatment' via the sea tubes. All such cleaners are based on a variation of a dilute hydrochloric acid and it was recognised that such cleaning would result in any pre-existing copper oxide coating (such as that formed through a conditioning process) being removed; this would therefore need to be re-established. The process proved to be extremely effective in restoring complete cooler cleanliness requiring just 24-hours rather than the previous 2-week strip, clean and re-builds (Fig 4).

**Fig 4** View as Fig 2 following chemical clean and debris removal (tubeplate diameter 850mm)

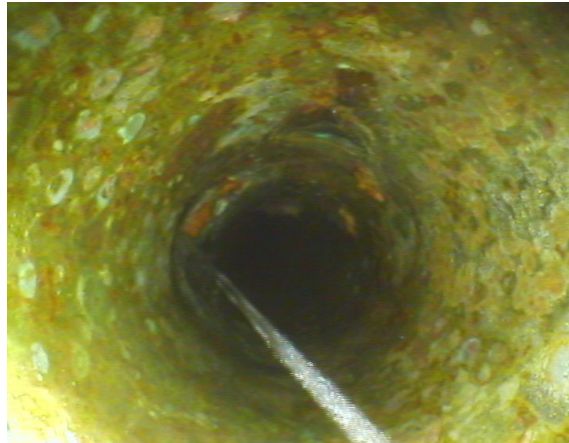
**Fig 5** A pitted tube identified in a cooler using a shell side hydrostatic test and an endoscope

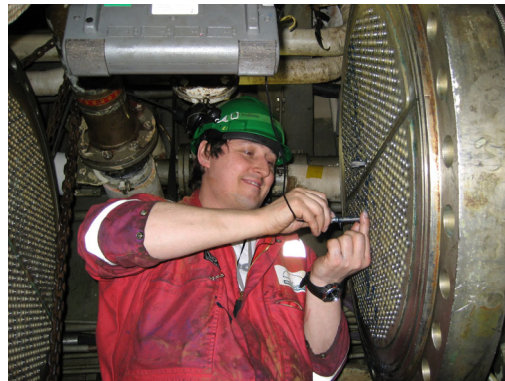
dry and can be typically removed from the ship by one man in a matter of hours. A submarine cooler on the other hand contains some 2,600 tubes and has an overall length of 5 m (Fig 11). The entire unit dry weighs 7,000 kg and can only be removed by cutting a hole in the submarine's pressure hull; the whole task would take as much as a year to complete. Even if this were done, the risk of accelerated galvanic or selective phase corrosion in the adjacent nickel-aluminium-bronze cast headers would be intolerable.

**Fig 11** Eddy current inspection via a removed seawater header – there are 2,584 Cu-Ni tubes in this design
