Centre Expérimental de Recherches et d'études du bâtiment et des travaux publics.

Corrosion of iron and/or copper embedded in concrete or plaster.

5 February 1965.

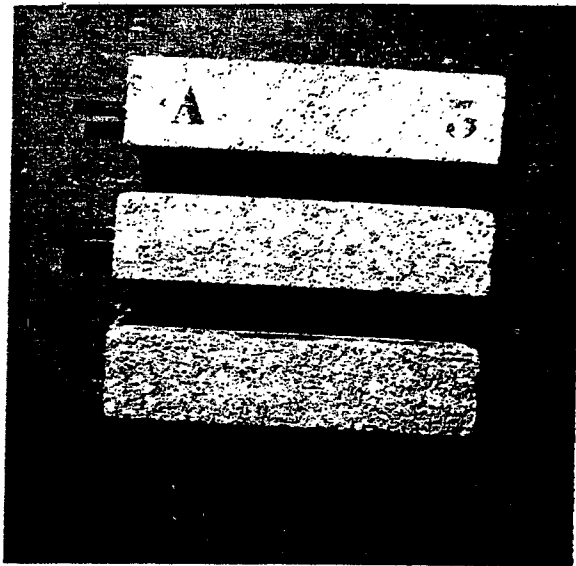
<u>Curve A</u> :- <u>copper</u> Wet	: -80mV.
	max.diff.: 220mV.
<u>Curve B</u> :- <u>copper</u> and iron without connection	Wet : -80mV.
	max.diff.: 220mV.
<u>Curve C</u> :- <u>copper</u> and <u>iron</u> without connection	Wet : -240mV.
	max.diff.: 320mV.
<u>Curve D</u> :- <u>copper</u> and <u>iron</u> without connection	Wet : -120mV.
	max.diff.: 140mV.

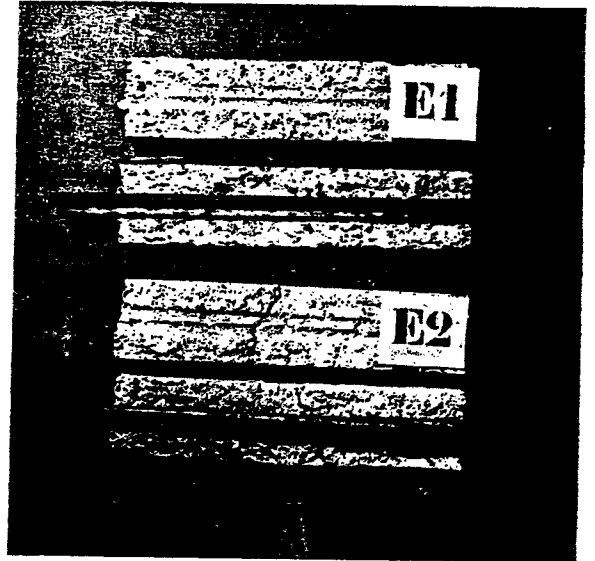
Curve E:- copper and iron with connection Wet : -140mV.
max.diff.: 260mV.

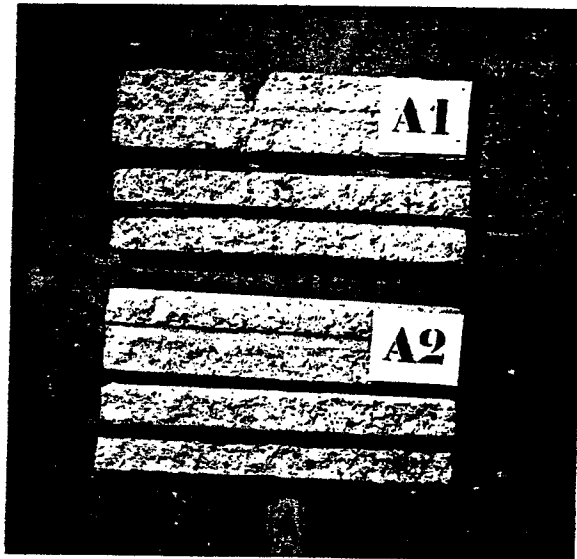
Curve F:- copper Wet : -90mV.
max.diff.: 110mV.

Curve G:- copper and iron without connection Wet : -100mV.
max.diff.: 160mV.

Curve H:- copper and iron without connection Wet : -380mV.
max.diff.: 200mV.

Curve I:- copper and iron without connection Wet : -280mV.
max.diff.: 80mV.

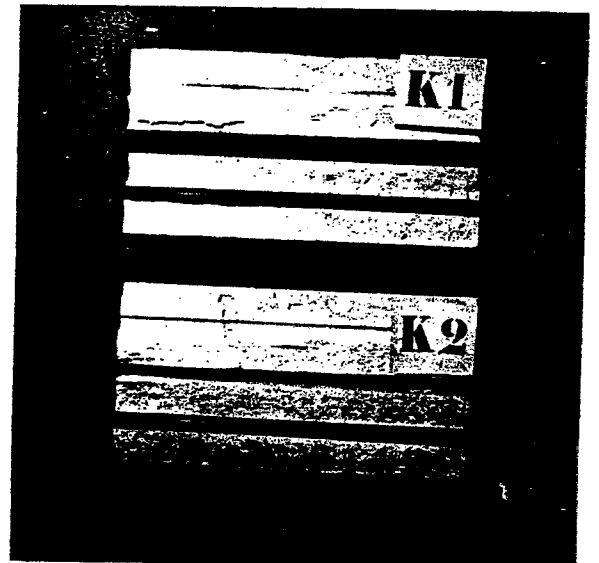
Curve J:- copper and iron with connection Wet : -380mV.
max.diff.: 240mV.

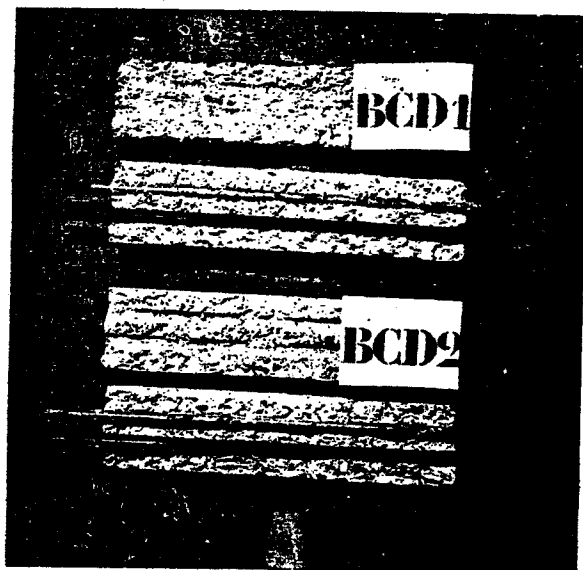
Curve K:- copper Wet :+30mV.
max.diff.:50mV.

Curve L:- copper and iron without connection Wet +30mV.
max.diff.:50mV.

Curve M:- copper and iron without connection Wet :-630mV.
max.diff.:650mV.

Curve N:- copper and iron without connection Wet :-670mV.
max.diff.:600mV.

Curve O:- copper and iron with connection Wet :-580mV.
max.diff.:580mV.
