## Copper-nickel piping reduces costs, biofouling/corrosion

**E. Kurt Albaugh,** Senior Project Engineer, Dolphin-Titan International, Inc., Houston

### 10-second summary

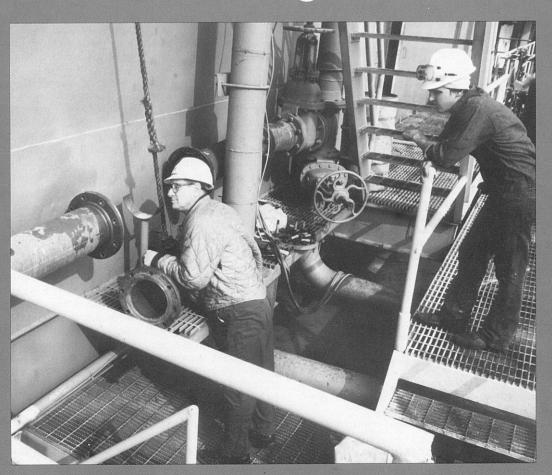
Fig. 1—Hard biofouling on an 8-in. Schedule 80 carbon steel header reduced the ID by 11/8-in., and the cross-sectional area by 52% in just 21/2 years of offshore service. Such fouling makes oversizing and frequent replacement of steel seawater piping components a practical necessity.

The depth of biofouling was fairly uniform throughout the straight sections of the seawater line, although it was noted that biofouling appeared to be thicker and richer in the discharge piping. This was attributed to the higher water temperature in the line, which enabled biofouling to grow at a faster rate.

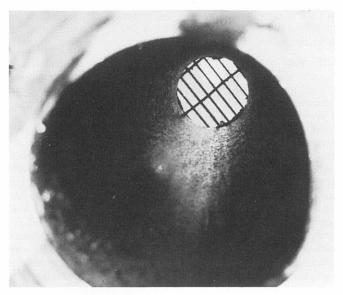
Fig. 2—Copper-nickel seawater piping spool removed for inspection after 22 months of continuous service. Neither biofouling nor measureable metal loss could be detected.

After 22 months of location service, the copper alloy spool sections were removed for inspection. Internal surfaces of both the copper-nickel and aluminum bronze pipes were covered by a characteristically thin and tightly adhering ox-

ide film. Neither were pitted nor had suffered a measurable loss of metal. And both were completely free from biofouling (Figs. 2 and 3). By contrast, the inside of the carbon steel spool piece was already both corroded and heavily biofouled (Fig. 4). Ultrasonic inspection revealed that pitting was also occurring under the corrosion products and marine growth. Although no more detailed tests could be performed at the time, it was clearly evident that the alloy spools were in far better condition than the steel.

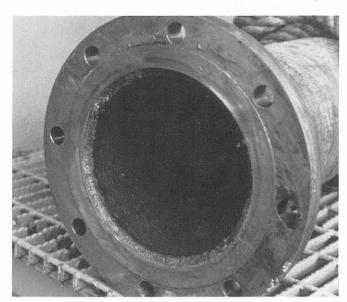
Fig. 3—Shown is an aluminum-bronze piping spool section after two year's service aboard Dolphin-Titan Rig 128. ID surfaces remain free from corrosion and biofouling.

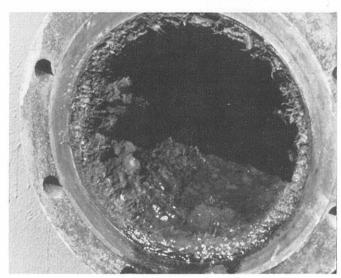
**Fig. 4**—Illustrated here is the 8-in. Schedule 80 carbon steel spool from same seawater line shown in Figs. 2 and 3. Extensive corrosion and biofouling have developed in less than 2 years. Pitting has also been detected by ultrasonic examination.

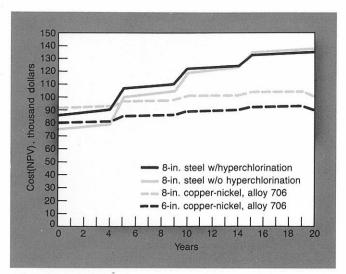
Fig. 5—Total Cost (NPV) of seawater piping systems for steel and Alloy C706 are compared. Copper-nickel systems have been determined to be more (life-cycle) cost-effective than equivalent steel piping.

Results of this analysis are graphically illustrated in Fig. 5, which indicates that under optimum conditions, Alloy C706 provides a definite cost advantage over carbon steel. The life-cycle cost of a 6-in. Class 200 copper-nickel system is \$28,635 less than that of a functionally equivalent 8-in. steel system. Even when total cost of a steel piping system is reduced by addition of hyperchlorination, it still exceeds the cost of both Alloy C706 systems by wide margins. Viewed in terms of return on investment, copper alloy provides a payback period as short as two years and, even in the least practical case, of using 8-in. 90/10 copper-nickel, the payback period is 8.8 years, still less than half the potential life of the platform or drilling rig.
