Networked Machine Shop/ Manufacturing Plant Learns the Value of Proper Grounding

How four years of bad advice kept an innovative company from realizing the potential value of its networked CNC-CAD/CAM systems

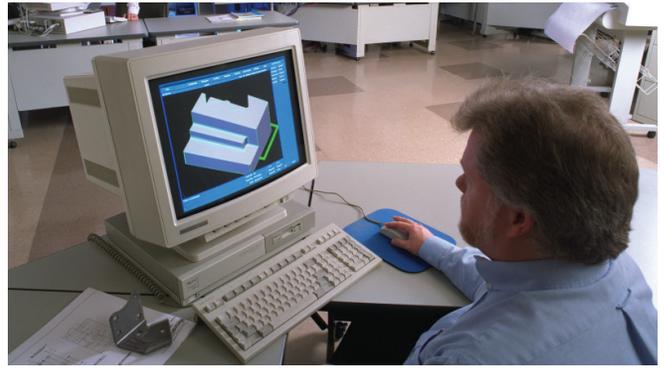
Unix-based CAD/CAM terminals were the first computers to be networked at McAfee Tool & Die, in 1992. CNC machine tools were networked in 1994, and both networks were linked in 1998. That's when things really went downhill.

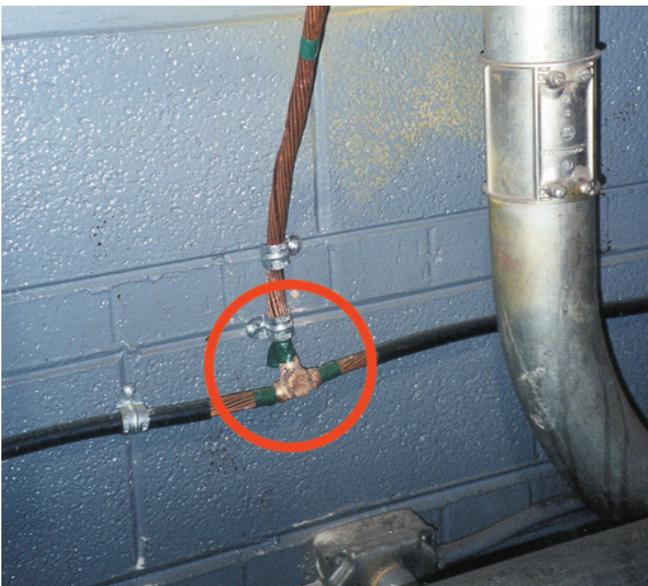
An exothermically bonded connection, circled, was used in this case, but approved copper or copper-alloy mechanical connectors could have been used as well. PowerEdge Technologies replaced an existing aluminum grounding system, whose connectors had corroded, with #4/0 AWG copper in order to provide lasting reliability.

"We brought the company's electrical and grounding systems back to basics. We set up the building steel as a reference, then bonded each CNC machine and all electrical equipment panels to it using #6 AWG copper and exothermic-type connections. We replaced all of the old aluminum with copper cable and copper connectors. Outside, we drove three new 3/4-inch X 10-ft ground rods in a triangular pattern at the main service entrance, burying them and their ground electrode

conductors two feet below grade to ensure good contact and low resistance. For electrode conductors we used #4/0 AWG copper, bonding everything with exothermic connectors. In fact, in all of our jobs, we use nothing but copper."

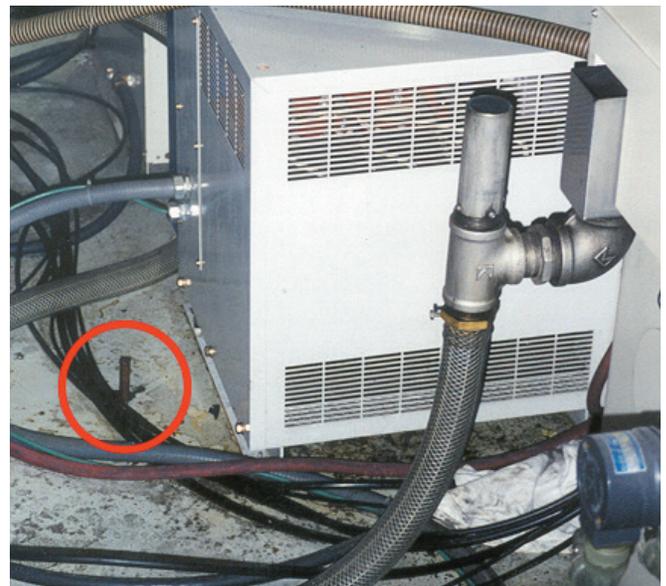
A supplemental ground rod at one of McAfee's CNC machines, circled. This and other supplemental ground rods were disconnected from the machines to eliminate damaging ground loop currents. The machines were then properly connected to the building's grounding system at the recommendation of PowerEdge Technologies, Inc.

This one requires some explaining. Supplemental ground rods for individual pieces of equipment are somewhat unique to the machine tool industry. No one would think of driving a separate ground rod for each computer in an office, but the practice is widespread in machine shops. In fact, the practice was recommended by 10 out of 15 CNC machine tool OEMs surveyed in a recent study conducted for the Electric Power Research Institute (EPRI). Three of the fifteen OEMs surveyed even said that failure to install the rods would void their equipment's warranty. Supplemental ground rods are permitted under the National Electrical Code® (NEC), but they should only be installed, if at all, after a careful analysis of the building's entire electrical, grounding and lightning protection systems. Installing supplemental ground rods at individual CNC machines is not a good idea. OEM installation manuals specifically do not recommend it. Supplemental ground rods, especially those that are allowed to "float," may actually decrease reliability and increase the risk of damage to the machines' electronic circuitry.

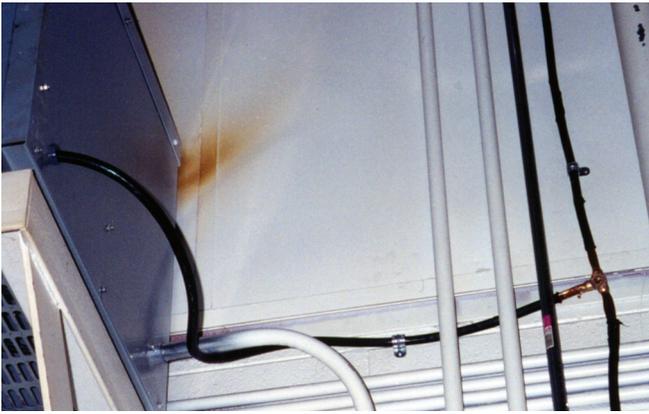
An overhead-mounted 480/240V CNC equipment transformer properly connected to the building's grounding system using #4/0 AWG copper, which is larger cable than that required by the NEC. The vertical ground conductor at far right is bonded to the building steel (not shown), which PowerEdge Technologies used as the building's reference grid.

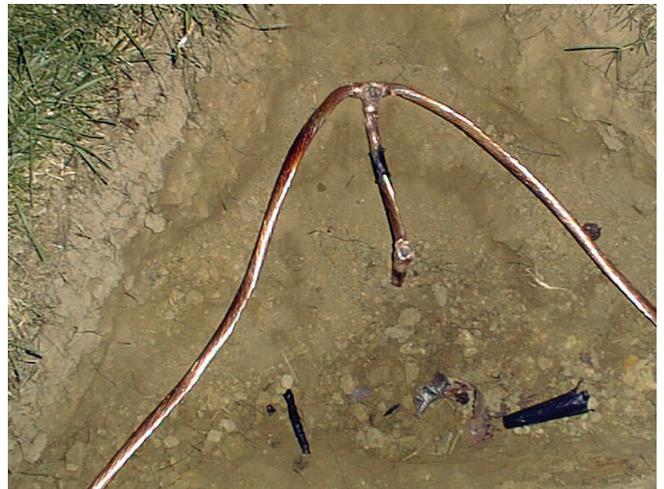
A new, bonded, grounding electrode conductor connection at McAfee Tool & Die prior to backfilling. PowerEdge Technologies specified #4/0 AWG copper for external grounding electrode conductors. The 10-ft grounding electrode and all conductors were buried at least two feet below the surface to ensure good ground contact. The all-copper system's 7 S ground resistance helps ensure reliable computer communications.

The new system has a ground resistance of only 7 S, and the ground system noise on the communications cables is below 1.5 V. John Stiles is more than satisfied. "Before PowerEdge came in, I was getting nothing but bad advice and I was running out of ideas. When Tim Cookson first looked at our shop, he walked around with a grin on his face like he'd seen it all before, and when he said 'Do this and it will work' instead of 'Try this and let me know,' I knew he could help us."

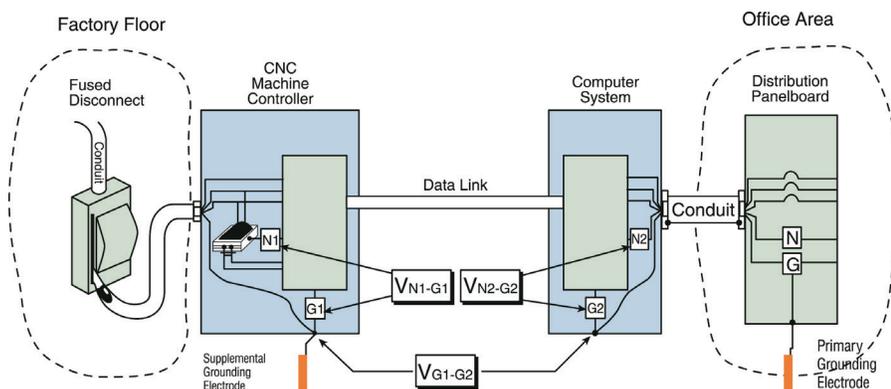
Any differences in the ground resistance of the main and supplemental grounding electrodes can drive ground loop currents circulating through the ground and grounding connectors connecting machines with other elements in the electrical and/or data systems. The grounding shield surrounding data cables connecting CNC machines and the central computer are one such return path. Current flowing in this path as a result of ground loops constitutes a noise signal that can disrupt data communications. This is precisely what happened at McAfee Tool & Die before the supplemental electrodes were disconnected and a proper grounding system was installed.

A supplemental electrode attached to a CNC machine. In this arrangement, the machine cabinet, as well as cable trays and other electrical equipment, are also properly bonded to the ground bus at the service entrance switch (the first disconnect). This practice is permitted under the NEC, but it can cause problems due to the formation of ground loop currents. Illustration adapted from *Power Quality Considerations for CNC Machines: Grounding*, Copyright 8 1997, Electric Power Research Institute. BR-107170. Reprinted with permission.

The CNC equipment is properly grounded through a "green wire" (not shown) and through the conduits and raceways, to the ground bus/neutral bus junction at the service entrance panel, and from there to the grounding electrode(s) located outside the building. Grounding connections are also made from the neutral-ground bond at the service entrance panel to a metal water pipe and to the building steel. The left of the figure shows a supplemental grounding electrode installed at the CNC machine and connected to the machine cabinet, as originally configured at McAfee Tool & Die. This arrangement is permitted under the NEC, which is concerned mainly about safety, but it is not recommended under IEEE Std. 142 (*The Green Book*), Grounding of Industrial and Commercial Power Systems, and IEEE Std. 1100 (*The Emerald Book*), Powering and Grounding of Sensitive Electronic Equipment.
