FloridaCredit Union Data Center Shrugs Off Direct Lightning Hit

Solid Copper Grounding System, In-Depth Surge Protection Keep System On-Line

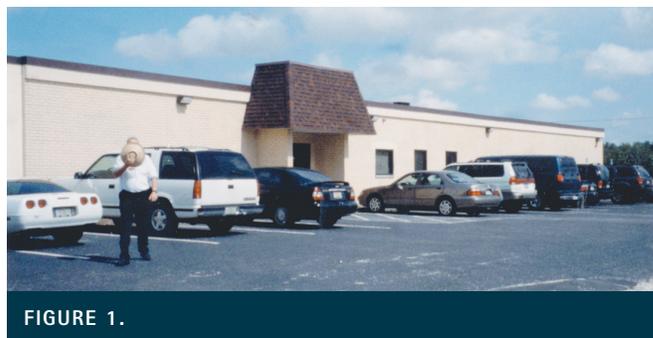
FIGURE 1.

Suncoast Schools Federal Credit Union is the ninth largest organization of its type in the USA, serving more than 215,000 members in 15 Florida counties. The bank's Tampa annex building (cover) is closely linked with a nearby data processing center (above) and with 28 branch offices throughout the Gulf Coast region. Because it is located in Florida's notorious "lightning alley," the data center is equipped with a robust, all-copper grounding system and multiple layers of both surge protection and uninterruptible power supply devices.

The bank operates a state-of-the-art data center (Figure 1) near its Tampa headquarters (cover). The center is housed in a single-story, 5,000-sq ft (500-sq m) cinderblock building that had once been a warehouse. Before moving in, Suncoast gutted the old structure completely and rewired it top-to-bottom for sensitive electronic equipment. Telephone equipment is housed in a separate building to diminish the risk of total system failure in the event of a severe lightning storm.

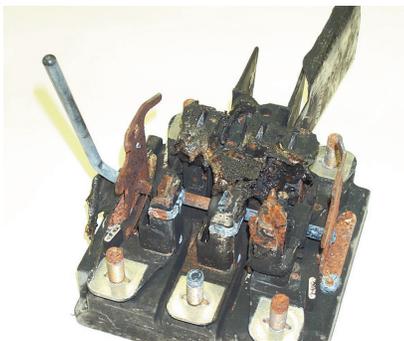
FIGURE 2A.

Figure 2a. A direct lightning strike to the data center's overhead service entrance cable destroyed the electric meter and meter socket but did no other damage, thanks to a solid copper, low-resistance grounding system and multiple layers of surge protection.

"When I got to the data center, the generator was still powering the building. That seemed odd, because if the generator had kicked in due to an outage, it should have shut down once utility power was restored. "Then I saw the meter, or rather, the mass of burned metal and insulation that was left of the meter socket (Figure 2a). Lightning had struck our 480-V service entrance cable. It blew the meter off the wall (we never did find it) and headed straight for the transfer switch and generator.

"Fortunately, our electrical consultant had recommended that we install a good grounding system, and it was that system, coupled with the cascading transient voltage surge suppressors (TVSSs) he had installed, that saved us. Because it was well grounded, the primary TVSS shunted the lightning surge to earth before it could do any damage downstream. The TVSS survived, as did all of our equipment.

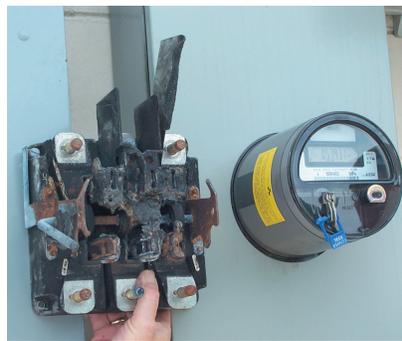
FIGURE 2B.

Figure 2b. shows the destroyed unit along with the replacement meter and socket.

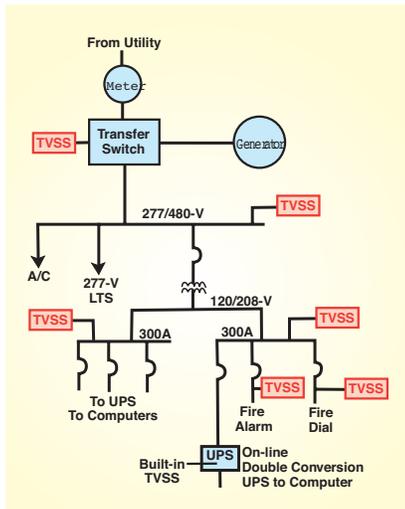
FIGURE 3.

Basic elements of the Suncoast data center's electrical system. Also shown are several of the up-to-seven layers of transient voltage surge protection installed by the Orlando-based electrical consulting company. The TVSS at upper left was directly in the path of a nearby lightning strike, but it shunted the current to ground and survived the hit without damage.

The protection system that saved Suncoast's equipment and data was designed and installed under the supervision of Power & Systems Innovations, Inc. (PSI), an Orlando-based company that specializes in protecting sensitive installations like the Suncoast data center. Because much of their work is done in the heart of Florida's famous "lightning alley," PSI has developed its own stringent specifications for commercial grounding systems. The power-quality provisions of those specs go well beyond the National Electrical Code® (NEC). Figure 3 shows a partial schematic of the system PSI designed for Suncoast. Starting from the ground up, its main elements include:

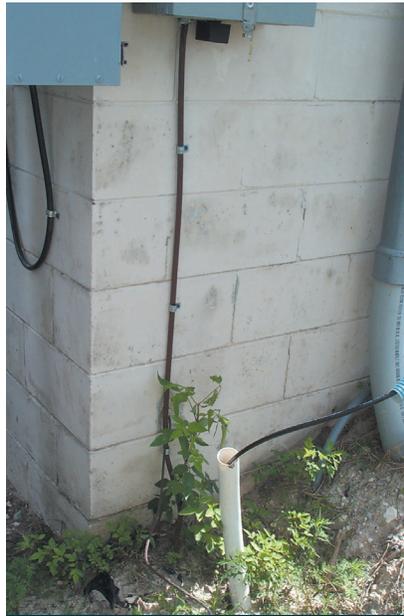
FIGURE 4A.

Figure 4a. The main grounding electrode conductor extends from the electrode array to the meter box (vertical cable) and to the service entrance panel seen at upper left. The 4/0 grounding cable leading to the right connects to the air-conditioning equipment subpanel. Exothermic welds (Figure 4b.) connect the grounding electrode conductor to other outdoor equipment.

- Three 20-ft x 5/8-in (6-m x 16-mm) copper-clad-steel grounding electrodes located at the service entrance (Figure 4a), between the emergency power generator and transfer switch (Figure 5a), and in a lot behind the building, respectively. Ordinarily, PSI would have preferred to install a buried, heavy-gage copper ringground around the building, but property constraints dictated the electrodes' location. The three electrodes PSI installed replaced a single galvanized rod left over from the building's warehouse days. The electrodes are exothermically bonded to a buried, bare 4/0 copper grounding electrode conductor leading from the main service entrance

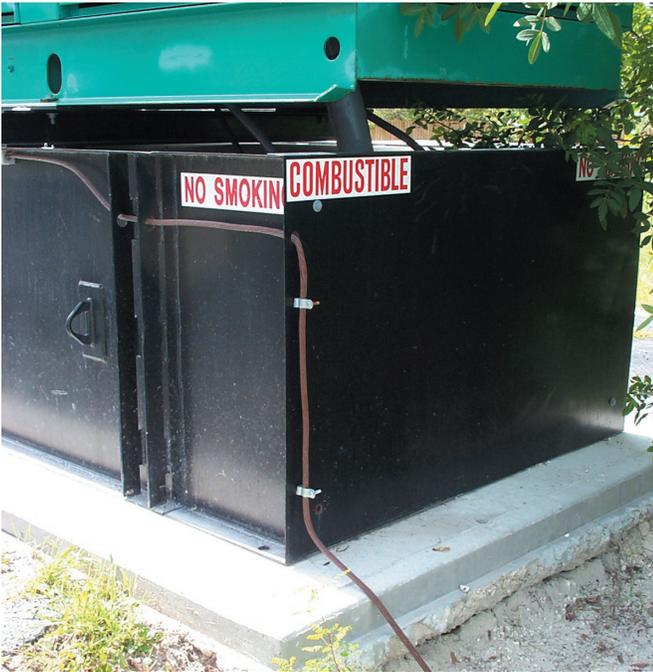
FIGURE 5A.

Figure 5a. View of the 4/0 grounding conductor for the 200-kW emergency generator. This conductor is exothermically bonded to the buried grounding electrode system described in the text. (Figure 5b.) Shows the corrosion-resistant bronze clamp that bonds the 4/0 grounding conductor to the generator base.

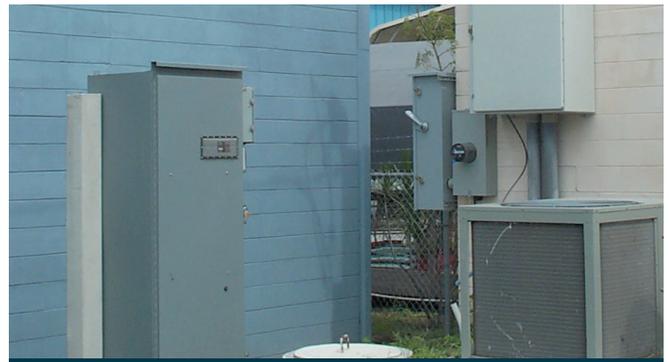
FIGURE 6A.

Figure 6a. The transfer switch (left), service entrance and meter location. One 20-ft x 5/8-in copper-clad-steel electrode is located between this transfer switch and the emergency generators, another at the service entrance, and a third behind the building. All are exothermically bonded to a buried 4/0 copper grounding electrode conductor. (Figure 6b.) Shows the grounding connection at the transfer switch.

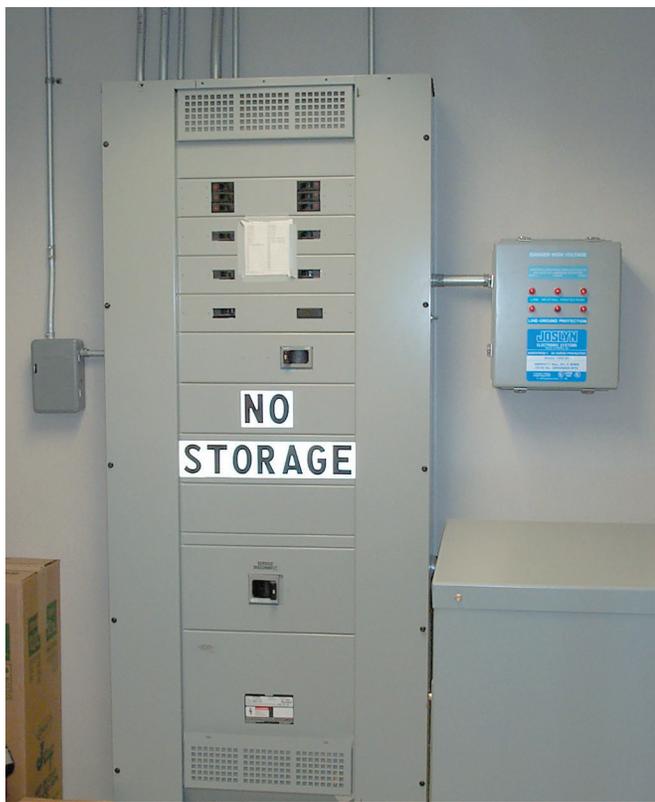
FIGURE 7.

Figure 7. The 480-V distribution panel shown here feeds a 480Δ – 208Y/120-V transformer (lower right), the 277-V lighting circuit and the two air conditioning units. Connected to the 480-V bus at the right side of the panel is a 200-kA-rated TVSS that provides both line-ground and neutral-ground protection.

- Another 4/0 copper grounding conductor connects the ground-neutral bus in the service entrance panel to the ground bus in a 480-V distribution panel in the building's electrical room (Figure 7). The bus serves the building's two 480-V air conditioning units (one is a back-up), a 277-V lighting circuit and the primary of the building's 480Δ – 208Y/120-V transformer. The transformer feeds two 120/208-V, 300-A distribution panels (Figure 8). One of the panels supplies power to the data center's main computer room, which houses the center's host computer, several servers and a variety of other sensitive equipment (Figure 9). The other panel feeds branch circuits to workstations and remaining outlets throughout the building.

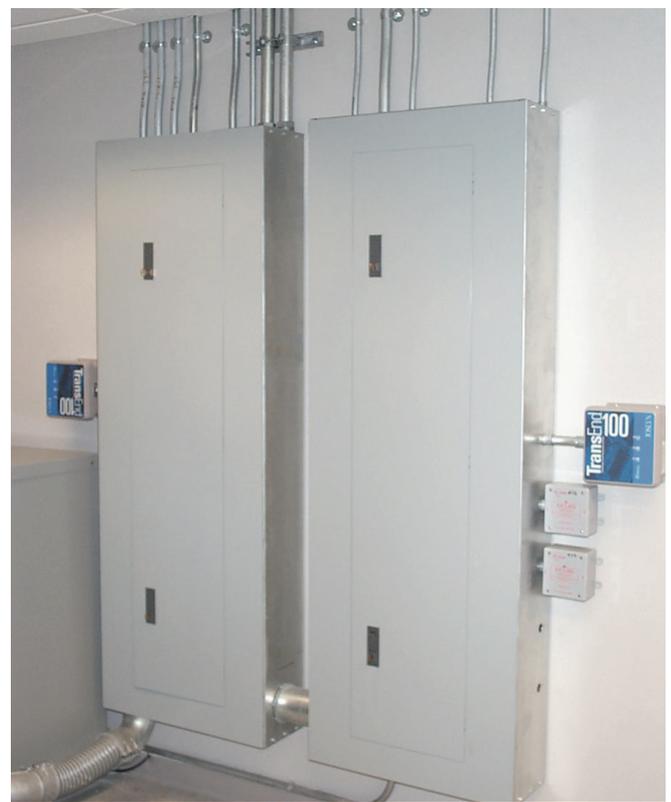
FIGURE 8.

Figure 8. Two 120/208-V branch circuit panels supply the data center's computer room and other locations in the building, respectively. Each panel is protected by TVSSs rated at 100 A (blue enclosures). Fire alarm and fire call circuits are additionally protected by TVSS devices rated at 20 A. There are as many as seven layers of surge protection in critical portions of the data center's electrical system.

TVSS units at the distribution panel. Surge strips are plugged into wall outlets where needed in the building. Finally, small units located at workstations contain surge suppression circuitry to protect individual computer terminals.

TVSS devices are scaled to match or exceed the size of the upstream risk. The large units on the main switch are rated at 200 kA; the smaller suppressors on the subpanels at 100 kA; the units for fire alarms at 20 kA; and so forth down the line. The main TVSSs provide both line-neutral and line-ground protection on all phases. The 100-kA and 20-kA units are also multimodal. It is important to note that all surge suppressors are securely connected to the building's equipment grounding circuits.

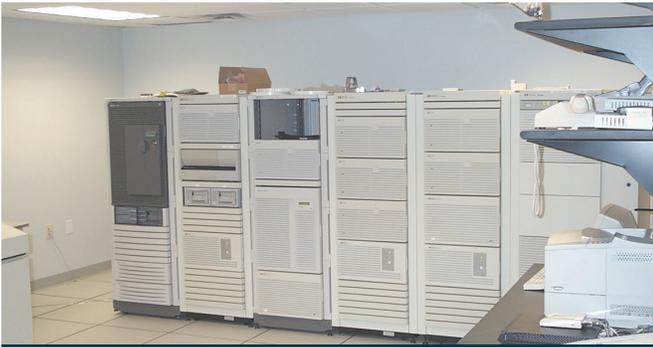
FIGURE 9A.

Suncoast Schools FCU's main computer room and the reason for the extensive grounding and surge protection described in this publication. Continuous power to the host computer (Figure 9a.) and various servers and other equipment (Figure 9b.) is assured by means of the stand alone 16-kVA UPS seen at the lower right. Smaller UPS devices are located at individual workstations.

- Multiple uninterruptible power supplies (UPSs): Two standalone 16-kVA UPS units serve the main computer room (Figure 9). Smaller units are found at individual workstations. The primary UPS is redundant in both electronics and batteries.
- Up to seven layers of voltage surge protection. A TVSS is installed on the transfer switch; another is located at the main 480-V bus. Additional TVSSs protect each of the two 120/208-V subpanels, including circuits serving the UPS units for the main computer. (Thus, both primary and secondary sides of the transformer are surge-protected.) Each of the air conditioning disconnects is individually surge-protected, and two branch circuits serving fire alarm and fire call circuits, respectively, are protected by additional
