Copper
Applications

A Case Study

Lightning Protection for Denver Fire Station Extends Beyond its Property Line

POWER QUALITY

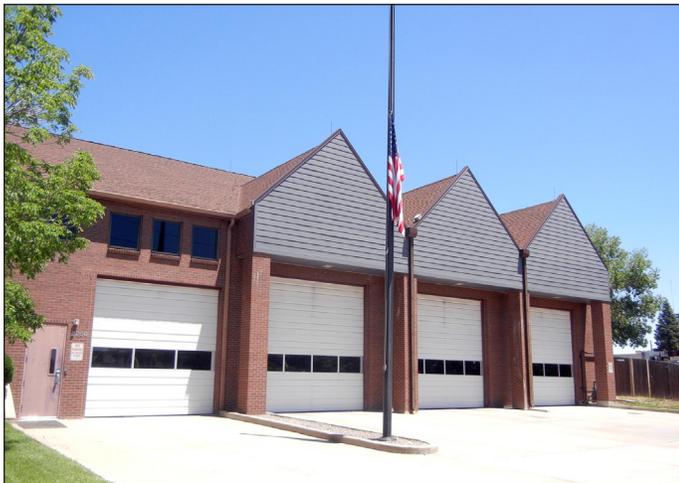
Figure 1. The Cunningham Fire Protection District's Fire Station No. 1 also houses administrative headquarters. From 1985, when the district bought the building, until 1999, electrical disturbances driven by summer thunderstorms caused increasingly expensive and hazardous and potentially fatal damage to communications systems.

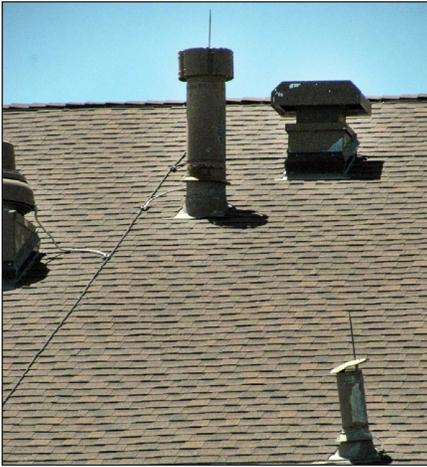
Figure 2. Strike termination devices (lightning rods) are mounted on all high points on the Fire Station No. 1 roof, and on all ungrounded metallic equipment. All termination devices and equipment are connected with 32-strand, 17 Ga. AWG braided cable. The cables are bonded to a collector ring (not shown) running around the roof's periphery.

Specifically, the Mr. Lightning team designed and installed strike termination devices (the currently accepted term for lightning rods, Franklin rods and air terminals) at all high points on the structure, as well as all ungrounded, metallic equipment on the roof. **(Figure 2)**. They connected rods and equipment with neatly installed runs of 32-strand, 17-gage AWG braided copper lightning cable. Leads from those cables were, in turn, bonded to a ring of braided copper running around the periphery of the roof, and from there, four braided copper down-conductors were run along the exterior walls of the building, terminating at 10-ft driven copper grounding electrodes, establishing the four points of grounding (earthing) required by NFPA specifications. Where practical, down-conductors could be located near the building. **(Figure 3a)** In places where such areas were blocked by sidewalks or paving, electrodes were offset from the building accordingly **(Figure 3b)**.

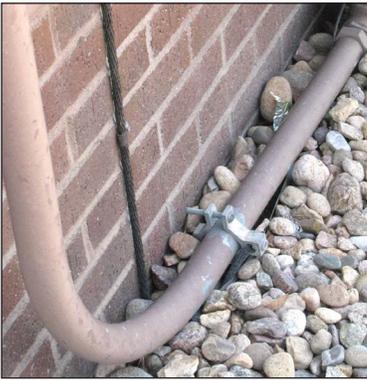
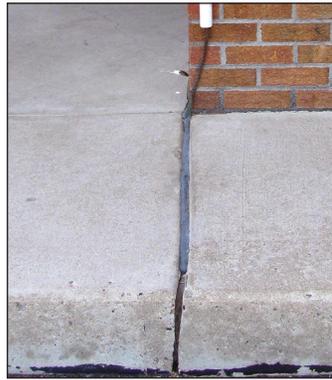
Figure 3. Where practical, 32-strand, 17-Gage AWG braided copper down-conductors were run directly to copper grounding electrodes near the building wall (3a, left). Where sidewalks or paving interfered, the electrode was displaced outward from the building wall and the cable extended to them (3b, right).

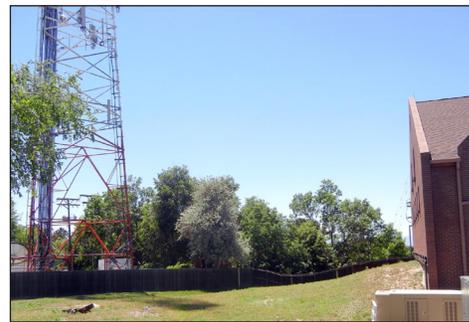
Figure 5. The TV and cellular transmission tower, left, is only 90 feet from the Fire Station No. 1 structure, right, and lightning energy from the tower could have passed to the station through the ground before repairs were

undertaken, especially since the two structures were not connected, and were therefore at different ground potentials. Mr. Lightning's solution was to connect the structures' grounding systems with a buried copper cable to avoid potentially hazardous step potentials. In addition, the company installed a 200-ft triangular copper ground grid at the fence line to absorb and dissipate

"The lightning protection system we installed on Fire Station No. 1 was a typical system meeting lightning protection standards," clarifies Bret Peifer, President and Owner of Mr. Lightning. "The process to design the building lightning protection system was straightforward, but the 200-ft-tall TV transmission tower was a different story. We decided to install a shield line that connected the tower to the fire station's lightning protection system. We bonded the steel structure of the antenna. The 60-ft-long shield line that we installed helped to intercept any step voltage from continuing into the building when the antenna got struck."

Mr. Lightning's final step was to lay out a 200-ft triangular array of copper cable along the property line between the tower and the station. (Figure 5) Its job was to absorb and dissipate to earth any high energy that might occur from a direct lightning strike to the tower.
