Fire Station Lightning Protection and Grounding Systems

Suburban Connecticut stations upgraded with all-copper lightning protection and grounding systems

This case study describes basic elements of lightning protection systems installed in the headquarters stations of two fire companies serving suburban communities near Hartford, Connecticut.

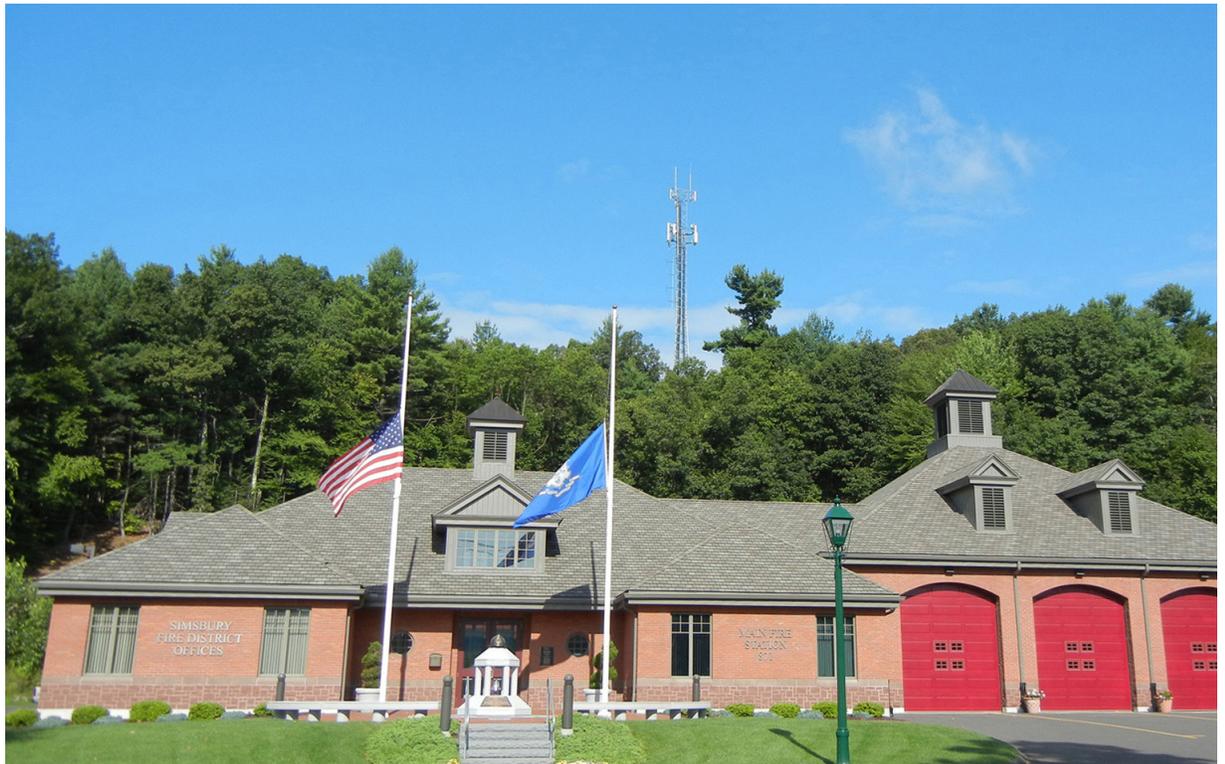
Simsbury Main Fire Station No. 1 is fitted with a robust lightning protection system. Neither the station nor its communications system has suffered any lightning-related damage since the new system was installed.

The station's communications center is served by a 140-ft tower located uphill and behind the facility (Cover). The tower acts as an ideal lightning rod and readily attracts strikes, as it did during the incident cited by Chief Kowalski. The tower's lightning protection system includes the tower steel, which is bonded to a buried ring ground and driven electrodes (not shown), the anti-intrusion cyclone fence, and down-conductors from coax cable shields shown connected to a copper grounding bar **(Figure 7)**. The entire tower system is bonded to systems at the fire station and outbuildings, thereby rendering all electrical/electronic equipment at the same ground potential.

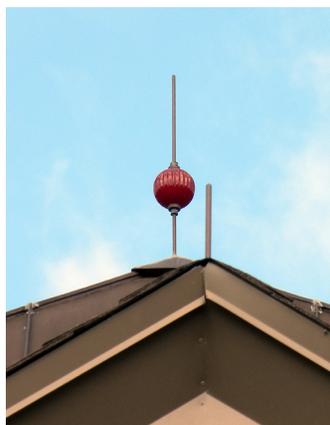
Figure 1. Air terminals (strike termination devices) are mounted at a code-mandated maximum 20-ft interval on the roof of the Simsbury Main Station No. 1. The decorative terminal is one of several installed for architectural reasons. Note the braided copper lightning conductors mounted along gable edges.

Mr. Barnard described the lightning protection system: "We design systems like this based on a 150-ft strike radius. We place air terminals where they're required by the measurements that radius calls for, in this case every 20 feet. (Figure 1) We connect all air

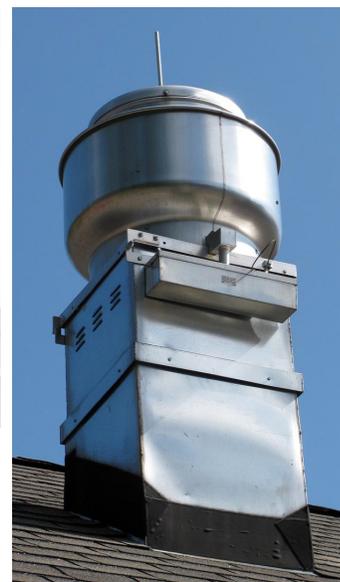
Figure 2. Rooftop ventilator with air-terminal. The otherwise ungrounded ventilator is within a six-foot strike distance of the lightning protection system's cabling (not shown) and is therefore connected to it.

terminals to each other and to the earth at not less than every 100 ft of the building's perimeter. Any metallic item we come near to we bond if it falls within a six-ft side flash distance (Figure 2). We also have to bond any underground water or gas pipes where the lightning might follow that path. (Figures 3 and 4, respectively). All these systems must be bonded together.

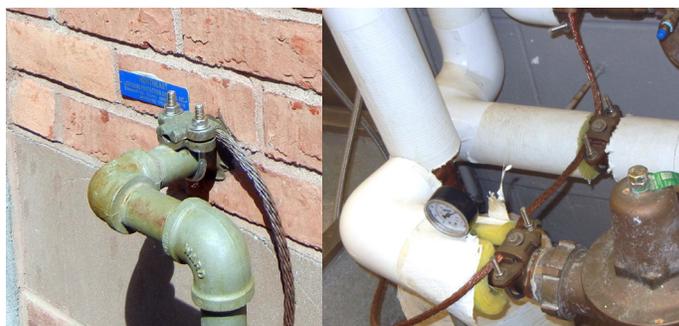
Figure 3. Braided lightning conductor (29 strands of bare 17-gage copper) is shown bonded to the fire station's water supply line, left. Note the use of UL96-approved copper alloy mechanical clamps. The clamps resist loosening and corrosion. Similar connections were applied inside the building.

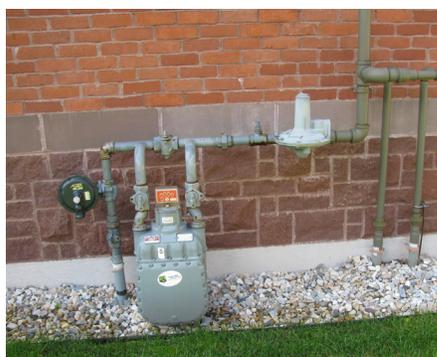
Figure 4. Ground Connection to Gas Service Entrance. The gas service and all exterior metal pipes are connected via the ring ground.

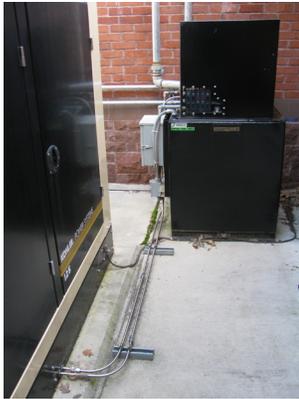
Figure 5. Grounding connection to the station's emergency generator shown at left. The braided bare copper grounding cable used here is routed to the generator fuel tank, center, and thence to the station grounding system via a wall penetration visible at right rear.

"Outdoors, we also grounded the emergency generator and the generator fuel tank, **(Figure 5)**. Any structural steel members would

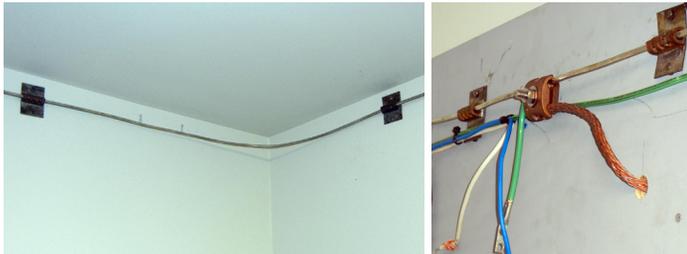
Figure 6. Halo ground installed around interior walls (left) to facilitate connections to electrical, telephone and electronic equipment, cabinet racks and wall penetrations, (right). Note the generous size of the braided lightning cable entering from lower left.

The chief added, "To facilitate bonding inside rooms we installed halo grounds, or lengths of copper lightning conductor encircling the rooms at near ceiling level. We installed two halos in the fire station: One is in the communications room and one in the server room where everything is terminated." **(Figure 6)**

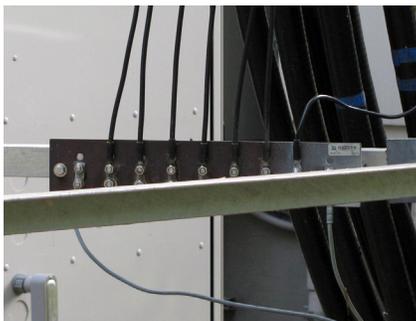
Figure 7. Grounding down-conductors from coax cables are bonded to a copper grounding bar near the base of the antenna tower. The tower's entire grounding system is connected to systems serving the fire station and outbuildings.

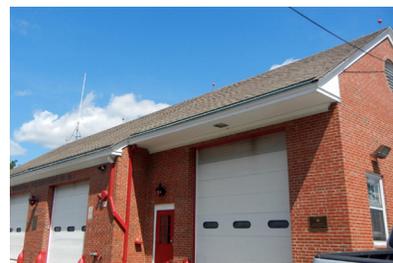
Figure 8. View of the Wethersfield, Connecticut Fire Station No. 2, one of the oldest in the state. The tower behind the station at far left serves the station's communication needs. Air terminals are spaced at 20-ft increments along the roof ridge line.

"Again, what we did here was install direct-strike lightning rods or air terminals on the roof in the places where lightning might strike based on a 150-ft strike radius. **(Figure 8)** As at Simsbury, the rods are within 24 inches of the outer edge of the roof and 10 inches taller than the objects they're protecting. Here the lightning rods are tied together by lightning cable containing 29 strands of 17-gage copper wire. The cables have multiple paths to ground situated not more than at 100-ft of perimeter apart on average.

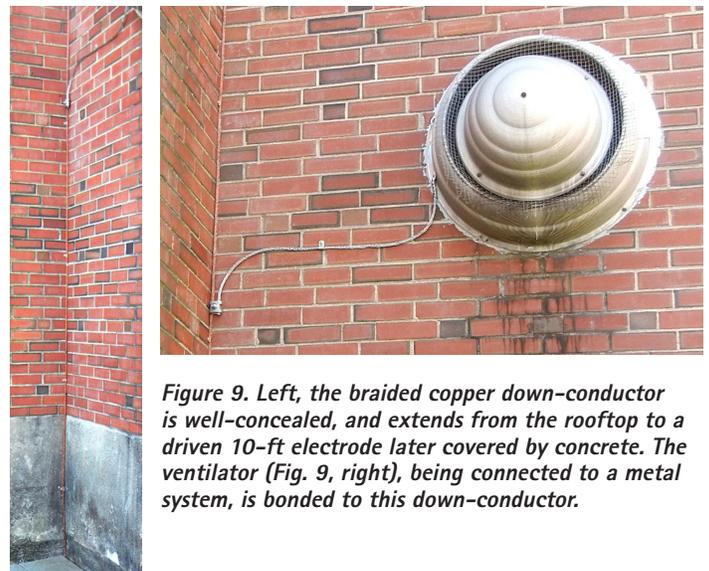
Figure 9. Left, the braided copper down-conductor is well-concealed, and extends from the rooftop to a driven 10-ft electrode later covered by concrete. The ventilator (Fig. 9, right), being connected to a metal system, is bonded to this down-conductor.

"The conductors terminate at four driven electrodes, 1/2 inch in diameter, extending to 10-ft deep. They are spliced together with buried or above-ground copper splices per UL 96, and anything that's within distance of 6-ft side-flash distance is also bonded to the grounding system **(Figure 9)**. There are various places where water pipes come into the structure and grounded systems enter the building. At these points, the lightning cable, either by the use of copper water lines or by direct cabling, needs to bond to the sprinkler system, phone grounds, cable TV grounds, and electric grounds. This system is a very effective but simple system of conductors, grounds and bonds.

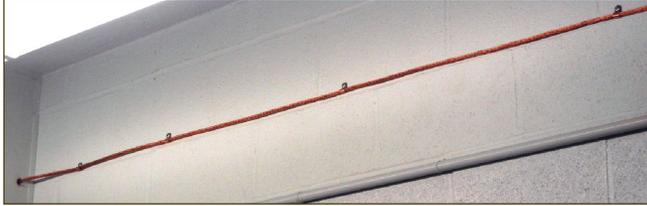
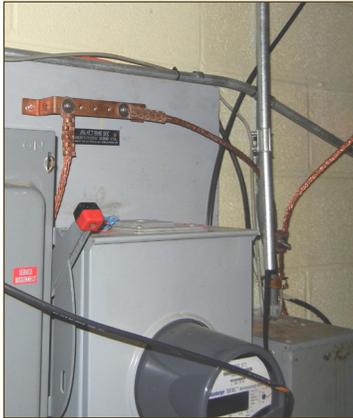
Figure 10. Upper photo: grounding conductors run along walls and from room to room in the venerable fire station. Lower photo: a copper ground bar serves as the ground-to-lightning system bus at the station's service entrance. Note that braided copper lightning cable extends all the way to the service entrance.

Interior grounding conductors are run along and through walls (Figure 10, upper photo), ultimately to the main grounding bar located at the station's service entrance and neutral-ground connection (Figure 10, lower photo). Avoiding the unnecessary costs of opening and patching walls in the building's interior.
