Macomb County  
Department of Roads & COMTEC

# Safety Center Tower Grounding

Professionally Installed and Maintained Lightning Protection and Grounding Systems Ensure Uptime and Reduce County's Costly Repairs

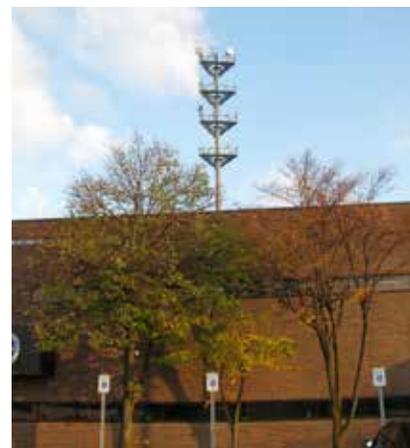
*The Macomb County, Michigan COMTEC safety center was rebuilt from an existing structure and upgraded to modern codes, including those dealing with grounding and lightning protection. It has never suffered lightning-induced damage.*

**Victoria Wolber** is the director of emergency management and communications for Macomb County, Michigan. She is based at COMTEC, the county's impressively rebuilt, 25,000 square foot safety center in Mt. Clemens, Michigan in the southeastern part of the state, **(Cover)**.

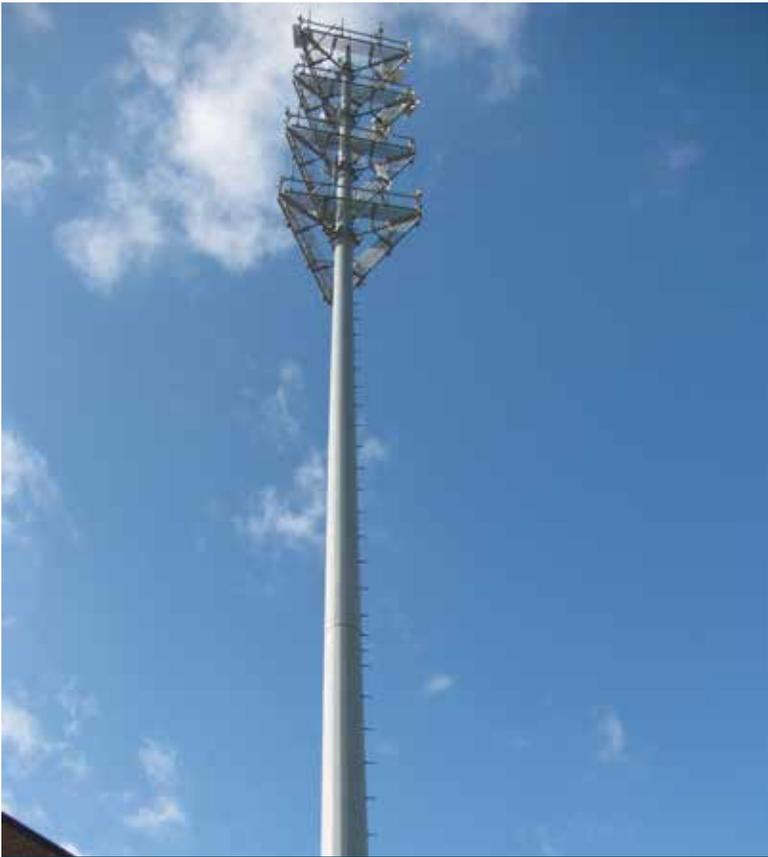
FIGURE 1.

*The COMTEC center's transmission tower was grounded when built, but age and corrosion had deteriorated the connections. Upgrades during restoration of the center included exothermically welded connections, new grounding electrodes and a buried copper ring ground.*

During re-construction, the building's open walls helped Guardian Equipment advised the engineers on designing and concealing the new grounding system. The building's antenna tower (**Figure 1**) had previously been grounded, but the existing mechanical connection method was found to be inadequate. Existing connections to the tower showed signs of aging. They were mechanical, in one case using a simple water pipe connector, and they had become loose over time. There was also some corrosion, which increases ground resistance (**Figure 2**).

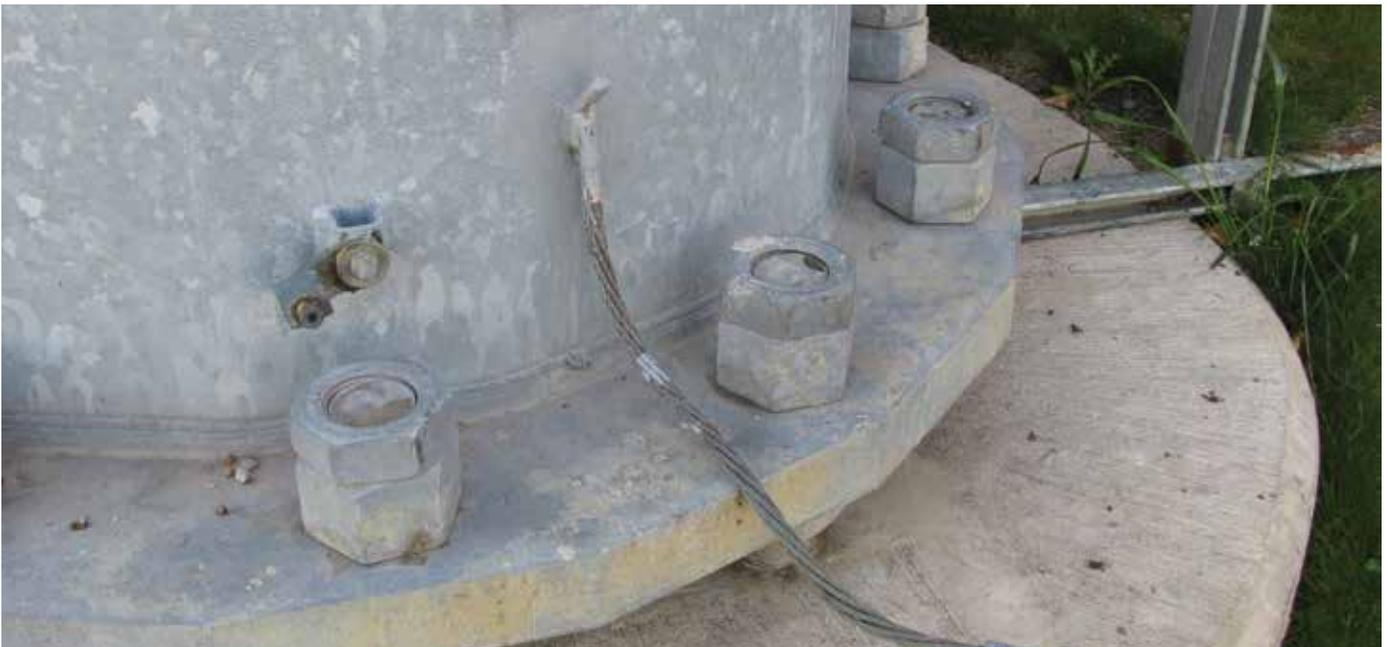
FIGURE 2.

*Tower-grounding cables were originally bonded with mechanical clamps such as the one shown at the far left foreground, but age and corrosion had loosened the connections, raising ground resistance. The facility upgrade included replacing those connections with exothermically welded bonds and 28R Class II lightning conductor cable, center.*

"We grounded the tower with 28R cable, which is a special Class II lightning conductor consisting of 28 strands of bare, braided AWG 14-Gage wire," said Fair. "We sometimes use tinned wire when our engineer of record thinks that it would give the conductor a longer service life, but that wasn't the case here."

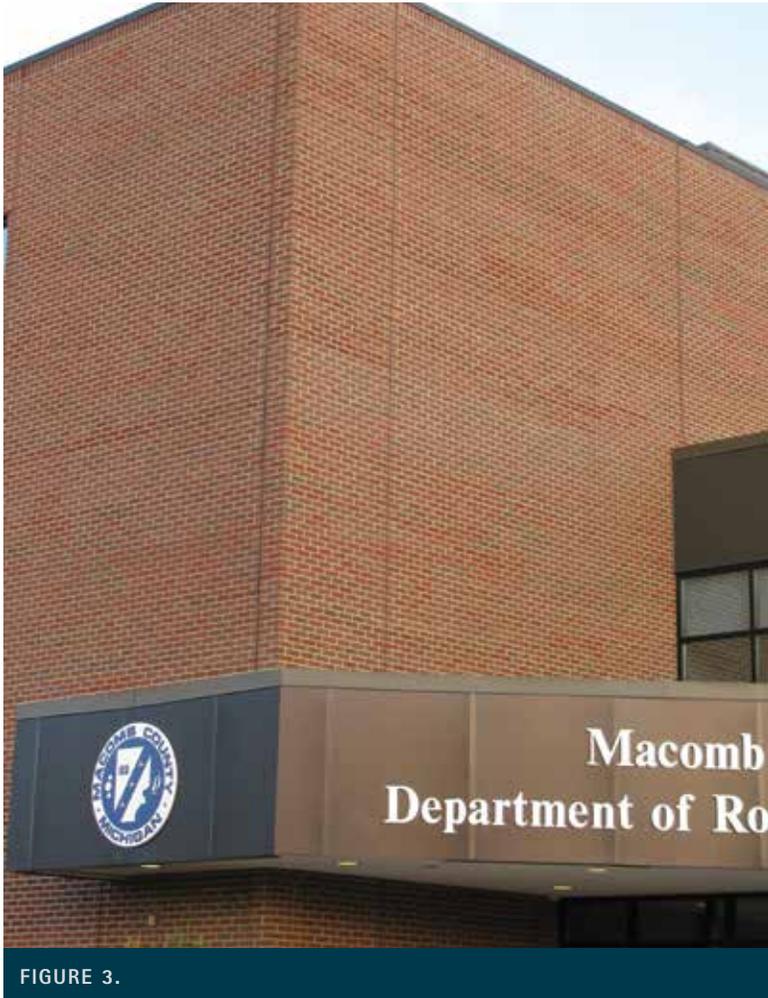
FIGURE 3.

*Copper lightning cable is unobtrusive when mounted against brown or red-brown surfaces such as COMTEC's brick walls. This property of the red metal is architecturally advantageous when installing rooftop lightning protection systems.*

"On the two-story side of the structure, which is less than 75 feet tall, we used 29-strand x 17-Gage Class I wire. It's a little thinner and less obtrusive to the eye," said Fair (Figure 3).

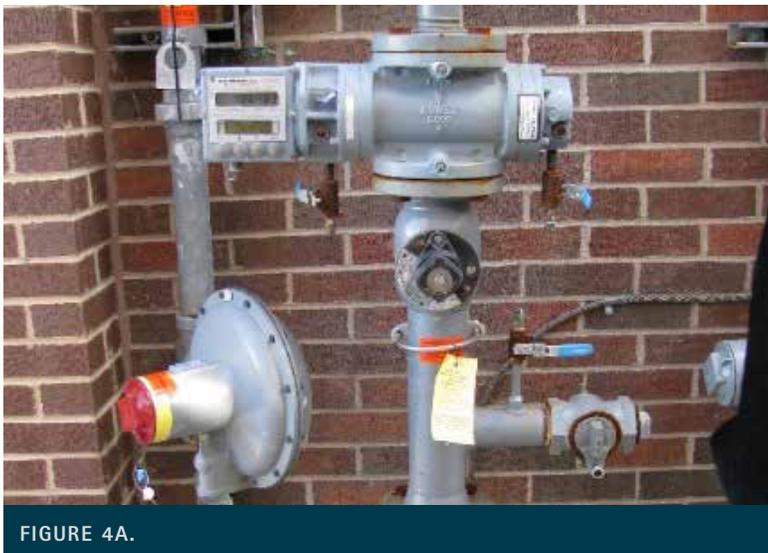
FIGURE 4A.

*A proper grounding cable connection to a gas service line. The silvery, copper-alloy, UL-approved cable clamp is cadmium plated to prolong corrosion resistance.*

All services, such as electric, water and gas were bonded together at a common ground potential and bonded to the building's grounding system, in accordance with code requirements (Figures 4a and 4b). Fair tags his installations where appropriate to inform workers of the Code-sensitivity of those connections.

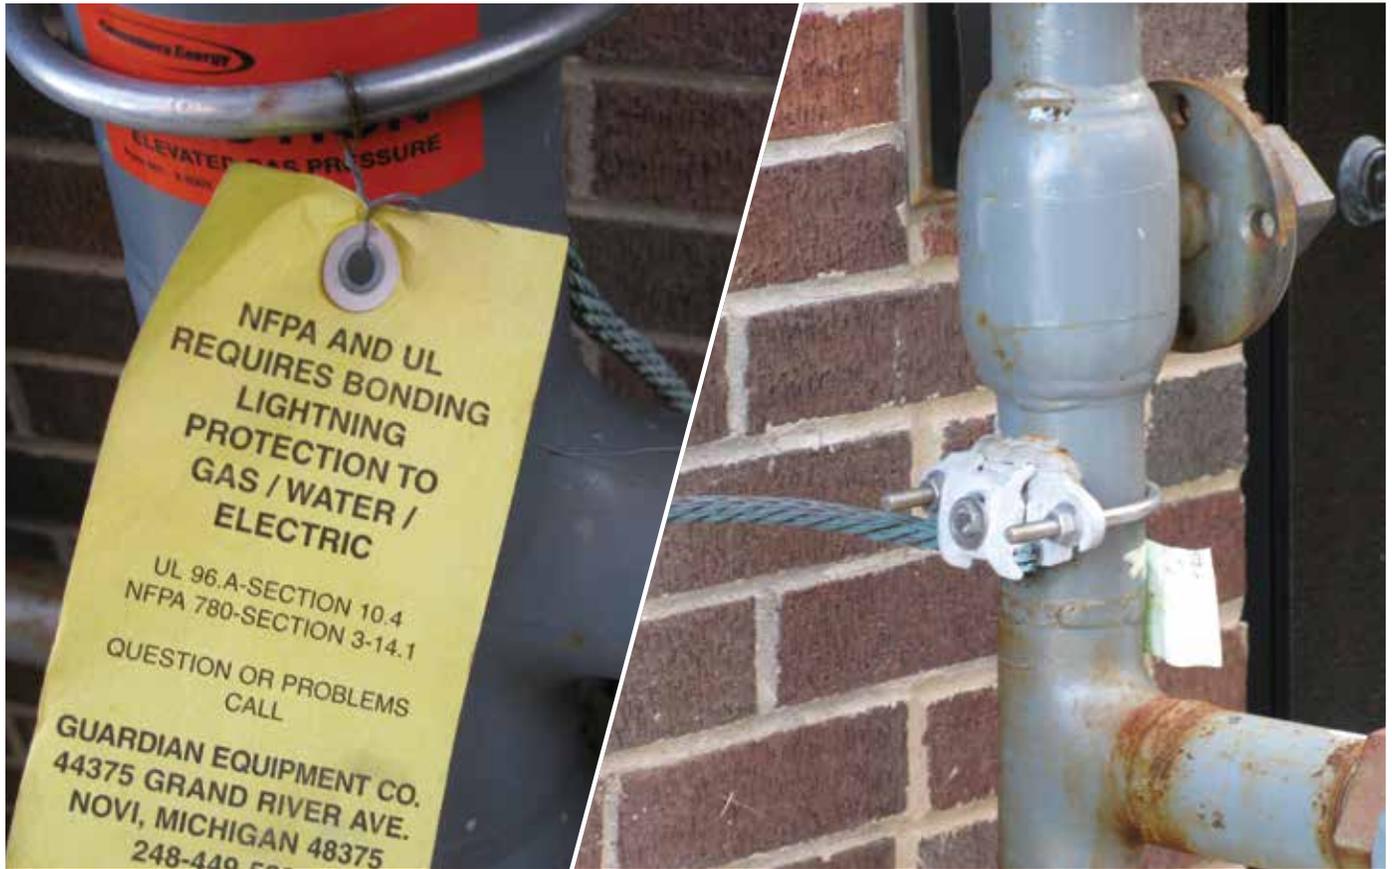
FIGURE 4B.

Grounding of the center's water and gas service entrances is provided by the heavy-gauge copper cable, right. The tag shown on the left alerts technicians that grounding to gas and other services is code-mandated.

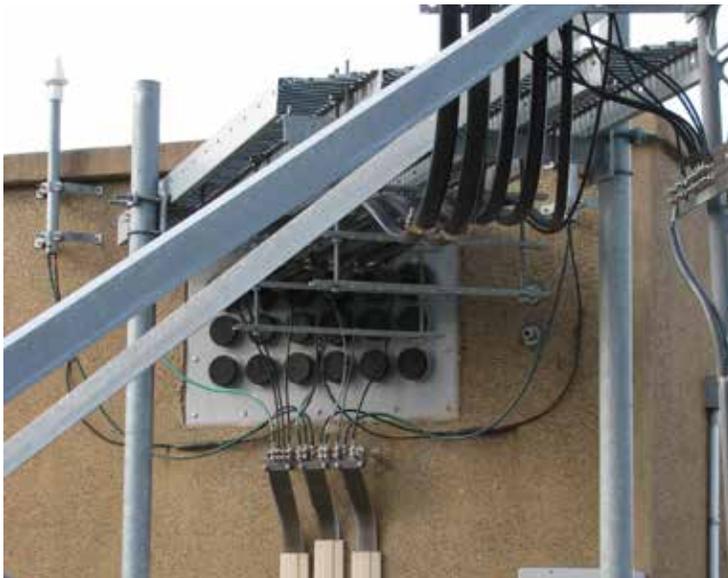
FIGURE 5.

When lightning strikes one of the nine auxiliary sites that the county operates, energy is bled off the coax on the vertical run (Fig. 7), the coax where it penetrates the firewall (see above), and the interior side of the firewall (Fig 9).

- Grounding connections from antennas, cables and shielded wave guides on the tower are made to a 1/4-inch thick copper grounding bar affixed to the tower steel about 10-feet above grade (**Figure 7**). From there, two heavy-gage copper down-conductors lead to a ring ground buried around the tower's base. The ring is bonded to driven, 10-foot x 3/4-inch copper-clad electrodes. Also connected to the ring is a third copper cable. That cable grounds the tower's steel structure and is exothermically welded to the tower's base to ensure durability and lasting reliability (**Figure 8**). The coax braid is further grounded at the exterior and interior firewalls (**Figure 5**).

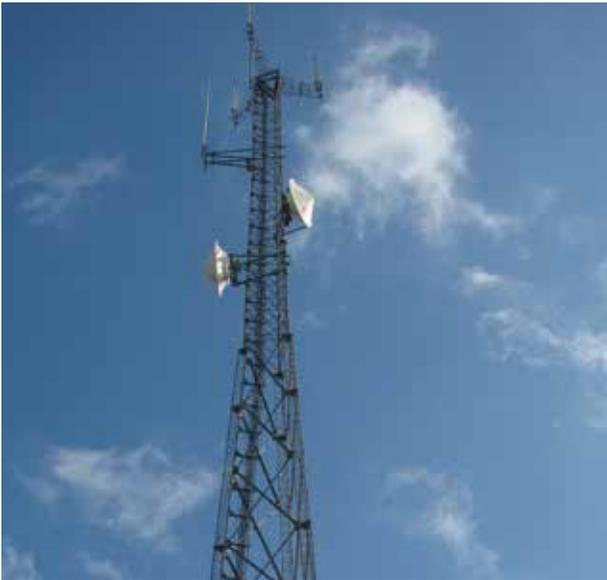
**FIGURE 6.**

*One of several auxiliary transmission towers operated by Macomb County. The towers extend emergency communications well beyond the range of the COMTEC headquarters tower. All towers are equipped with the same high-quality, all-copper grounding systems as those installed at COMTEC.*

Macomb County operates several auxiliary transmission facilities that are located such that they provide emergency communications to the county's 850,000 residents throughout the large 479 square miles jurisdiction. The auxiliary facilities are each equipped with a tower (**Figure 6**). The towers, as well as the facilities themselves, are protected from lightning strikes by robust, all-copper grounding systems.

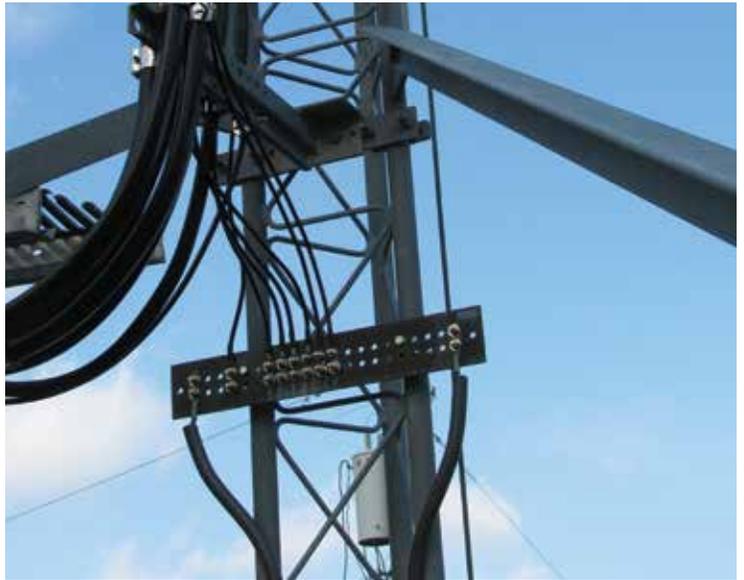
**FIGURE 7.**

*A copper grounding bar is mounted on the tower approximately 10 feet above grade. The six small-diameter cables leading upward from the bar connect to shields on cables and/or waveguides leading down from antennas above. The two heavy grounding cables leading downward from the bar are the down-conductors shown in Figure 9.*

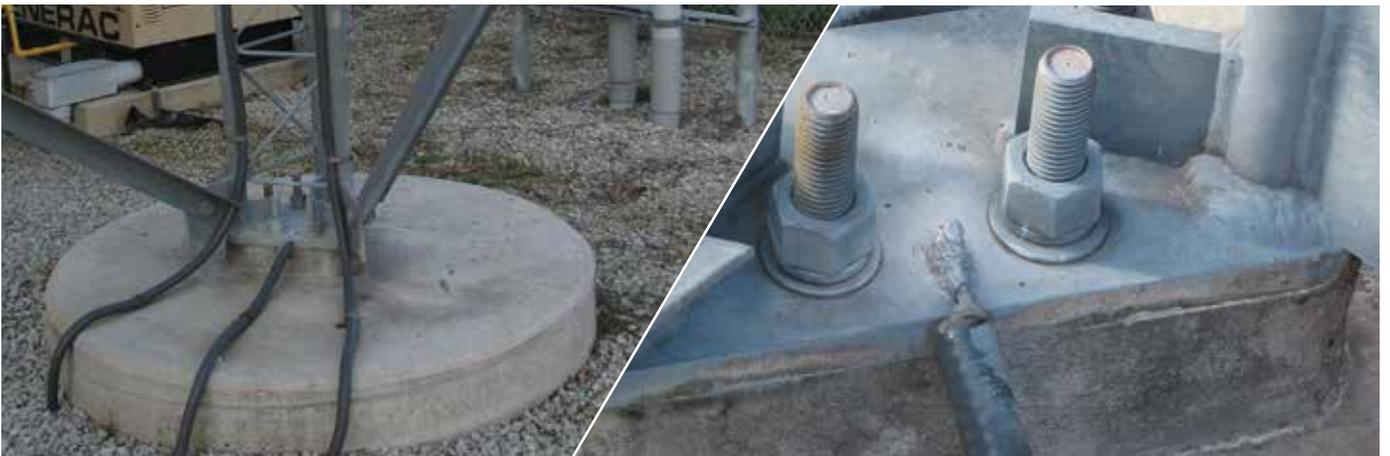
**FIGURE 8.**

*The photo on the right shows the reliable, exothermically welded grounding connection to the center cable, which connects the tower's steel structure to a buried bare-copper ring ground surrounding the tower and to the interior grounding bar shown in Figure 9.*

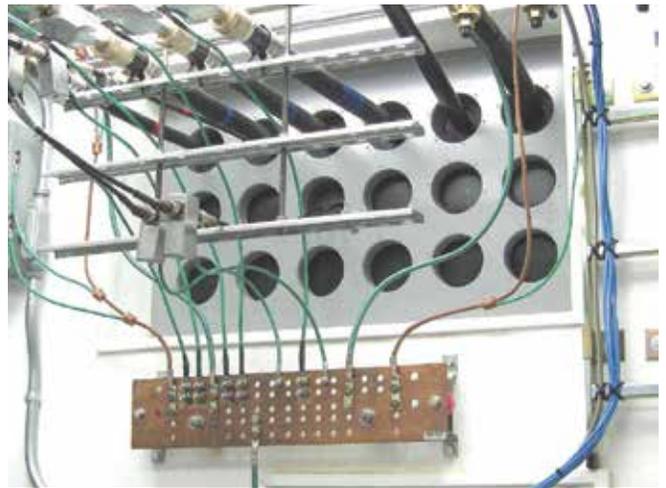
**FIGURE 9.**

*The facility's interior grounding bar is located on the inside of an exterior wall, immediately below penetrations for cables from the tower. Various green wires connect to those cables and to other grounding bars at the facility.*

- The ring-round and its driven electrodes, plus down-conductors from the tower and grounding conductors from elsewhere in the facility are collected at an interior copper grounding bar located on the inside of an exterior wall just below the space for cable penetrations (**Figure 9**).
- Finally, all sensitive electronic equipment is properly bonded in its racks, with cables firmly attached to individual pieces of equipment at locations that can easily be inspected (**Figure 10**). The racks themselves are also grounded.

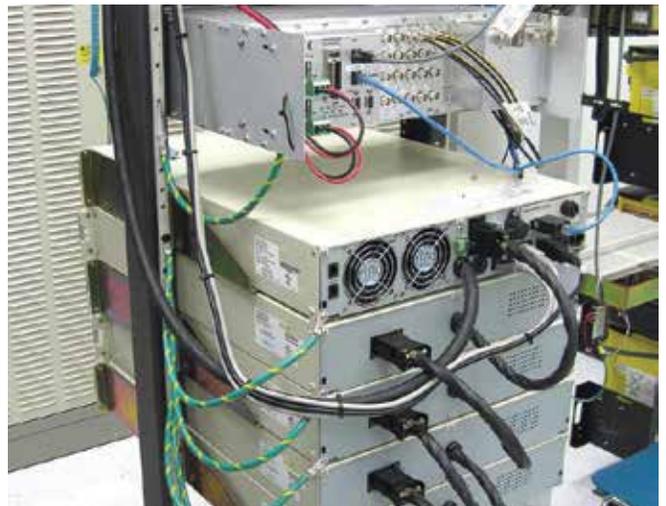
**FIGURE 10.**

*Properly bonded communications equipment features individual ground leads to each cabinet. The rack itself is also bonded (not shown). Grounding, bonding and power feeds for sensitive equipment should be isolated from standard equipment or lightning circuits.*
