August 1993 • Volume 32 • Number 8

CORROSION BY POTABLE WATERS IN BUILDING SYSTEMS

Arthur Cohen
Copper Development Association Inc.,
260 Madison Ave., New York, NY 10016

Water Treatment to Mitigate Corrosion of Copper Plumbing Systems

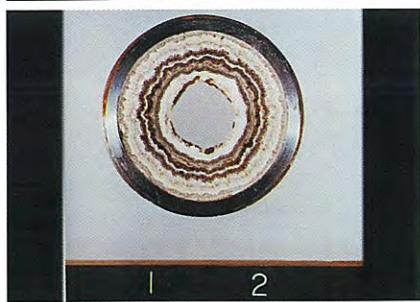
FIGURE 1

Severe scaling in a galvanized steel pipe hot-water distribution system.

This is understandable because hard waters normally deposit protective calcium carbonate scales in all plumbing systems. Figure 1 is a typical example of severe scaling in a galvanized-steel-pipe hot-water distribution system. Soft waters, by contrast, are highly aggressive because they do not provide this protection. Conditions that lead to corrosion or scaling are listed in Table 1.¹

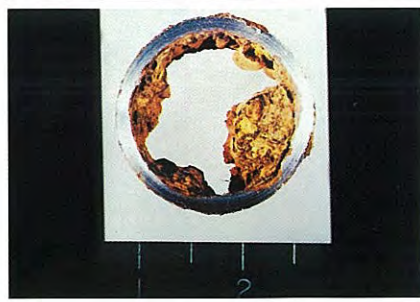
FIGURE 2

Typical flow-restricting tubercle formation in a galvanized steel pipe system.

Steel and galvanized steel deteriorate by pitting, which can perforate the pipe and fitting wall. Galvanized steel systems often must be replaced because of flow-restricting tubercle formation (Figure 2) or the brown staining on porcelain fixtures when galvanized coating dissolves from the steel and fitting surfaces.

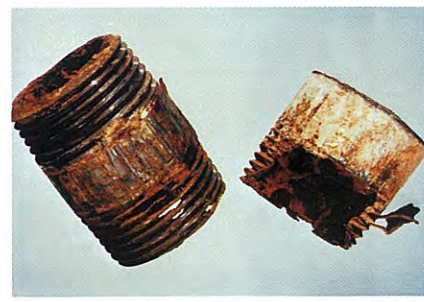
FIGURE 3

Typical oxygen differential-type concentration cell in threaded joint.

The other form of deterioration that can occur in steel and galvanized steel systems is oxygen differential-type concentration cells. Typically, this occurs under discontinuous deposits and crevices. Once initiated, concentration cell corrosion (as well as pitting attack) can be accelerated by the occluded cell phenomenon, where chloride ions migrate to and concentrate at the localized corrosion sites, forming hydrochloric acid in the pits (Figure 3).

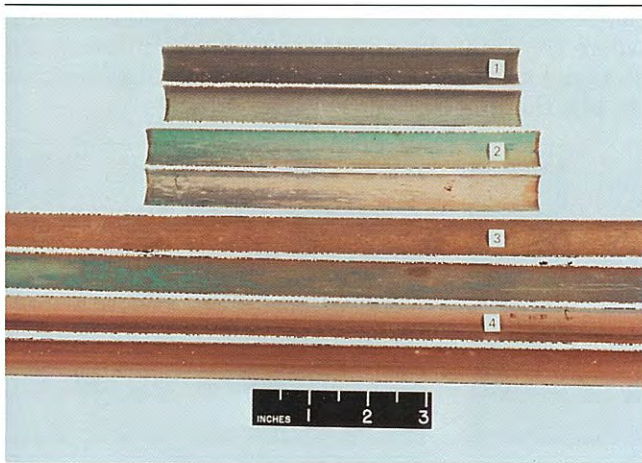
FIGURE 4

Typical etched surface of copper tube associated with plumbing fixture staining.

Cuprosolvency is annoying because it causes colored water (blue/green) and staining of plumbing fixtures. Generally, it is caused by soft, low alkalinity, low mineralization water having a pH of 7 or lower. Typical copper plumbing tube associated with staining is shown in Figure 4.

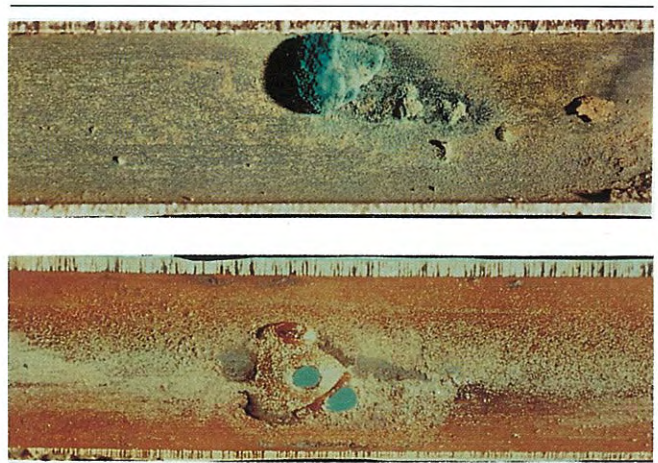
FIGURE 5

Typical interior surface of copper water tube that has failed due to pitting corrosion.

The typical interior surface of copper water tube that has failed due to pitting corrosion is shown with the tubercle intact in the top half of Figure 5, and after chemical cleaning to remove the tubercle and scale in the bottom half.

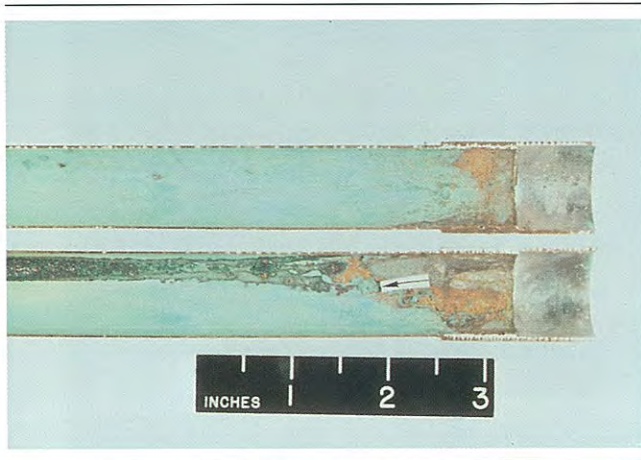
FIGURE 6
Typical flux run originating in plumbing system joint.

Cold water pitting attack has also been linked to chloride-containing soldering-flux residues in the form of flux runs on the waterside

surfaces in plumbing system joint areas (Figure 6). Cold water pitting attack has also been associated with very small quantities of hydrogen sulfide in the conveyed water (Figure 7).

Soldering flux, chloride-induced cold-water pitting of copper can be eliminated by the use of a mildly corrosive flux which satisfies the requirements of ASTM B 813⁹ and when the systems are assembled per the requirements of ASTM B 828.¹⁰

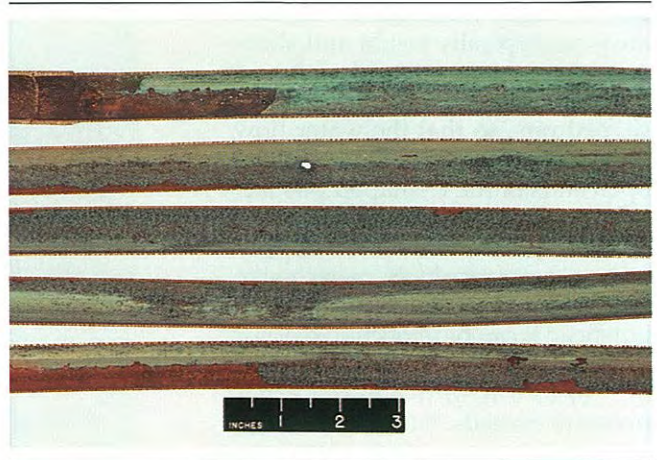
FIGURE 7
Pitting attack of copper plumbing tube due to trace amounts of hydrogen sulfide in the water conveyed.

Sulfide-induced cold-water pitting can be avoided by ensuring that this aggressive species is reduced to an acceptable level by the water distributor. Typically, this is accomplished by aeration using properly sized and maintained equipment.^{11,12}

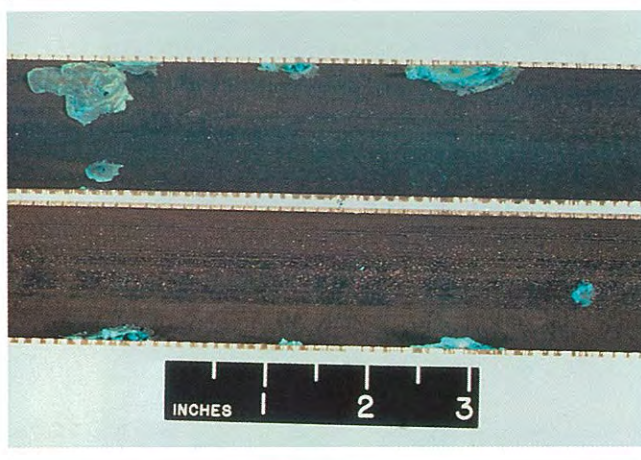
FIGURE 8
Hot water pitting corrosion of copper plumbing tube caused by the microdeposition of manganese dioxide.

Hot water pitting of copper is associated generally with microdeposition of cathodic materials such as manganese dioxide (Figure 8), hydrated hematite (Figure 9), and aluminum hydroxide (Figure 10) as a result of underlying copper metal losing its protective film.

Hot water pitting can be overcome by avoiding the deposition of aggressive species such as manganese dioxide, hydrated hematite, and aluminum hydroxide on the hot metal surface. The severity of these

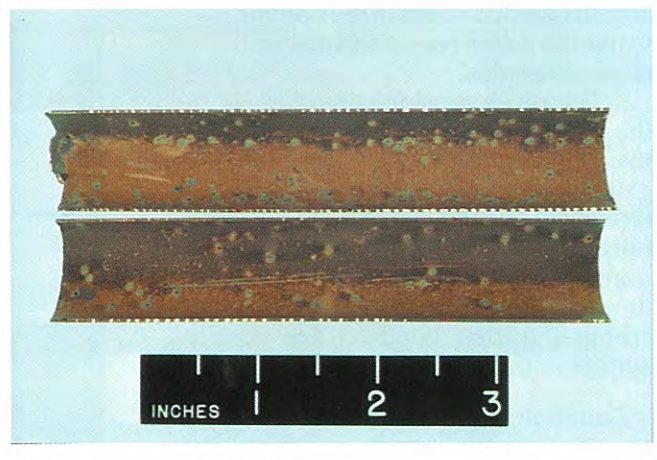
FIGURE 9
Hot water pitting corrosion of copper plumbing tube caused by the microdeposition of hydrated hematite.

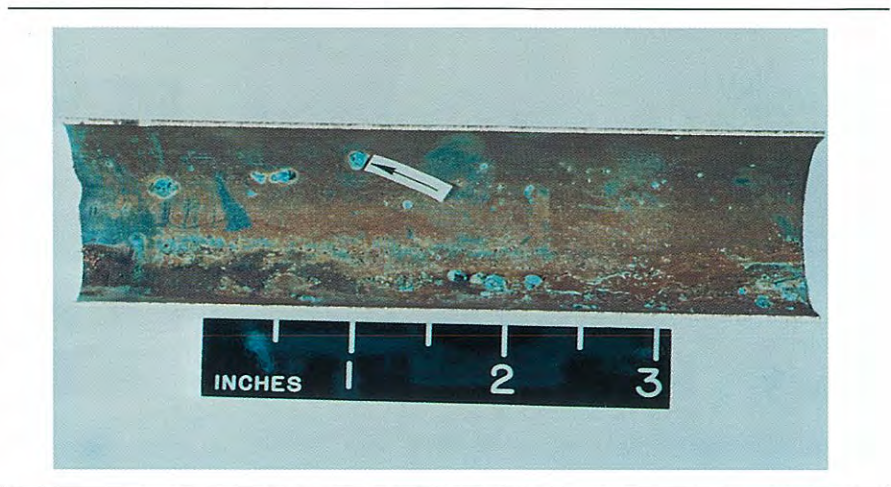
FIGURE 10
Hot water pitting corrosion of copper plumbing tube caused by the microdeposition of aluminum hydroxide (Al(OH)₃).

Where the source of the aluminum is the coagulant (for example, aluminum sulfate), the hot water pitting concern associated with this element can be overcome by reducing the quantity of coagulant, by using an alternative coagulant such as iron sulfate, or by raising the pH of the water to approximately 8.5.⁷

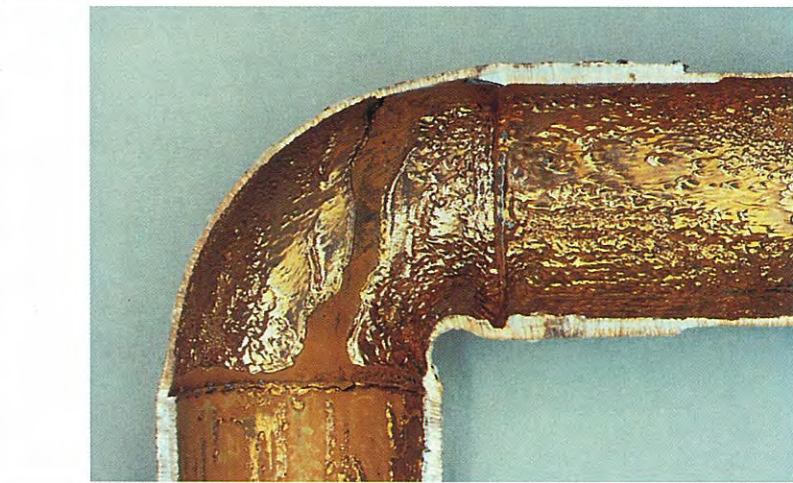
FIGURE 11
Typical impingement corrosion characterized by eroded interior surface. Such erosion is caused by excessive water velocities compounded by sudden changes in flow direction. Unreamed tube ends leave burrs that promote increased turbulence.

tings is easily recognized. Affected areas are typically bright and shiny (void of corrosion products) and usually contain U- or horseshoe-shaped pits, so that the water flow direction can be established by the open ends of the U-shaped pits facing downstream (Figure 11).

Erosion-corrosion of copper tube systems results from excessive localized water velocity and/or turbulence.⁴ It can be expected to occur if water velocities exceed 1.2 to 1.5 m/s (4 to 5 ft/s), when the water pressure exceeds 550 kPa (80 psig), and/or the water is heated to temperatures over 60°C (140°F). It is facilitated by waters softened to near-zero hardness with appreciable quantities of dissolved oxygen and carbon dioxide. The presence of abrasive suspended solids in the flowing water have also been associated with erosion-corrosion.

Erosion-corrosion of copper tube systems can be prevented by restricting the routine flow rate of water in the system to a maximum of 1.2 to 1.5 m/s (4 to 5 ft/s); limiting the temperature of the circulating hot water to about 54°C (130°F); and controlling the water pressure to a maximum of about 552 kPa (80 psig).⁴

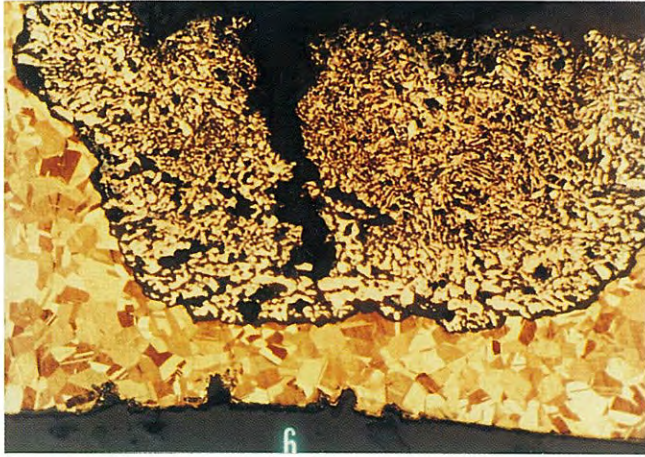
FIGURE 12
Plug-type dezincification (cross section).

Copper-based alloys currently are not widely used for domestic water service. They are used to a limited extent for fittings but are widely used in valves. Plug-type (Figure 12) and layer-type (Figure 13) dezincification typically occurs in waters having high chlorides and/or low temporary hardness, when the water is stagnant, and probably has a relatively low pH.

Dezincification is characterized by its reddish copper color and the

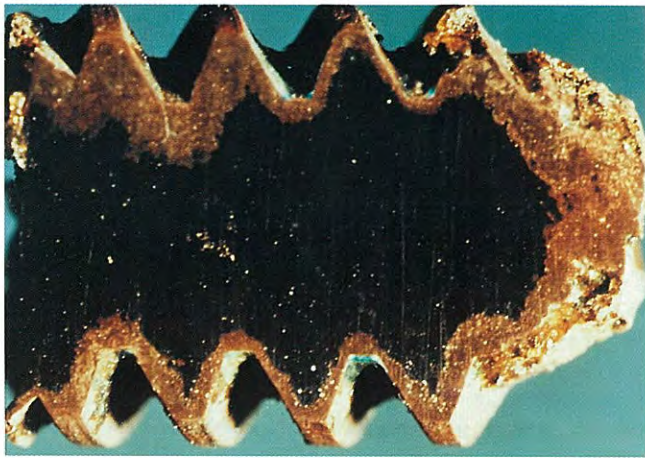
FIGURE 13
Layer-type dezincification (cross section).

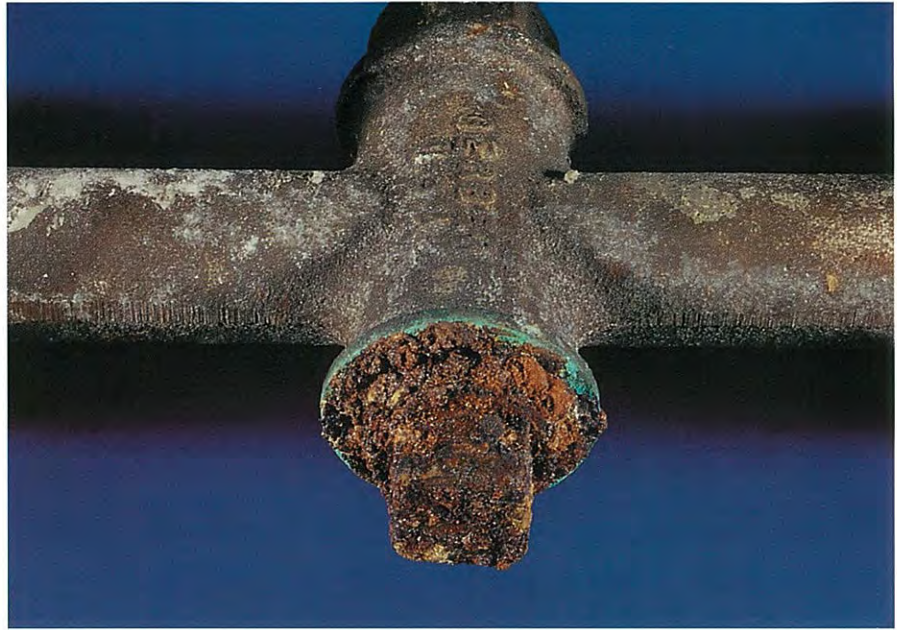
FIGURE 14
Steel nipple used to close bronze valve.

sodium silicate-polyphosphate organic blends, starting when the pipe system is put into service. In general, galvanized steel pipe and fittings should not be used for hot-water service at temperatures above about 60°C, unless there is documented evidence that the potential reversal between zinc and steel will not take place. Under no circumstances should galvanized steel be installed downstream of copper tube systems. Similarly, galvanized steel couplings should not be used to connect copper plumbing systems, and steel nipples should not be used to close bronze valves (Figure 14).

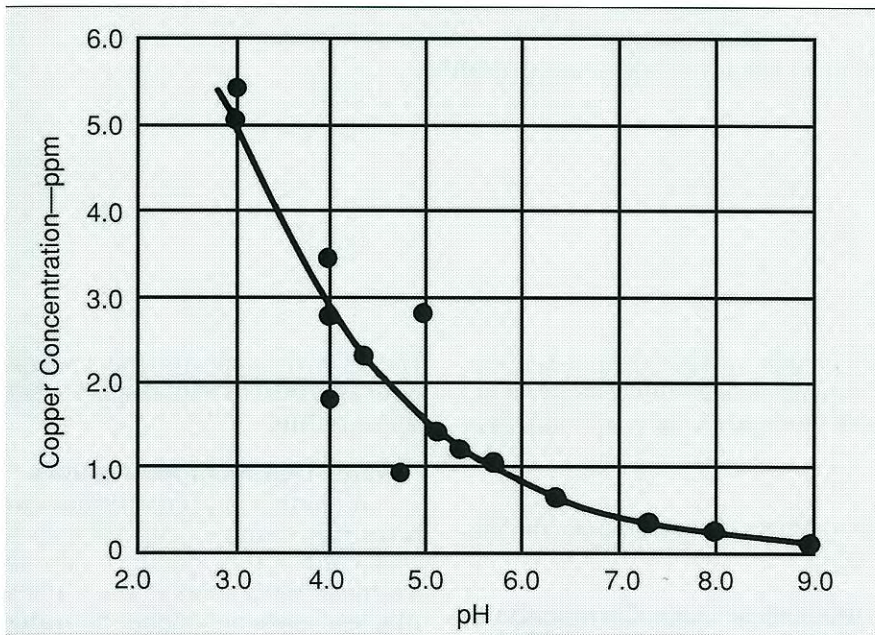
FIGURE 1

Effect of pH on corrosion of Cu. Water with adjusted pH was allowed to flow through 18.3 m (60 ft) of new 19 mm (0.75-in.) Cu tube at a rate of 0.25 L (1/15 gal) per minute. Samples were collected at 1 and 1.25 h and analyzed for Cu concentration. The results were averaged and plotted vs pH.

A number of Cu corrosion concerns (for example, cuprosolvency and cold water pitting) can be avoided by alteration of the water's pH. It is common practice by water utilities in many communities to raise the pH to eliminate cuprosolvency and the associated green staining of plumbing fixtures. The benefits of these treatment programs can be seen in Figure 1.¹⁰
