# Copper Applications

## Copper Corrects Power Quality Problems in Columbus, Ohio, High-Rise Office Tower

Recurring Problems Vanish when Copper Replaces Aluminum Feeders

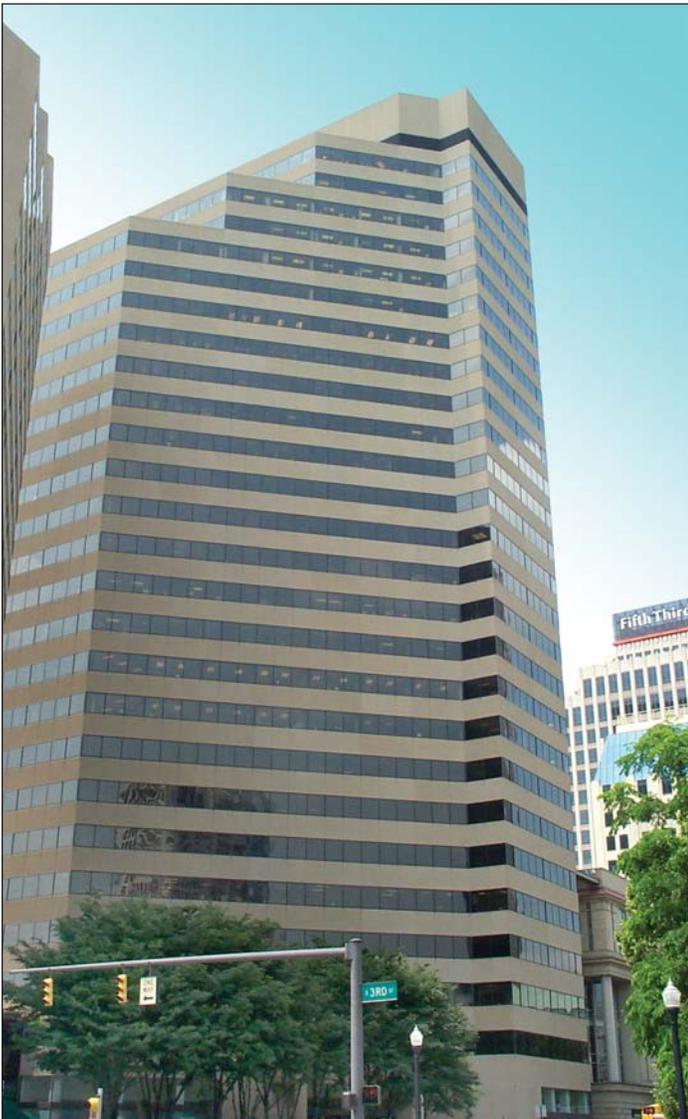
**C**aveat emptor — Let the buyer beware! Good advice, whether you're buying a used car or dealing with high-end commercial property. Case in point: Capitol Square, an attractive 27-story, 400,000-sq ft office tower located in downtown Columbus, Ohio (cover photo). Built in 1982, Capitol Square and its electrical system served its early occupants well. Until, that is, growing loads and some false economizing taken at the time of construction caught up with the original system.
