COMMUNICATION CENTER

Florida 911 Center Upgrades Lightning Protection System for Maximum Safety

Additional Electrodes, a Ring-Ground, Halo Grounds, Multiple Equipment Jumpers and Several TVSSs Protect Life-Saving Communication Equipment

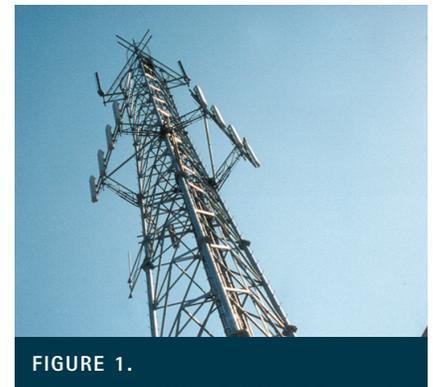
FIGURE 1.

The Communication Center shares its 90-ft antenna tower with a cellular telephone/long-distance service provider. Both tenants maintain their own lightning protection/grounding systems. Of the two systems, the Communication Center's is far more extensive and considerably more robust.

The Communication Center shares its antenna tower with a cellular-phone/long-distance service provider. The telephone company built the tower on the municipally-owned site, basing its lightning protection/grounding system on its own and telephone-industry specifications, in this case grounding the structure through reinforcing rods in the concrete footers. This system, known as a Ufer ground, is listed under the National Electrical Code® (NEC) as an acceptable grounding method.

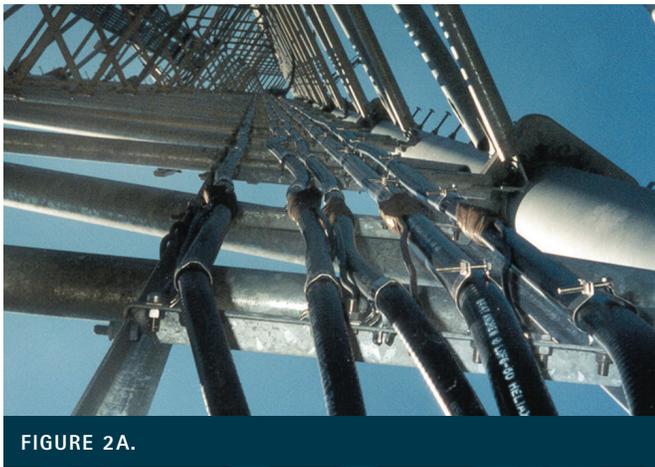
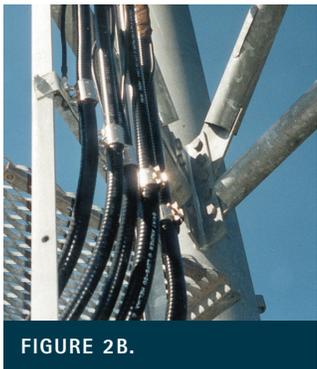
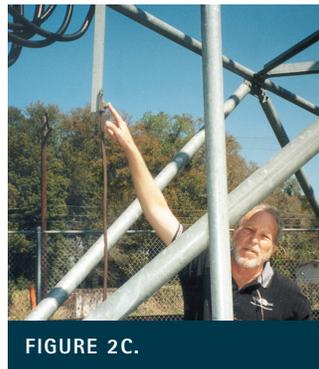
Braided, tinned-copper #29X lightning cables are soldered to the shields of coax cables (Figure 2A). The #29X leads are bonded to 4/0 copper cables, which are connected to a horizontal bus on the tower structure (Figure 2B).

John West, Power Et Systems Innovations, Inc. (PSI), indicates where a length of bare 4/0 copper extends downward to a grounding electrode located directly below (Figure 2C).

For each coax cable, West split a length of the lightning cable, wrapped it around an exposed portion of coax shield, soldered it in place and clamped and re-insulated the assembly (Figure 2A). West next soldered the lightning cable to lengths of 4/0 copper, then bonded the 4/0 to a short horizontal bus mounted on a nearby cable tray (Figure 2B). From there, he bonded to a vertical length of bare 4/0 copper, running the 4/0 straight down to a new grounding electrode driven directly below (Figure 2C).

Bonds to the coax shields were made above the point where the cables take a 90° turn toward the Comm Center building. West recommends this practice. "If a lightning strike were to come down the cable shield and encounter a turn in the cable, it could either follow the cable toward the building or continue in a straight-line path to earth. By grounding the cable shield above the bend, we increase the odds that the strike will continue straight downward.

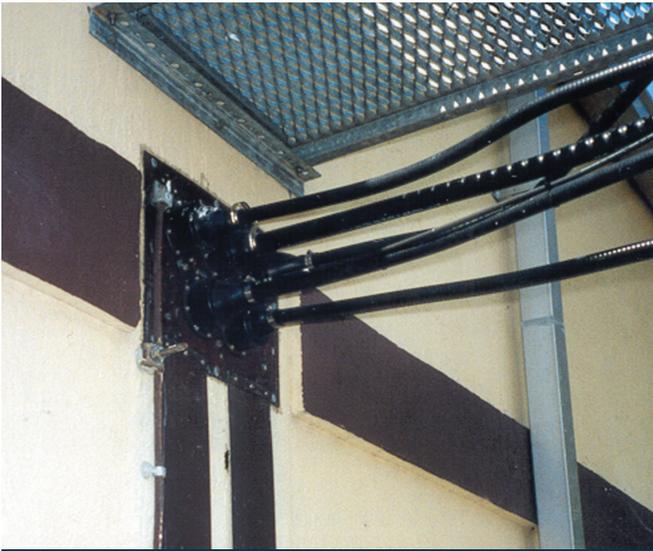
FIGURE 3.

Coax cables enter the Communication Center through a 1/4- in (6.4-mm) thick copper plate mounted on an exterior wall. The cables' shields are bonded to the plate. The plate itself is connected to a buried ring-ground by the bare 4/0 copper cable visible at the left side of the plate.

"For extra protection," West continued, "we also bond to the coax shield at the point where it enters the building (Figure 3). We first mounted a 1/4-in (6.4-mm) thick copper grounding plate to the building wall. The plate has cutouts for

the coax to pass through. We exposed a section of cable shield and bonded it to the plate. Then we bonded the plate to the building's grounding system using a vertical length of 4/0.

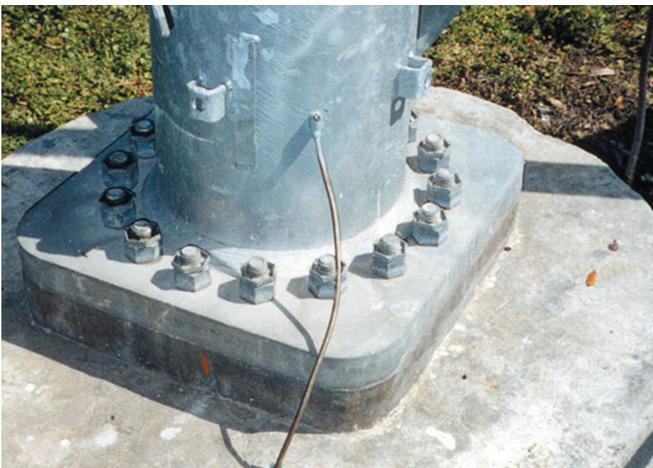
FIGURE 4.

The antenna tower was grounded during construction using #2 AWG bare copper bonded to reinforcing rods in the footers (Ufer grounds). PSI augmented this system by bonding each of the tower's four legs to two electrodes (not shown) driven on diagonals extending outward from the tower. The new grounding-electrode conductors are bare 4/0 copper.

"We also wanted to improve on the tower's Ufer ground (Figure 4), originally installed by the phone company, so we drove two more electrodes on diagonals leading outward from each of the tower's legs. Those electrodes form what is called a star-ground. We used bare 4/0 copper to connect all electrodes. We then bonded a lead from the nine new

electrodes to the Center's primary electrode, which is located below the service entrance panel. The entire system has a ground resistance of less than four ohms."

Why a star ground for the tower? "Current flow from a lightning strike tends to spread outward when it enters the ground," West explained. "By locating the tower's grounding electrodes on diagonals and connecting them with heavy-gage copper, we help dissipate the charge into the ground and away from the building we want to protect."

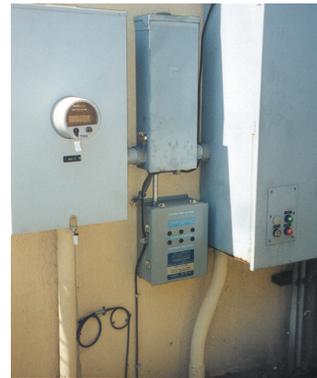
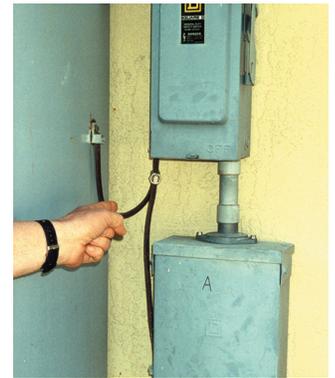
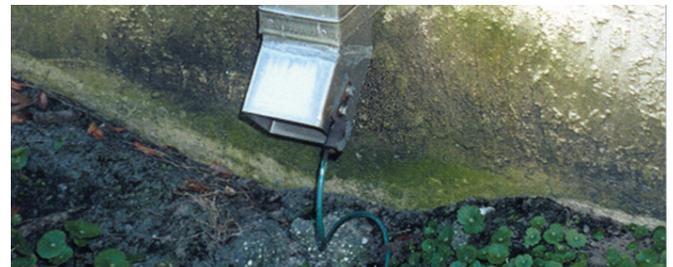
The service entrance (Figure 5A) and sub-panels (Figure 5B) are bonded to a buried 4/0 copper ring-ground, as are all other exterior metal objects, including downspouts (Figure 5C). Note the large TVSS beneath the middle panel in Figure 5A.

West next drove a series of electrodes around the Comm Center at 20-ft (6-m) intervals. The electrodes were bonded to a 4/0 copper ring-ground connected to the primary grounding electrode at the service entrance. Additional 4/0 cables were installed from the ring-ground to all metal objects on or near the building's exterior: electrical panels, sub-panels, a chain-link fence and even metal downspouts (Figure 5).

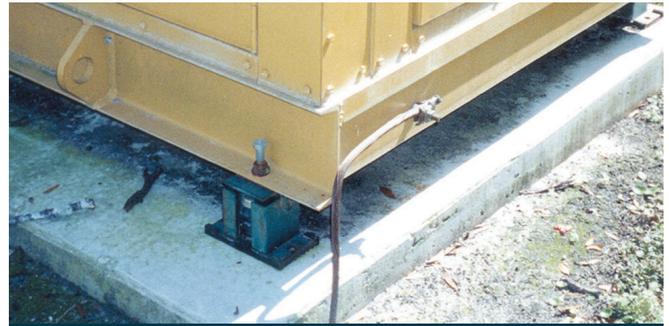
FIGURE 6.

The emergency generator is also connected to the ring-ground, and is additionally grounded to reinforcing rods in its concrete pad.

The Center's emergency power generator is connected to the ring-ground with 4/0 copper. An additional ground connection is made from the generator frame to reinforcing rods in the concrete pedestal on which the generator stands (Figure 6).

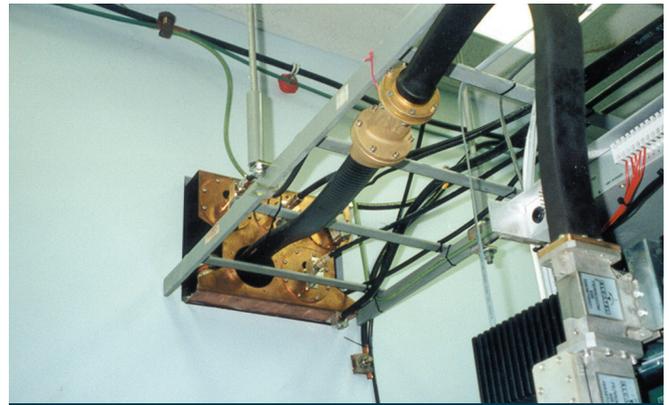
FIGURE 7.

Figure 7. Coax cables enter the Communication Center through a fabricated copper grounding plate. Waveguides (light-colored connector and black rectangular shape to the right) connect to communications equipment. The grounding plate is bonded to a 4/0 copper halo ground that circles the room near the ceiling (black cable, top of photo).

Connections from the exterior grounding system (i.e., the primary electrode, ring-ground and connections to the coax cable shields) lead into the building at two locations. One connection is made by way of a fabricated copper frame at the point where the coax enters the building (Figure 7). The frame is aligned with the matching copper plate mounted on the exterior wall. A second grounding conductor penetration can be found at the service entrance.

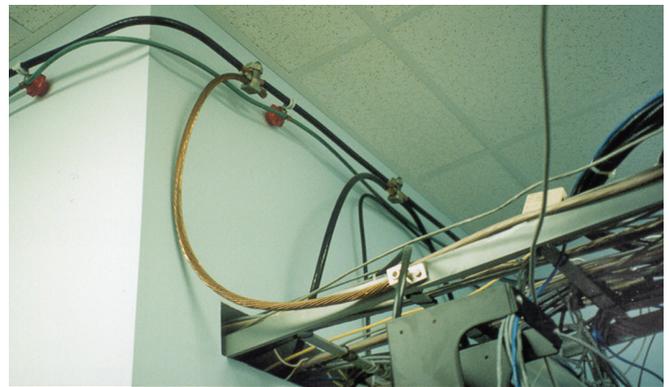
FIGURE 8.

Figure 8. The new halo ground connects to equipment racks with bare 4/0 copper and tinned copper lugs. Note generous bend radii at all turns and corners. Large radii are recommended for grounding conductors in situations where HF signals are present. PSI left an existing halo ground in place (green #6 AWG cable, top of photo).

More 4/0 copper connects the halo grounds to the equipment racks that crowd several of the facility's rooms (Figure 8). At first glance, the cables appear to be rather loosely draped, but West explains that this arrangement is intentional. "Recommended practice calls for bends in lightning protection/grounding conductors to have generous radii, with no sharp bends. This is particularly valuable where high frequencies such as those associated with communications equipment, or lightning, are involved."

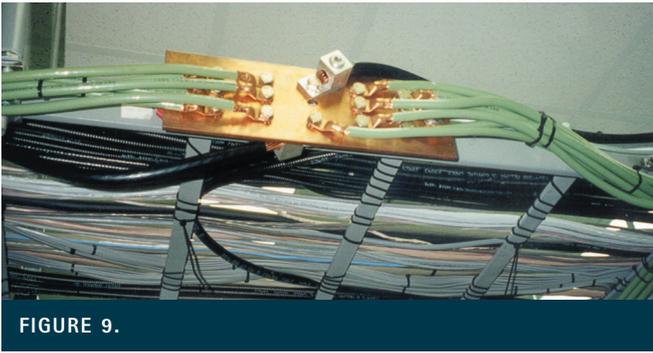
FIGURE 9.

Grounding jumpers from individual equipment consoles (green #2 AWG cables) connect at several 1/4-in (6.4-mm) thick copper bus plates mounted on equipment racks. Insulated 4/0 copper cables lead from these plates to the 4/0 halo ground and from there to the main grounding connection at the service entrance panel.

Additional 4/0 grounding conductors lead from the halo to 1/4-in (6.4-mm) thick copper bus plates mounted at convenient locations on the racks (Figure 9). The plates serve as collectors from which #2 AWG copper cables extend to individual equipment consoles. All connections are made using copper, tinned-copper or copper alloy (bronze or brass) bolt-on lugs.

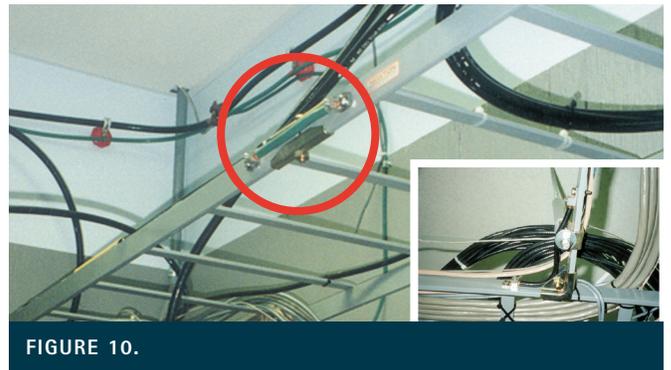
FIGURE 10.

Joints between sections of equipment racks are jumpered with copper conductors. Such connections provide electrical continuity and ensure that all connected equipment sees the same low ground potential.

Joints between sections of the fabricated equipment racks are jumpered with short lengths of #2 AWG copper (Figure 10). These connections ensure that all equipment connected to the racks see the same low ground potential.

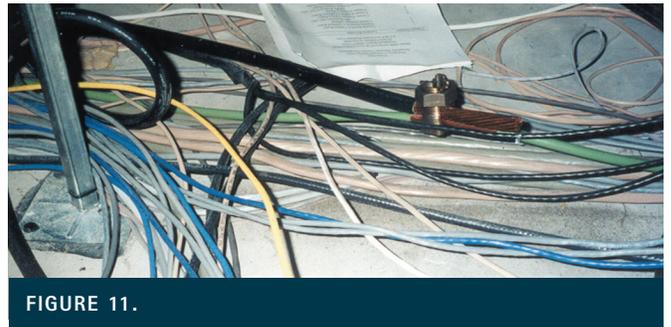
FIGURE 11.

Grounding connections in the dispatch room are made beneath the floor to reduce clutter. Here, a 4/0 copper grounding conductor leading to the service entrance (black cable, top center) connects with #2 AWG leads (green cable) that extend to the dispatchers' consoles and other equipment in the room.

grid was not considered necessary here, so West home-ran grounding jumpers from each equipment console to a 4/0 cable leading to the building's grounding system. Jumpers are made from insulated #2 AWG copper; as was done elsewhere in the Center, all grounding connections in the dispatch room are made with bolt-on copper-base lugs (Figure 11).

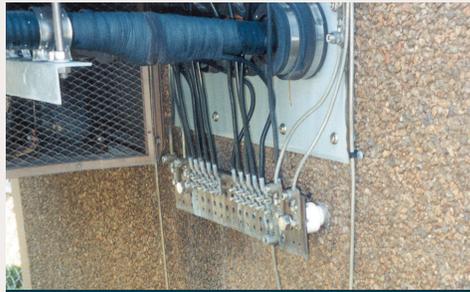
FIGURE 12.

Grounding connections to coax cable shields at the cellular-telephone/long-distance service provider that shares Winter Park's antenna tower are made on the horizontal run of the cables. Connection to vertical runs provide better lightning protection, according to PSI's John West. #2 AWG grounding electrode conductors installed by the telephone company are the minimum size permitted under the NEC. The Winter Park Communication Center up-sized its grounding electrode conductors to more-robust 4/0 copper.

Grounding connections to coax cable shields at the telephone service provider that shares Winter Park's antenna tower are made on the horizontal run of the cables as they enter the service provider's building (Figure 12). Such connections are not as protective as those on the Communication Center's system, shown in Figure 2. In addition, grounding electrode conductors installed by the telephone company are #2 AWG. For better protection against lightning damage and to ensure a low-impedance ground connection, the Communication Center's facilities utilize robust 4/0 copper grounding electrode conductors. A grounding connection to the telephone company's building was made at a lifting lug on the modular structure (Figure 13).
